Z & Z Intimates Ltd

Plot # 1-3, Road # 02, CEPZ, Chittagong, Bangladesh
(22.289779, 91.777223)
07th January, 2018

Observations

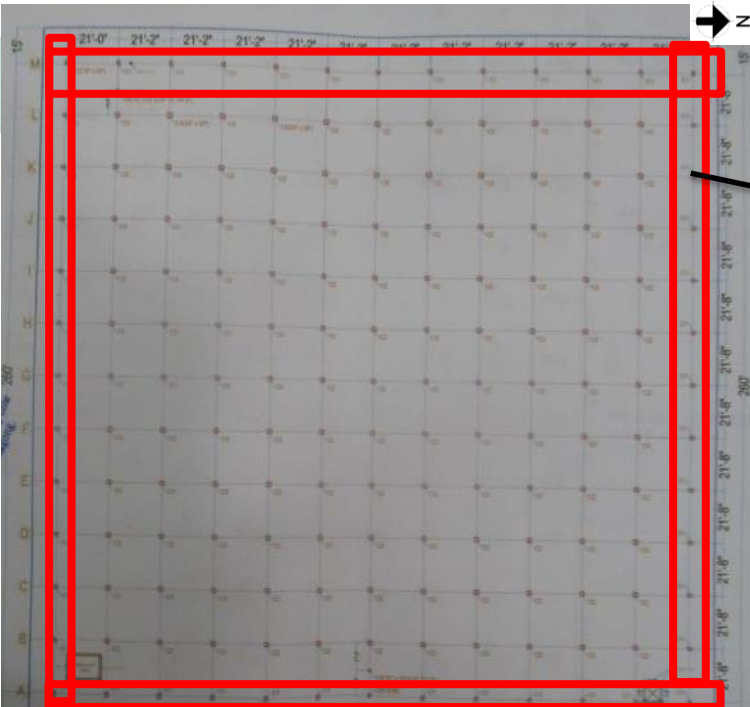
Column Layout

Rebar in C-1 type column was found by ferro scanning 10nos. instead of 12nos. on 4th floor.

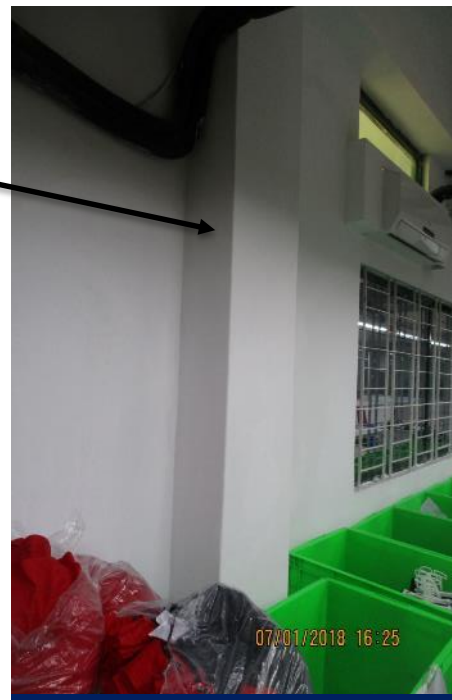
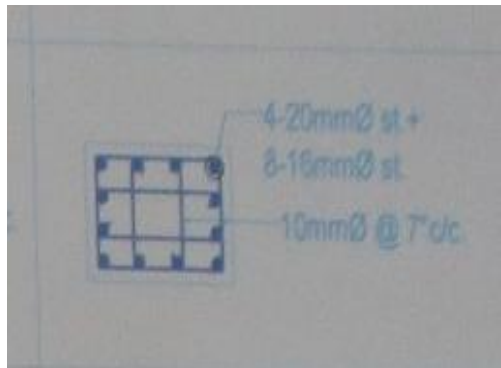
C-1 type column

Column schedule for 4th floor of C-1 type where shown 12 nos. rebar

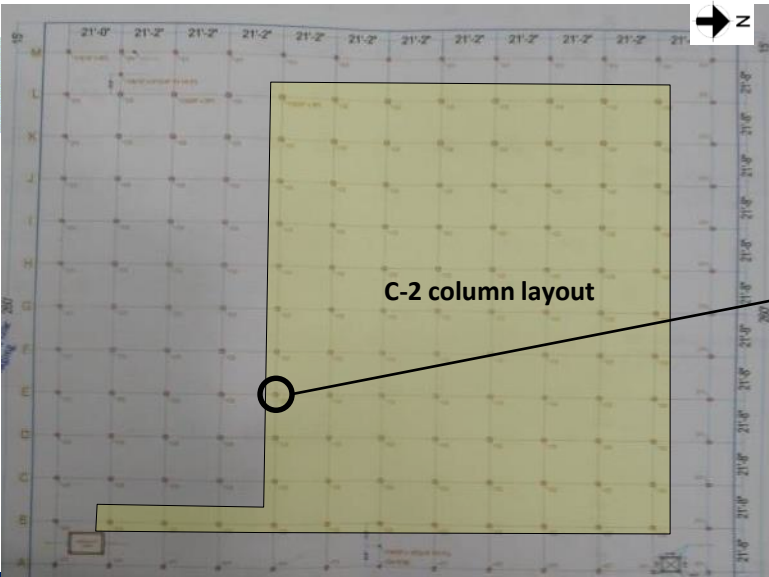
Column Layout

Rebar in C-2 type column was found 12nos by Ferro scanning. On 4th floor and 14 nos. On 3rd floor whereas 16 nos. rebar was shown in column schedule for 3rd and 4th floor.

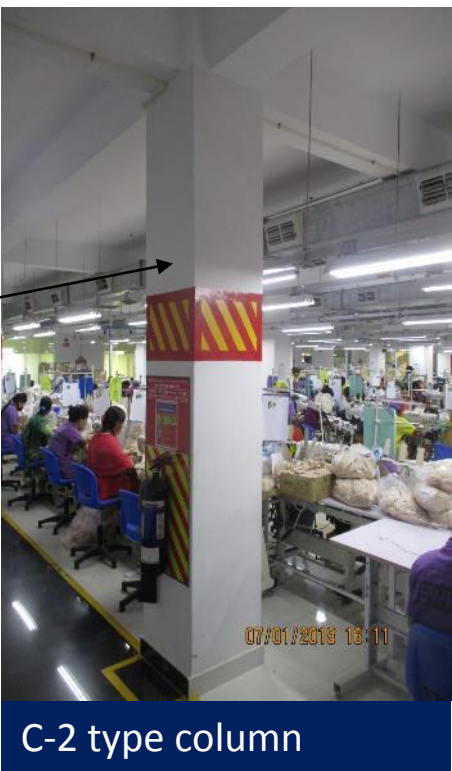
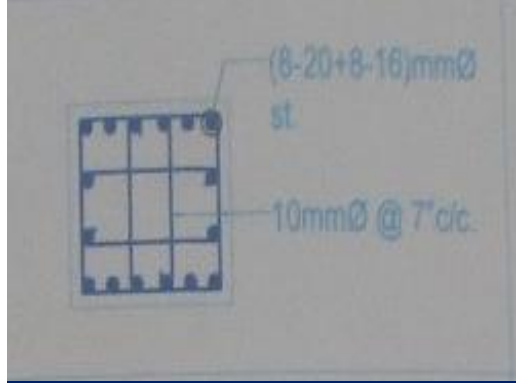
C-2 type column

Column schedule for 3rd and 4th floor of C-2 type where shown 16 nos. rebar

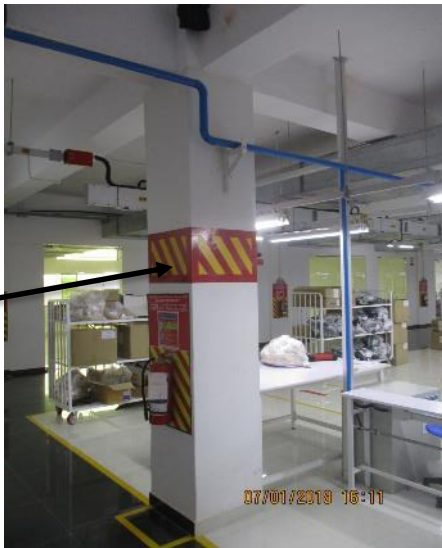
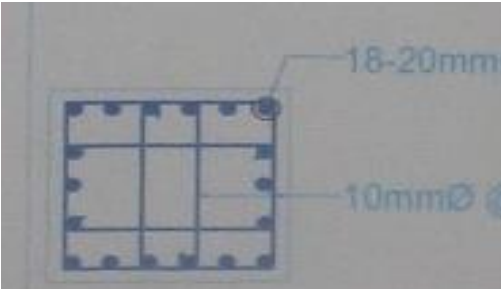
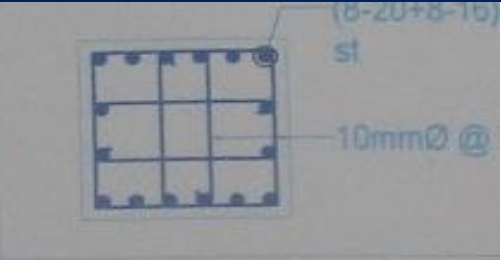
C-3 type column

C3-Column
18 nos. rebar shown in column schedule ground to 1st floor

C3-Column
16 nos. rebar shown in column schedule 3rd to 4th.

The rebar was checked by ferro scanning and found non-identical with column schedule on ground, 1st, 3rd and 4th floor.

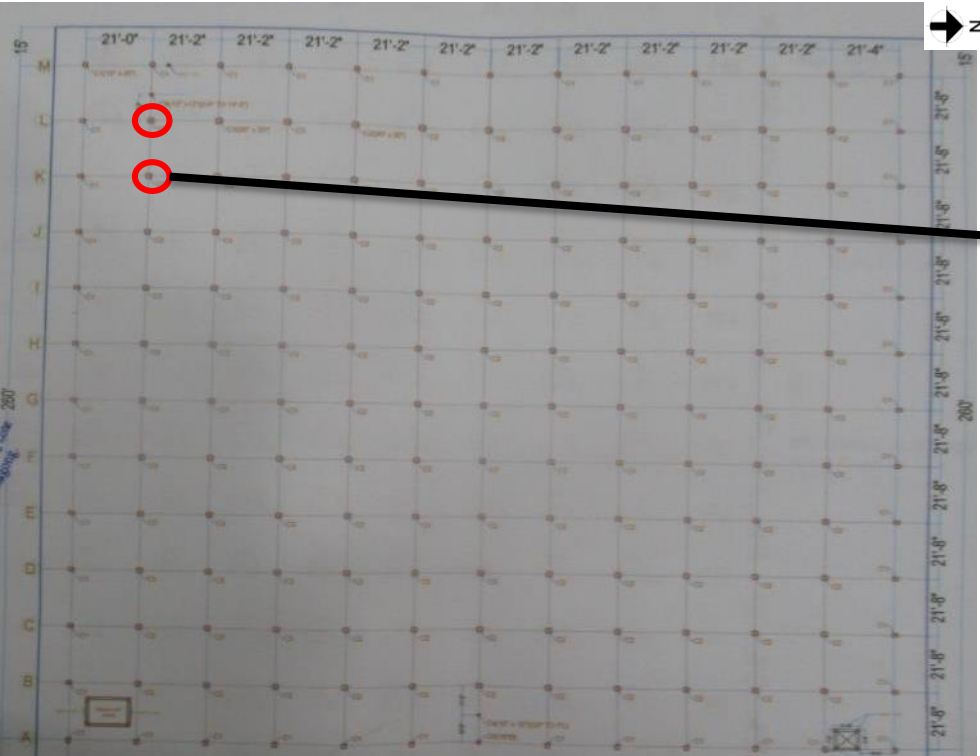
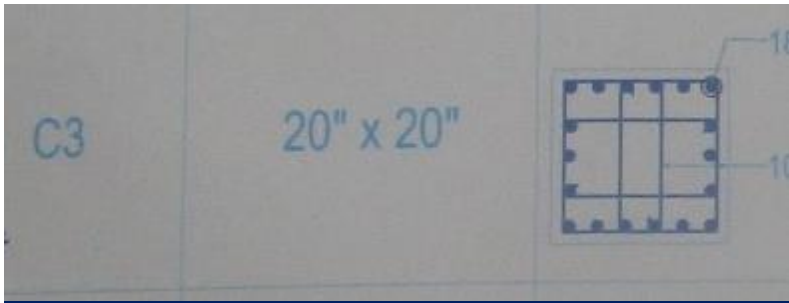
Column Layout

500mm x 500mm dimension was shown for C-3 type column in column schedule

The dimension was measured 400mm x 500mm with render on 3rd and 4th floor but the dimension was mention 500mm x 500mm in column schedule.

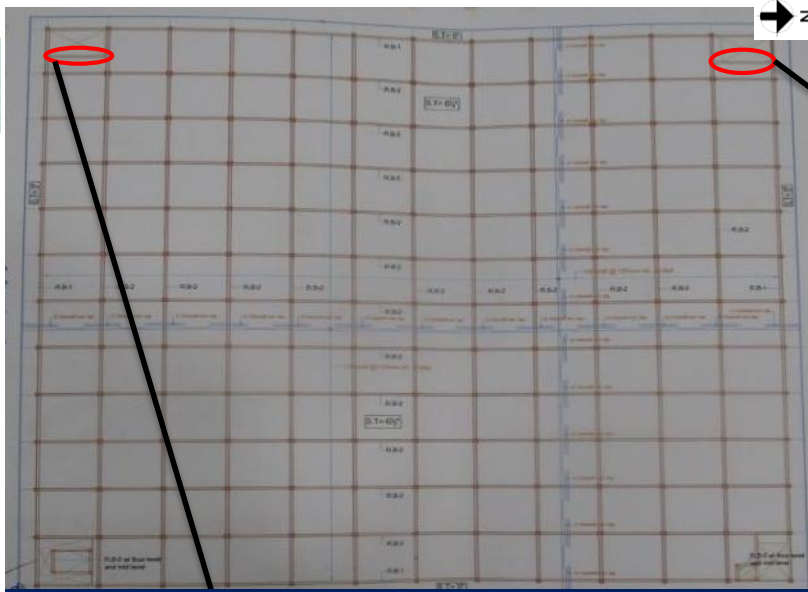
Typical beam layout

The marked beams on south-west and north-west side stair was not found but the beams were shown in drawing. Factory is required to revise the mentioned mismatch and produce the accurate as-build drawing.

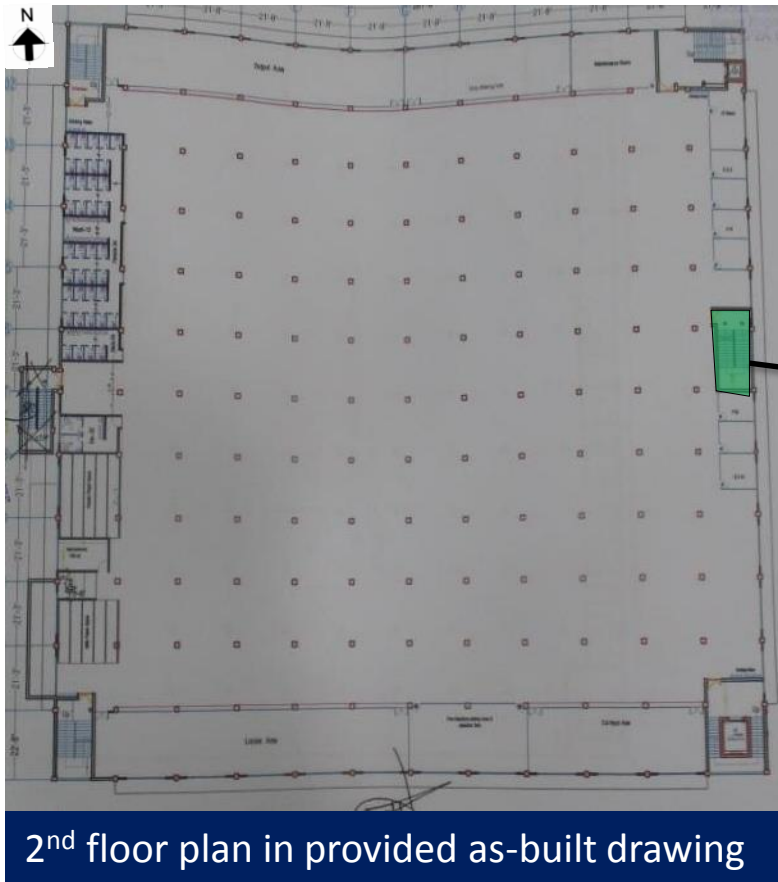
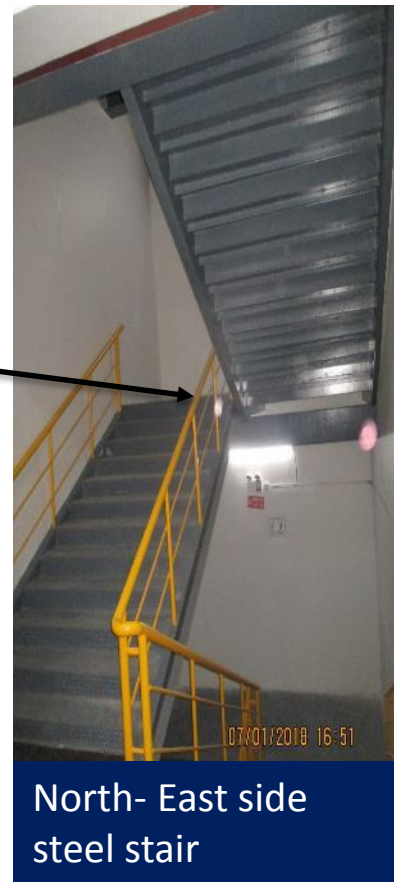
2nd floor plan in provided as-built drawing

North-East steel stair drawings was not available. Also, the steel columns of the stair are adjacent with the reinforced columns of the building.

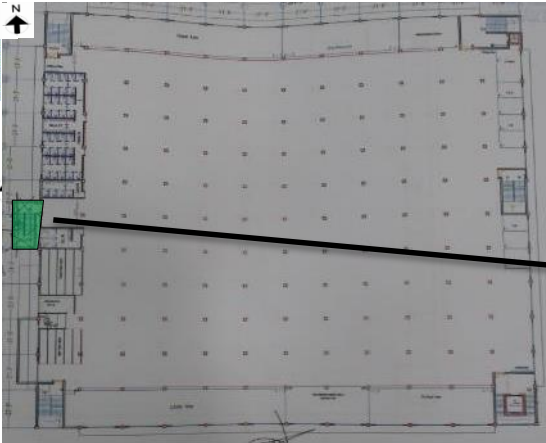
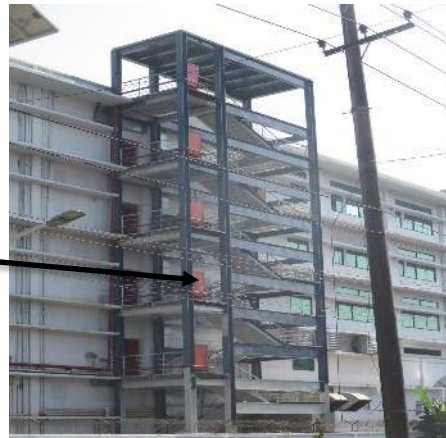
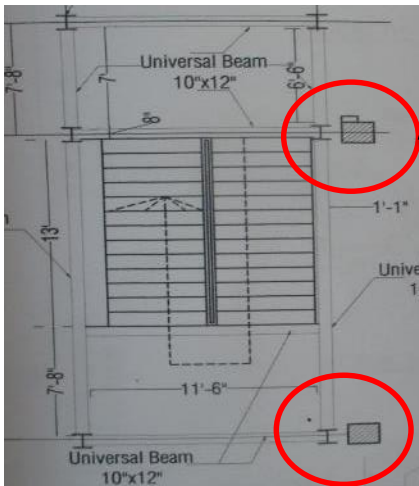
2nd floor plan

Connection detail of the beam – column joint and steel beam layout was not include in the provided drawing. Also, the steel columns of the stair were rest the pile cap of the reinforced column. Factory engineer is required to update the drawing and assess the foundation of the stair cases.
