# Meek Sweater & Fashions Ltd.

Plot No: 1693, Bashon Sarak; Gazipur  
(23.973789N, 90.374398E)  
13<sup>th</sup> May 2018

# Observations

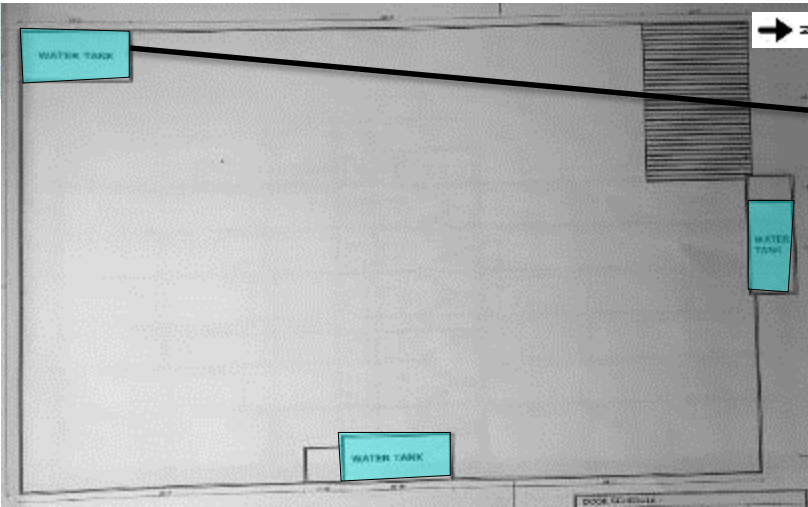
Roof Layout

Cursory calculation indicates that highlighted columns appear to be stressed above normal design limits due to over head water tank and brick wall & floor built-up of toilet area. Factory engineer needs to check column stress as a part of Detail Engineering Assessment(DEA) . Factory should take necessary action according to report.

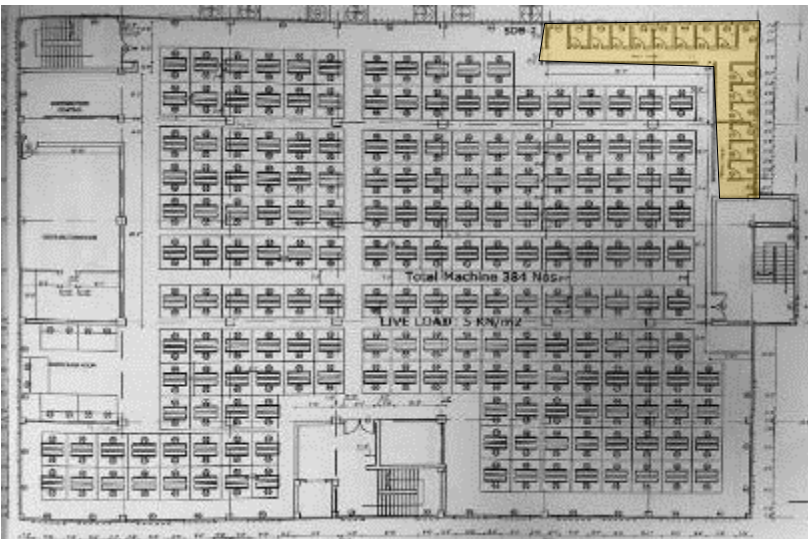
Typical floor layout

200mm built-up and 125mm thick outer brick wall on toilet area

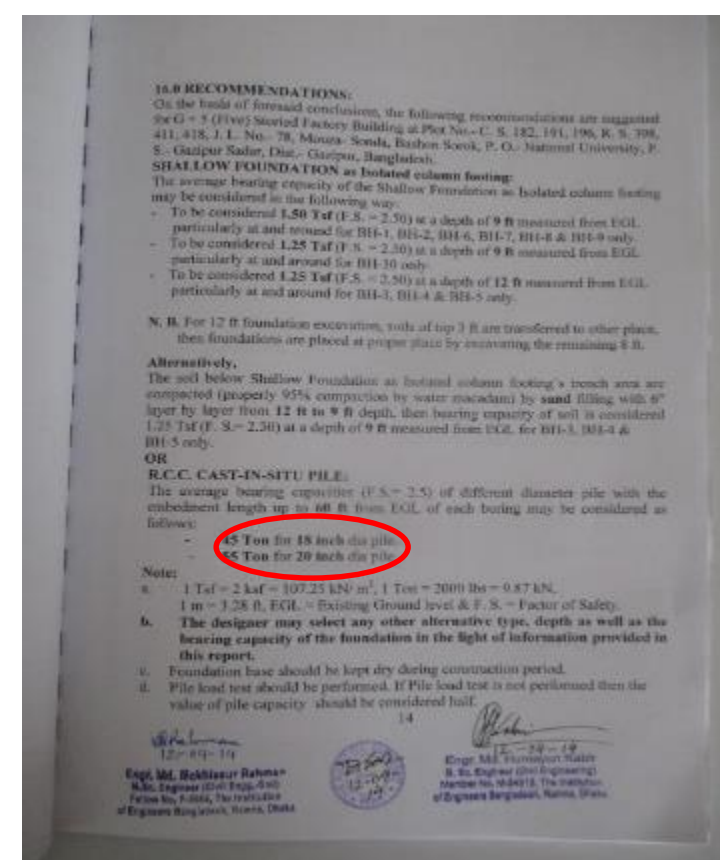
Recommendation of geotechnical investigation report

Cursory calculation considering the pile capacity based on soil test report indicates that pile appears to be stressed above normal design limits at marked zone. Factor of safety (FoS) is less than the minimum requirement of BNBC. Factory engineer is required to review the adequacy of pile considering actual bearing capacity of soil and comply with BNBC.

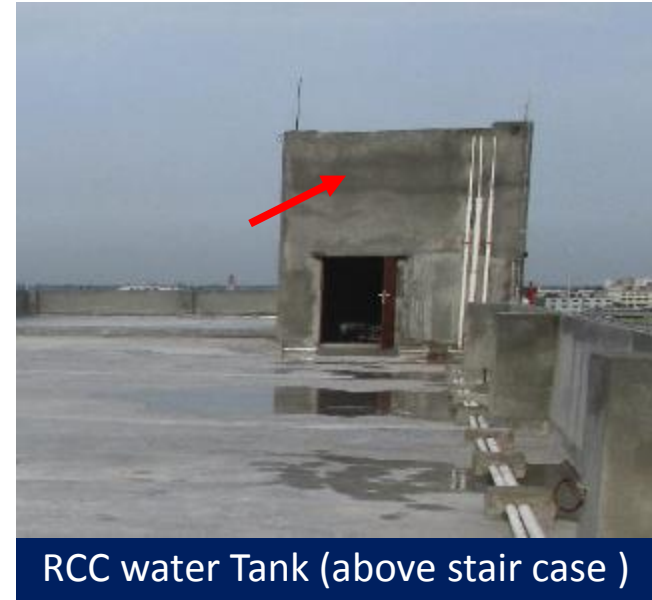
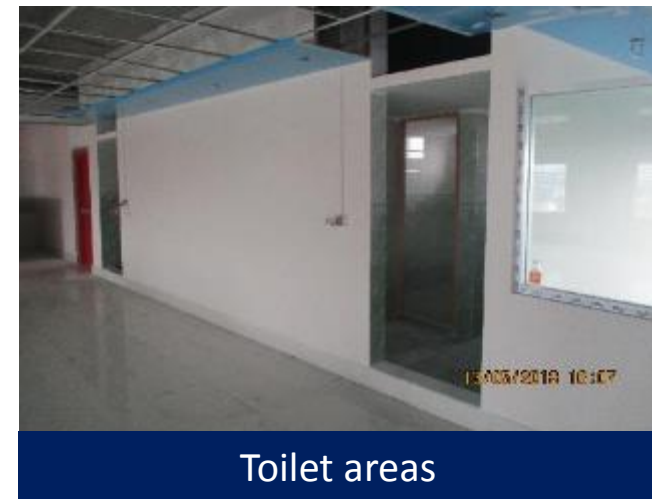
Column layout

Cursory calculation indicates that highlighted columns appear to be stressed above normal design limits due to loads of water tanks and brick walls of toilet areas. Factory engineer need to check column stress as a part of Detail Engineering Assessment (DEA) and factory should be take necessary action according to report.

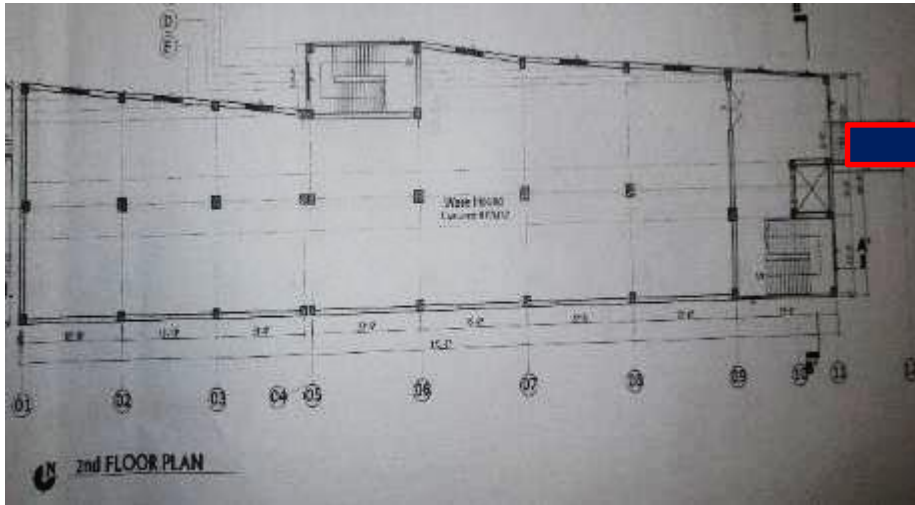
2<sup>nd</sup> floor Plan (Ware-House Building)

# Beam Adequacy check for link bridge
