# Aspire Garments Limited

491, Dhalla Bazar, Singair, Manikgonj

24<sup>th</sup> December 2017

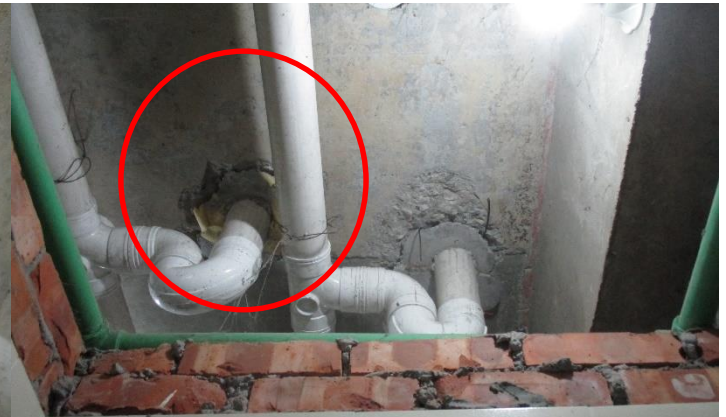
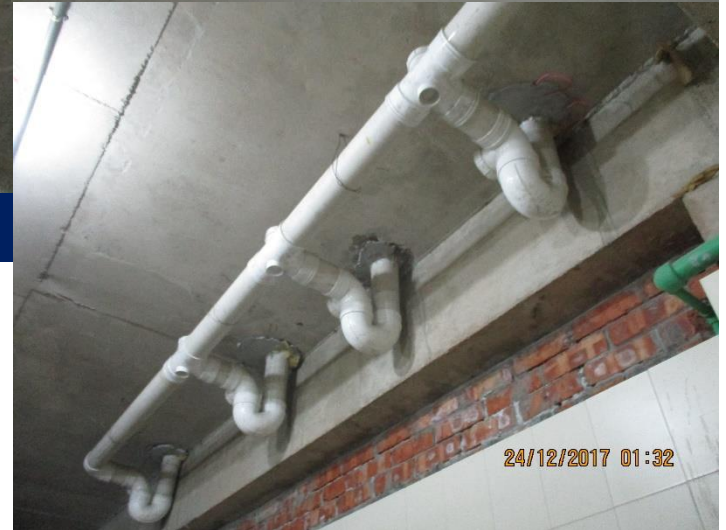
# Loose concrete repair work around plumbing area

Concrete repair work around ducting facility in toilet area appeared loosen. Falling hazard may occurred direct to personal. Building engineer is required to repair the loose material works to prevent falling hazard.

| Item No. | Observation | Recommended Action Plan | Recommended Timeline |
|---|---|---|---|
| 1 | Loose concrete repair work around plumbing area | Building engineer is required to investigate the locations and carry out sustainable repair works. | Immediate - Now |

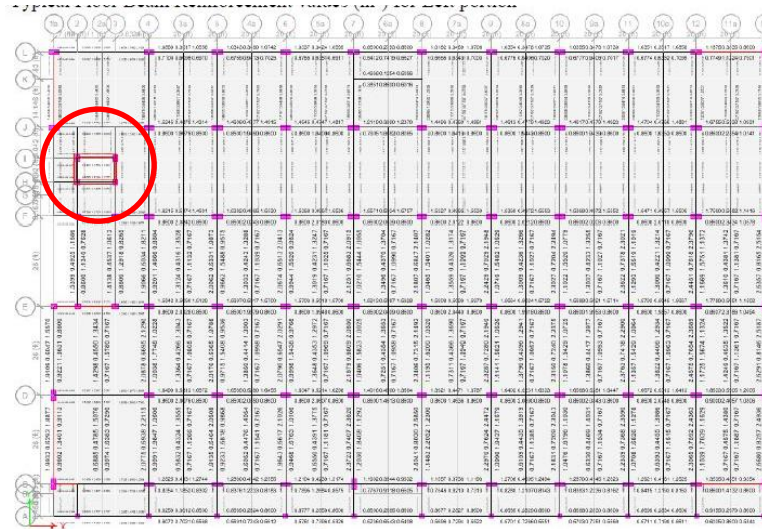
**Design report to be verified by Accord.**

The structure was modeled using 3-D computer program and designed for all possible load combinations. The following observations have been done.

- The top deflection of the structure was found within allowable limit.
- The foundations were designed based on the unfactored reactions of the columns.
- The thickness provided in pile cap is found satisfactory from the punching and beam shear point of view.
- The column sizes and reinforcements were checked by hand calculations with those obtained from ETABS.
- The foundations and the columns can bear the load coming from 6 storied garments building and the structure is found safe and stable for all possible load combinations.
- The reinforcement found in the shear wall is found satisfactory.

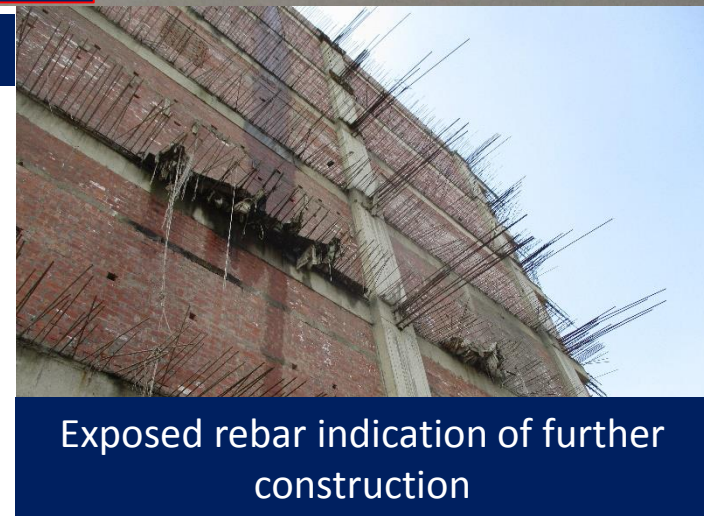
Part-B of the building will be constructed in future. Rebar kept exposed without any corrosion protection.

| Item No. | Observation | Recommended Action Plan | Recommended Timeline |
|---|---|---|---|
| 9 | Exposed rebar to weather | For both durability and serviceability, rust proof paint or any appropriate method is recommended. | 6-weeks |
