Logos Apparels Ltd.-Unit-2

Telerchala, Mouchak, Kaliakoir, Gazipur

01st July 2018

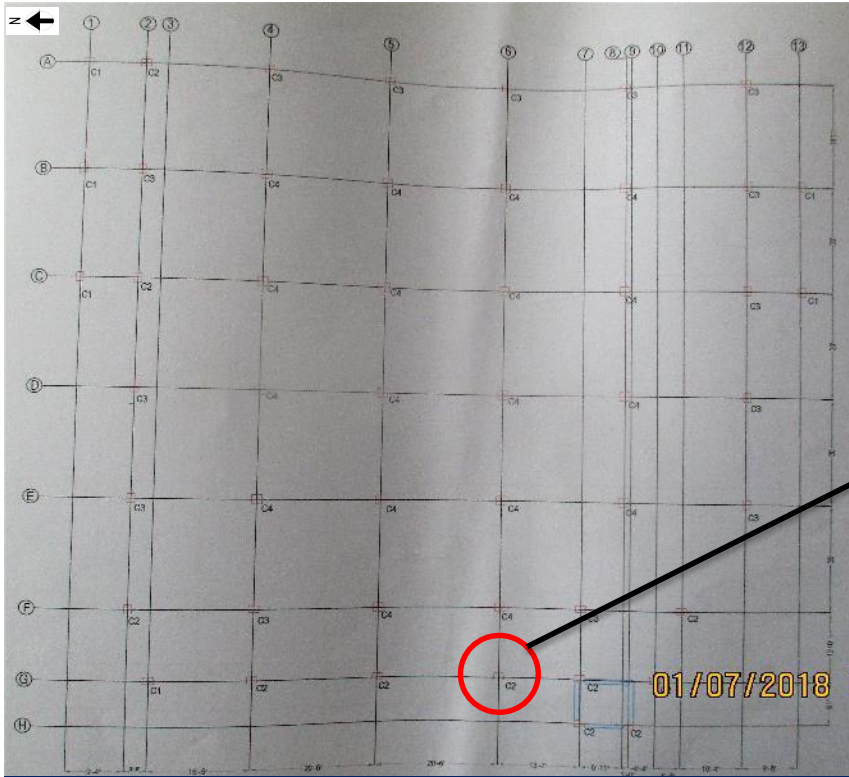
Column layout

Cursory calculation (considering 63 psf live load and core test report provided by the factory) indicates that highlighted columns appear to be stressed above normal design limits due to overhead water tank and brick wall & build-up of toilet area. Whereas all columns were declared as safe for carrying 42 psf live load in the conclusion of the provided DEA report. Factory is required to revise the DEA report according to BNBC provision and submit to ACCORD for further review.

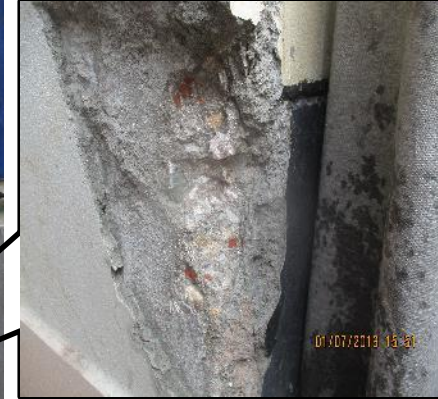
Mixture of stone & brick aggregate was found in the marked column

Combination of stone aggregate & brick aggregate was found in the above marked column. Factory is require to verify the concrete strength of the marked column and incorporate it in the DEA report.

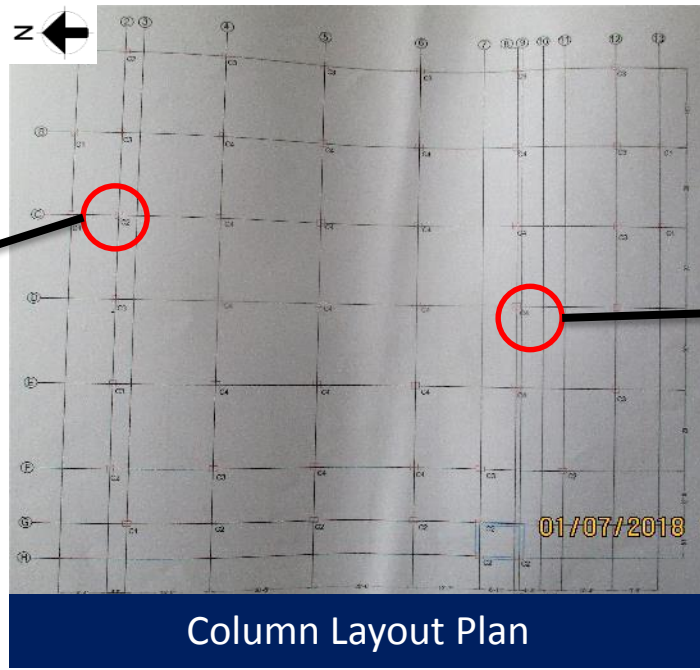
Column Layout Plan

C-3 type column

12 nos. rebar found by ferro scanning in C-3 type columns instead of 16 nos.

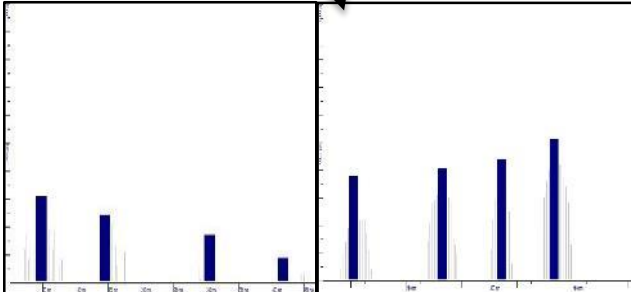
Number of rebars in C-3 & C-4 type columns were found less than that of shown in column schedule of as-built structural drawing.

Factory is required to update the as-built drawing which reflect the actual condition.

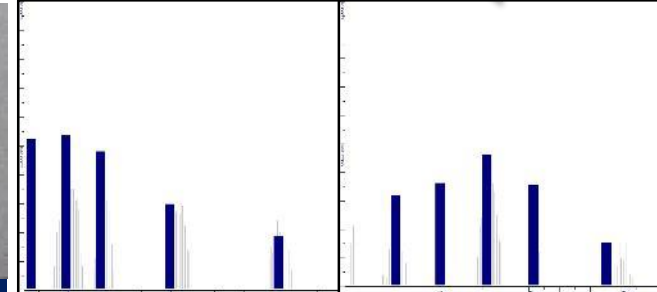
16 nos. rebar found by ferro scanning in C-4 type columns instead of 20 nos.

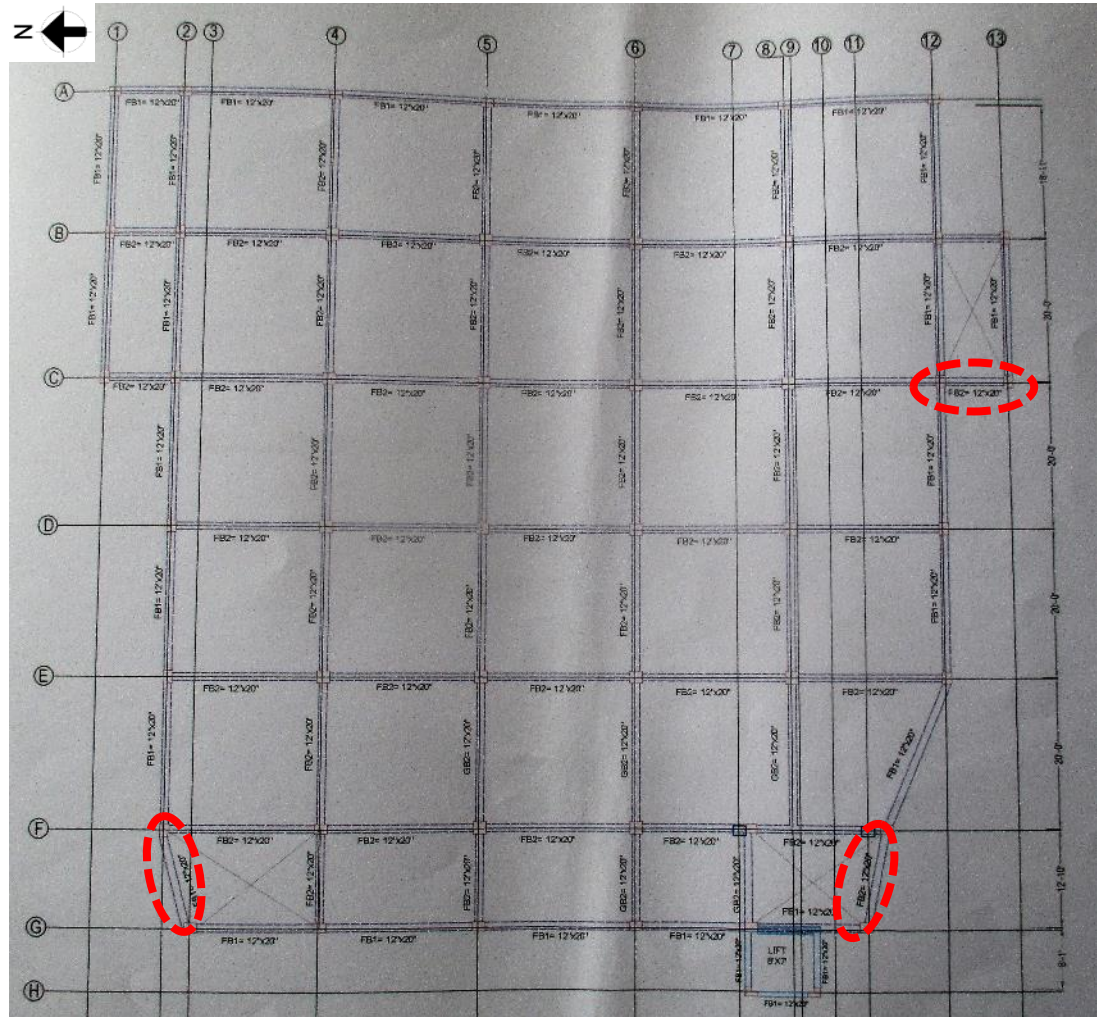
Beam Layout Plan

No floor beam was found at stair case on marked location.

Three beams were not found at the marked location on each floor. Whereas, floor beams were shown in provided as-built drawing.

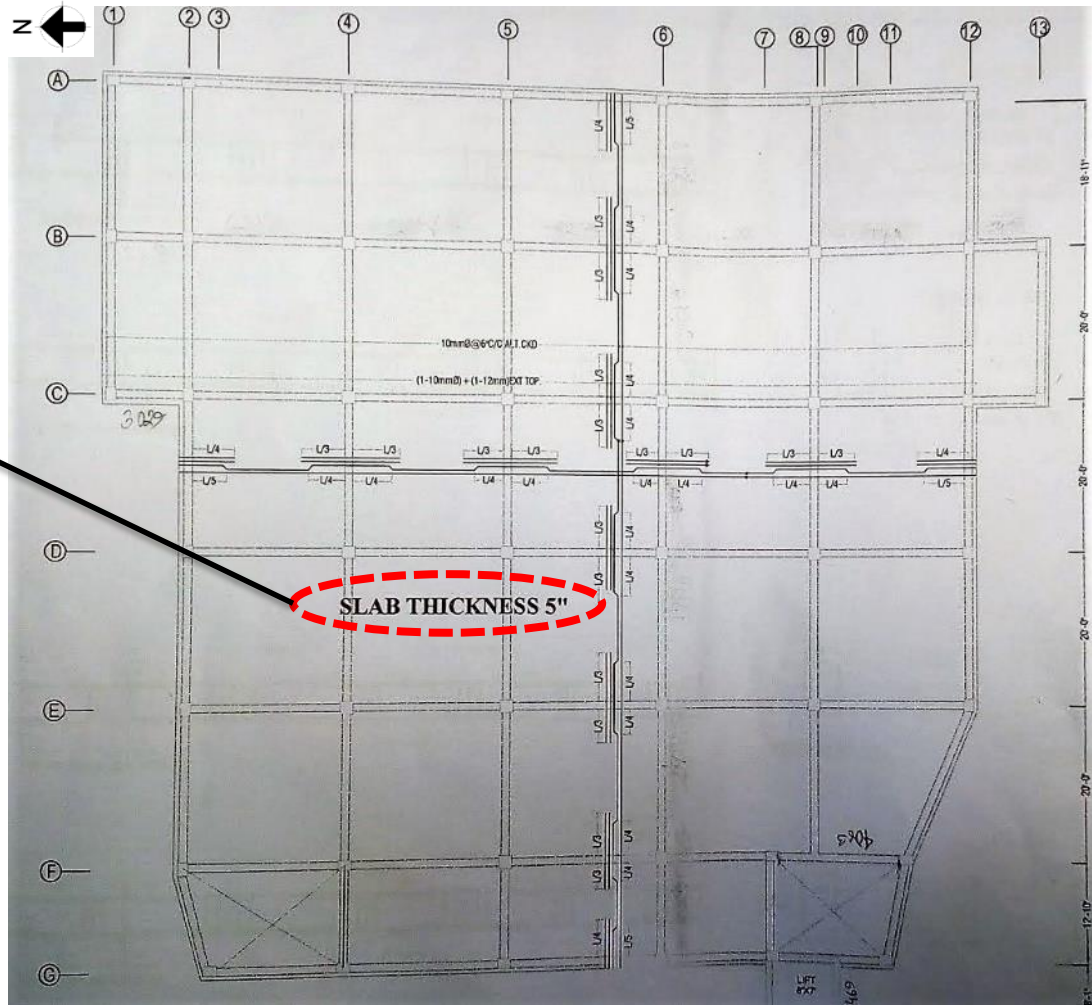
Slab layout Plan

Slab thickness was found 6 inches on site

In provided drawing, slab thickness was shown as 5 inches. Whereas, slab thickness was found 6 inches on site.
