# Bela Fashions Ltd.

6 Shing Bari Road Boro Dewra Tongi, Gazipur-1700.

15<sup>th</sup> July 2018

# Observations

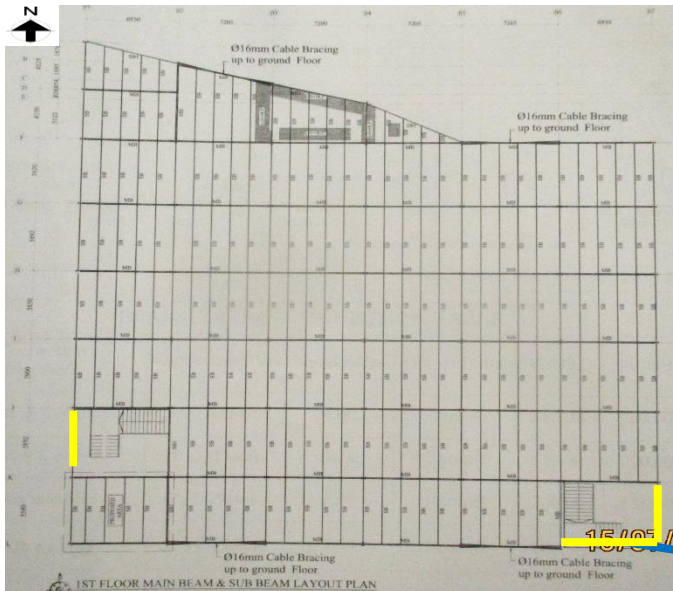
Beam layout

At end bay (near stair) no steel beam has been provided. But in provided design report that beam has been considered . Load transferring medium of end frame and first internal frame is not clear.

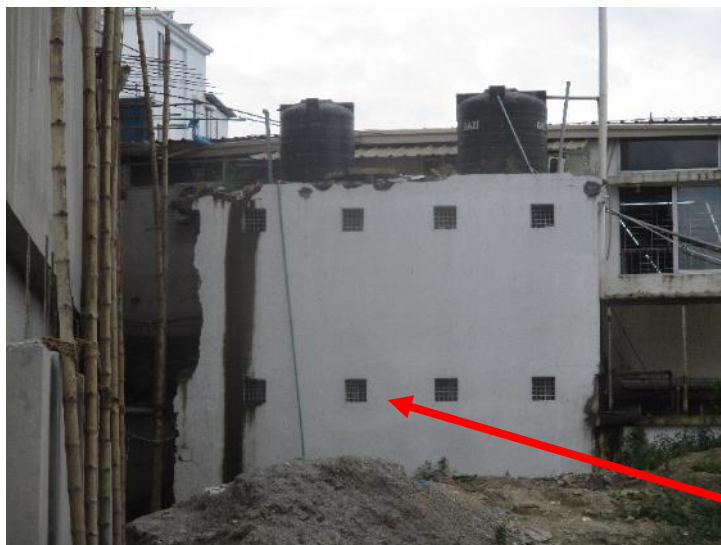
2-storied RCC toilet block

Undocumented extension observed at South side of production building.
