A-One Polar Ltd. (New Buildings)

Vulta, Rupgonj

28th May and 3rd June 2018

Observations

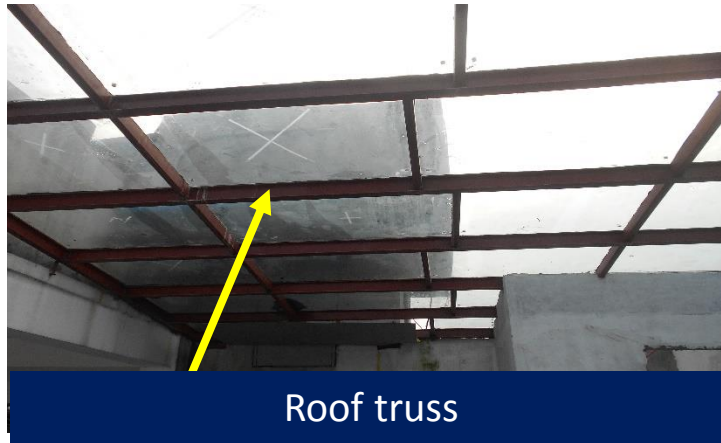
Roof truss

Location and details drawing of water tank was not found in the As-built drawing. As-built drawing of roof truss was missing.

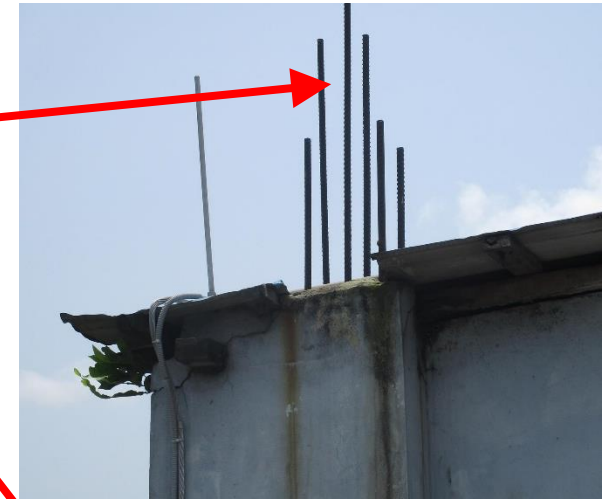
8 nos. rebars are shown in column schedule where 6 rebars were found onsite. Also, the column layout of the provided drawings did not match with on site arrangement. Additional columns were found during inspection which has been marked as green.

6 Rebars in stair column

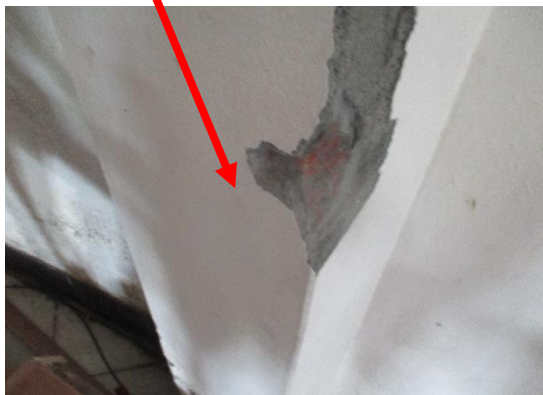
Additional column

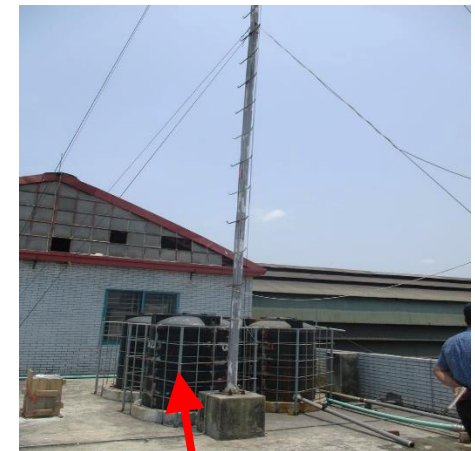
4x1000 ltr. Water Tank and a mast on 3rd floor

Floor beams were missing on marked location of 1st & 2nd floor. Undocumented roof truss was found on 3rd floor . Water tanks were observed on 2nd floor roof (4x1000 litre). Also, Cantilever beams were found in south direction of the building but not shown in as built drawing .

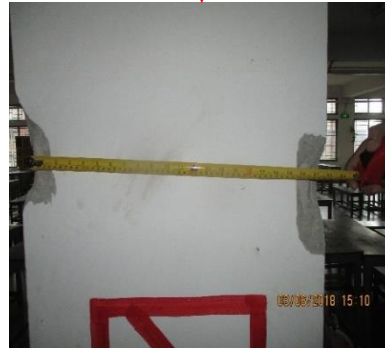
C2 Column was measured 500mm instead of 550mm

The dimension of all C1 and C2 type columns were found smaller than column schedule. Diameter of C1 column was measured 600mm instead of 650mm and C2 column dimension was found 600mm instead 550mm. Moreover, on B-3 grid (marked as green on layout) the orientation of C2 column didn't match with column layout plan.

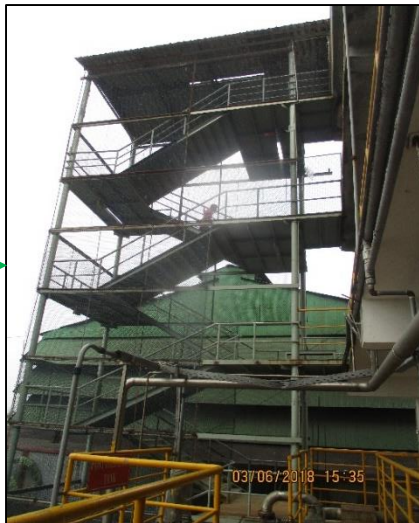
Emergency Steel stair on north face.

No document was found of emergency steel stair on north side and south side. Factory Engineer is required to prepare as-built drawing (structural and architectural) and carry out stability check against the lateral loads.

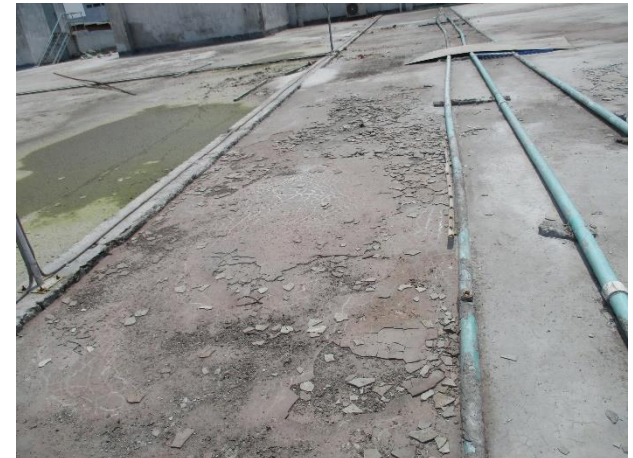
Water ponding was found in the roof. Also, poor water proofing layer was observed on roof slab. Building engineer to develop proper drainage system and provide proper water proofing layer on roof.

Poor water proofing layer

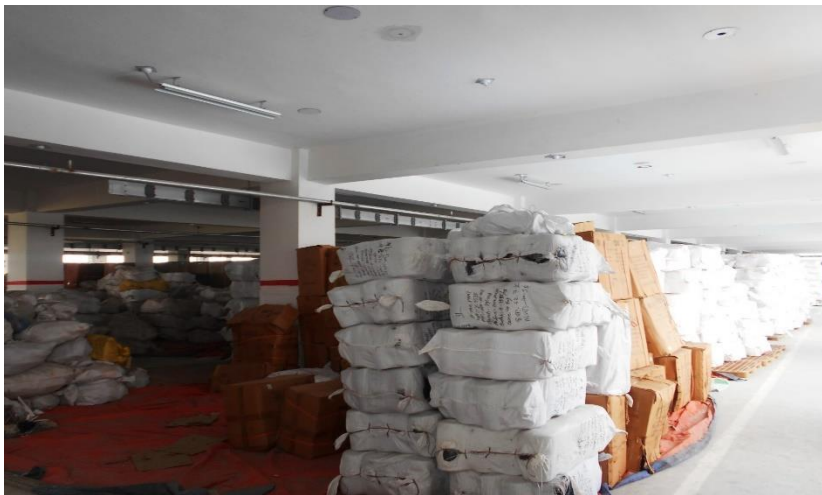
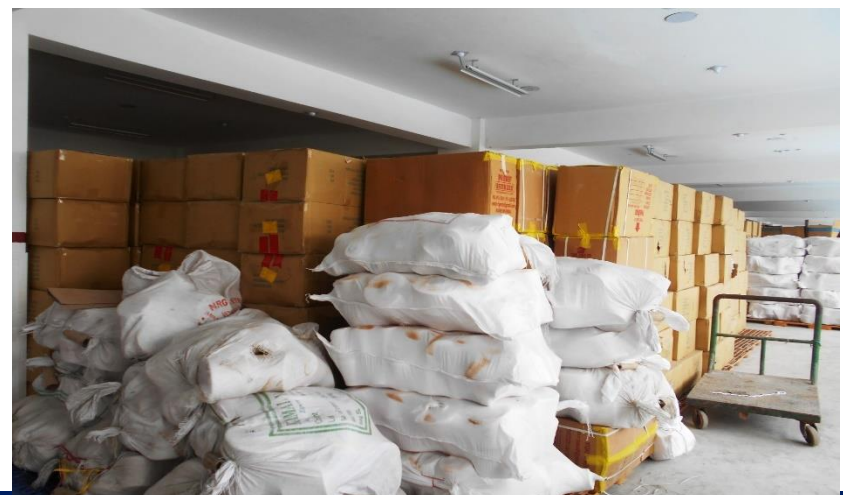
Loading in 2nd floor

No load management program was found. Load was found around 83 psf. Load restriction height marking is required and load management plan is required to be followed.

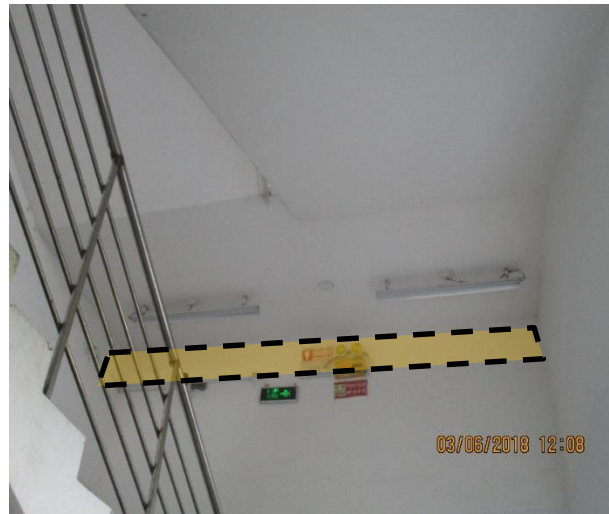
Cross section of Stair.

Discrepancies between as- built drawings and on site condition

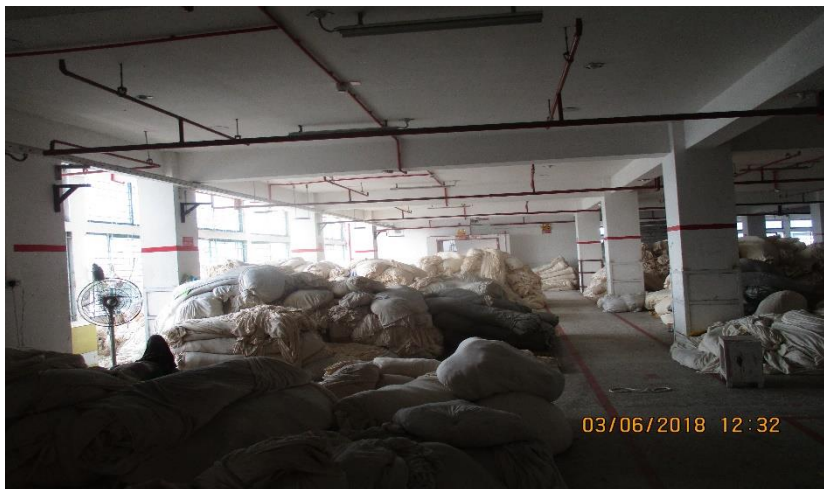
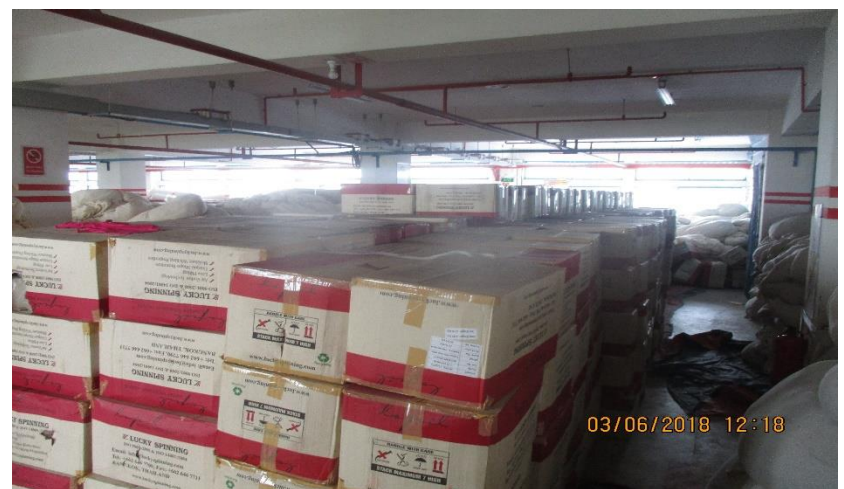
Loading in 2nd floor

No load management program was found. Load was more than 63 psf. Load restriction height marking is required and load management plan is required to be followed.

Implement floor load management program
