# Mega Denim Ltd.

88/1, B.K Bari, Taltoli, Mirjapur, Gazipur sadar, Gazipur  
(24.120966, 90.378342)

23<sup>rd</sup> September 2018

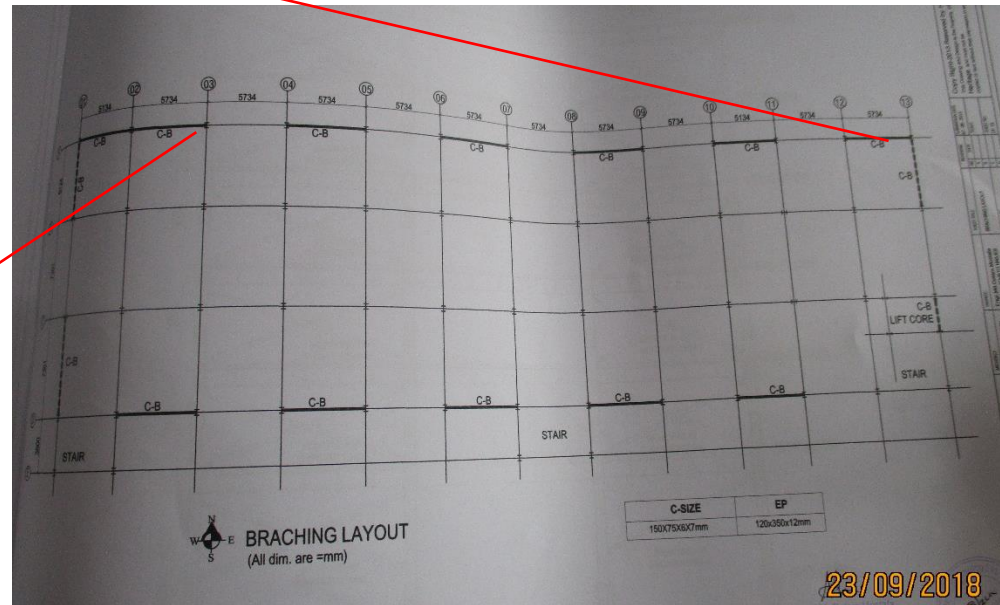
Bracing layout

**Bracings are not installed as per  
bracing layout**

Bracings were not installed as per bracing layout. Bracing was missing at several location on 2<sup>nd</sup>, 3<sup>rd</sup> and Ground floor.

| Item No. | Observation | Recommended Action Plan | Recommended Timeline |
|---|---|---|---|
| 2 | Bracings are not installed as per bracing layout | Install missing bracing as per bracing layout. | 6-weeks |
