# Anowara Fashions Ltd.

35/A ,Hajigonj Road,Narayanganj.

24<sup>th</sup> September 2018

# Observation

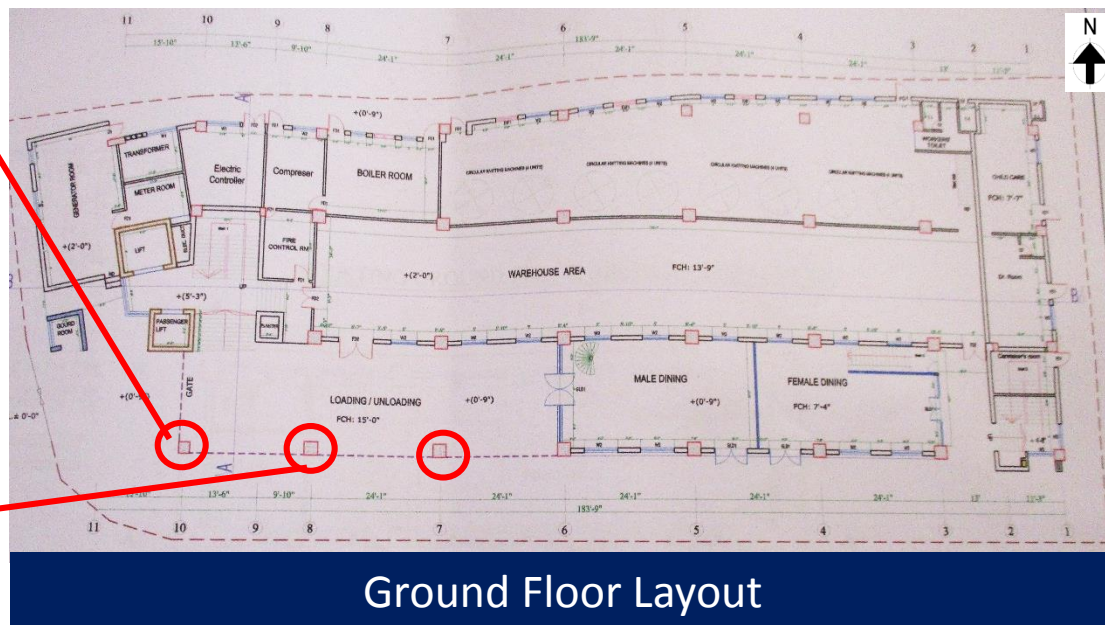
Ground Floor Layout

# Columns susceptible to vehicle impact

Impact protection not provided to columns at loading –unloading area. Columns are susceptible to impact loading from vehicles.

1: Columns susceptible to vehicle impact.
