Cute Dress Industry Limited

Bathuli, Shaha Belissor, Dhamrai, Dhaka

31st October 2018

Observations

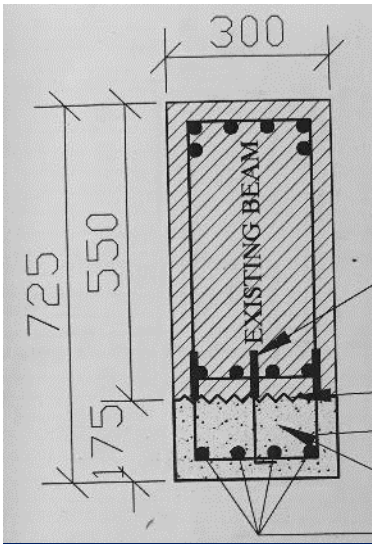
Retrofitted beam schedule

According to the design report, some beams were required to be retrofitted. But onsite, the retrofitted beams layout did not match with drawing. Factory is required to revise the design report as per on site condition.

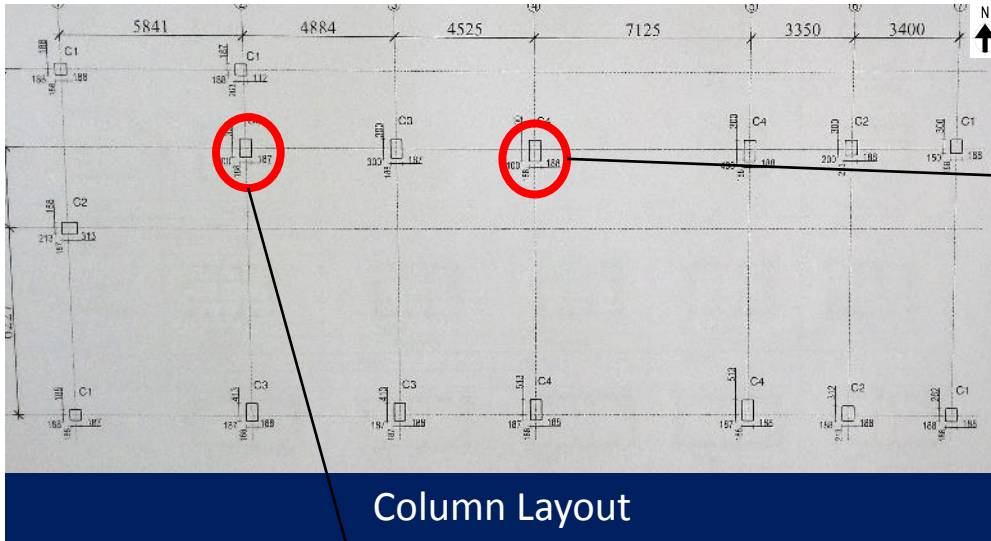
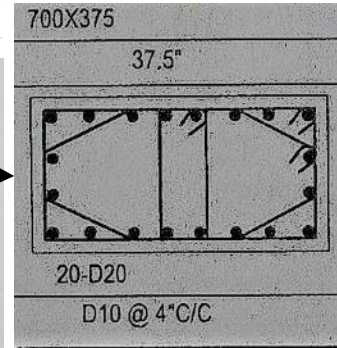
Column schedule of C-4 column

3 rebars were found in short direction of C4 columns instead of 4 rebars

Factory is required to produce accurate as-built drawings reflecting actual on site condition.

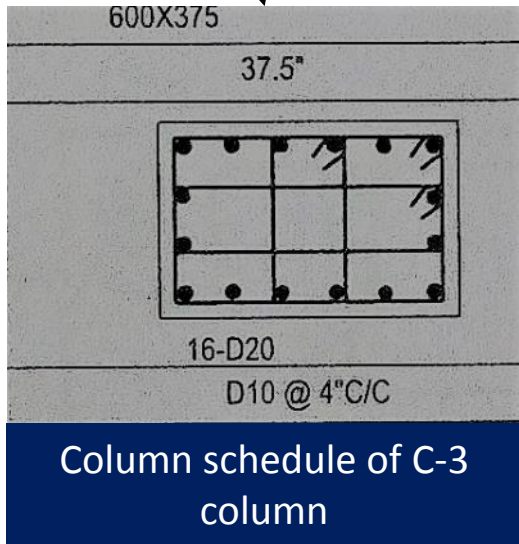
Column schedule of C-3 column

12 nos. Rebars (5x3) were found in C-3 column instead of 16 nos. rebars
