# Four Brothers Fashion - Unit 2 (Ref. 9235)

66-68 Haji Deen Mohammad Road, Dhaka Uddyan, Beribadh, Mohammadpur, Dhaka

15.MARCH.2014

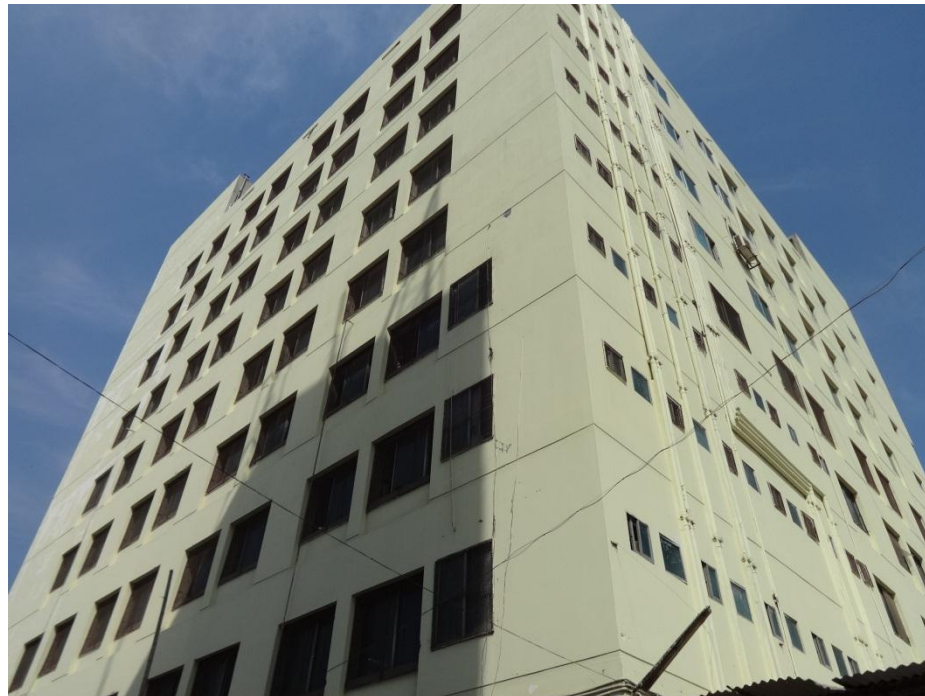
Typical internal columns, while matching the details set out in the structural drawings, produce a 'yellow' result from the column load run-down.

While not an immediate concern, a factor of safety between 1.5 and 1.86 is sufficient to warrant a review of design loads and stresses.
