# Geebee (Bangladesh) Limited Extended Unit.

FS SFB 02 Karnaphuli EPZ Chittagong  
(22.278980, 91.789511)  
8<sup>th</sup> November 2018

# Observations

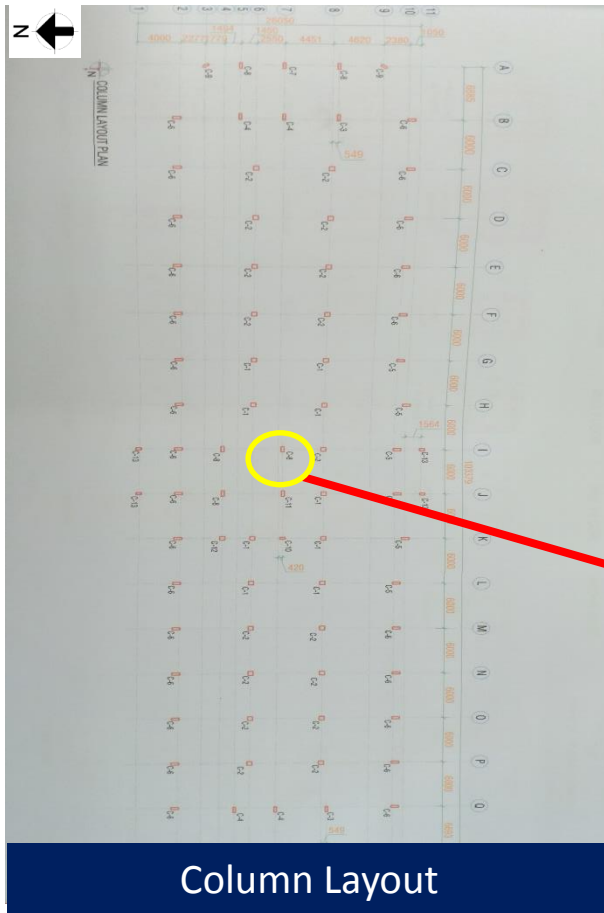
Column Layout

Number of rebar for C-2 column does not match with column schedule. 12 nos. of rebar are found by ferro scan whereas 16 nos. of rebars are shown in column schedule. Also size of C-8 type column found 500 mm instead of 750 mm in long direction and size of C-10 & 12 type column found 260 instead of 380 mm in short direction. Also, mismatch found in beam layout.

| Item No. | Observation | Recommended Action Plan | Recommended Timeline |
|---|---|---|---|
| 1 | Discrepancies between provided drawings and on site condition.<br>(Main Production building) | Building Engineer to survey as-built structure and prepare accurate as-built survey information for the building. | 6-weeks |
| 2 | Discrepancies between provided drawings and on site condition.<br>(Main Production building) | Produce and actively manage a loading plan for giving consideration to floor capacity and column capacity. | 6-weeks |

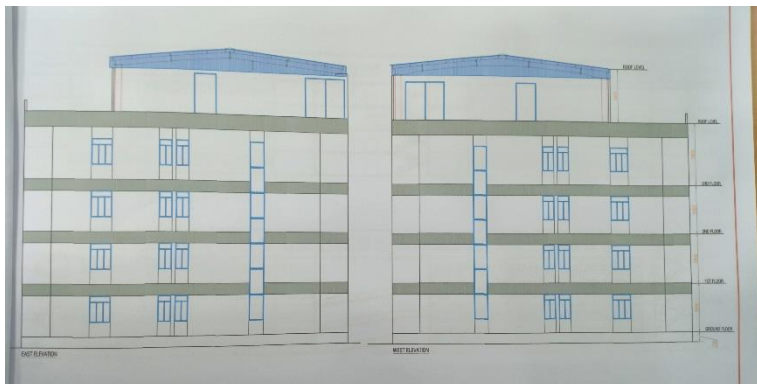
Currently the building is 3 storied. Factory has a future plan to built a shed on current roof. Proposed drawings were available during inspection. Factory engineer is required to carried out a Detail Engineering Assessment considering BNBC provision prior to any extension work.

Proposed roof shed

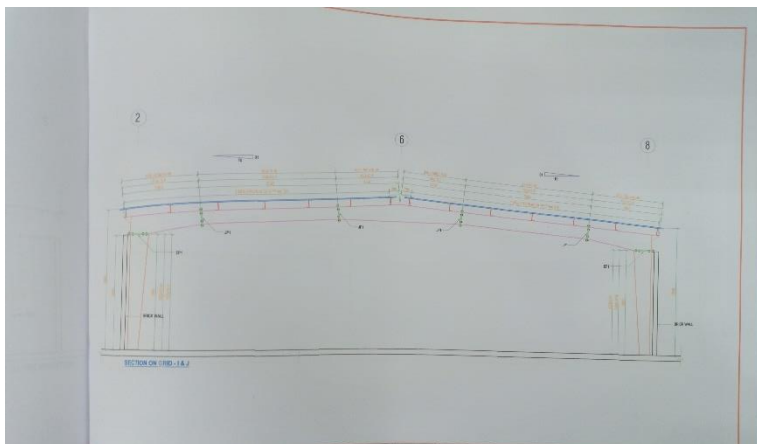
Proposed roof shed (Portal frame)
