Entrust Fashions Ltd.

46/1 Nayanagar Main Road, Chairmanbari Mor, Nayanagar, Turag, Dhaka-1230, Bangladesh.

25th October 2018

**Lack of bracings and discrepancy observed
between As built drawing and on site condition**

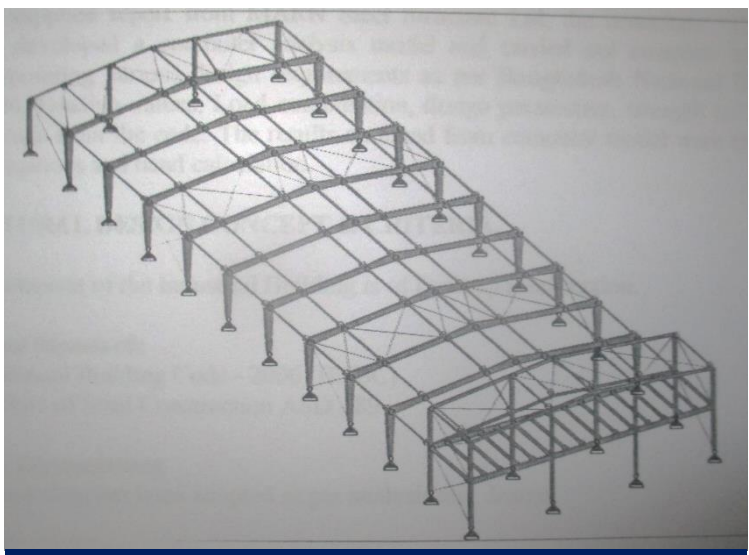
Bracing Layout in structural drawing

Onsite roof bracing location did not match with drawing

Vertical and roof bracing layout did not match with drawing and FEM model. Factory is required to revise the bracing layout in as-built drawing and FEM model accordingly.

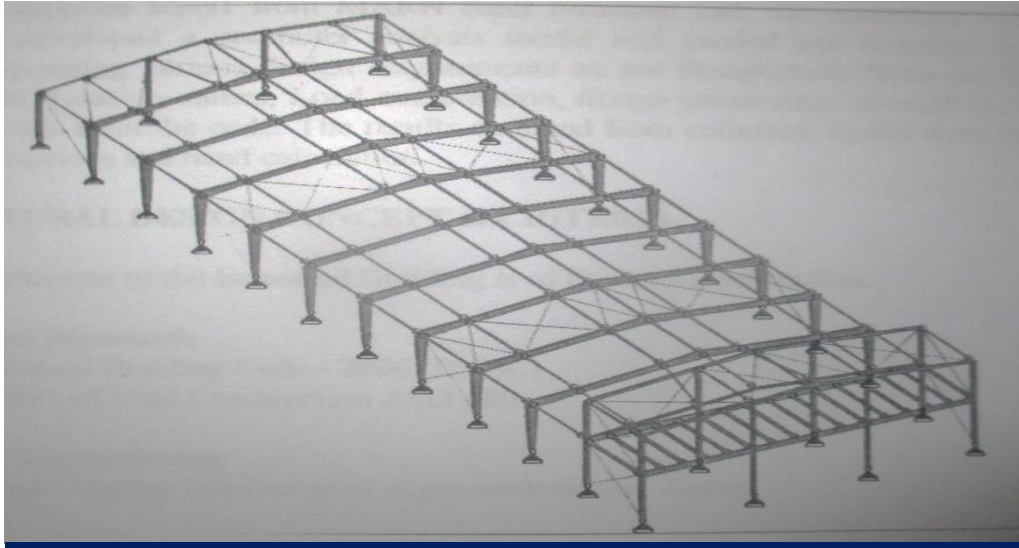
Bracing Layout in structural drawing

Vertical bracing not found according to the drawing

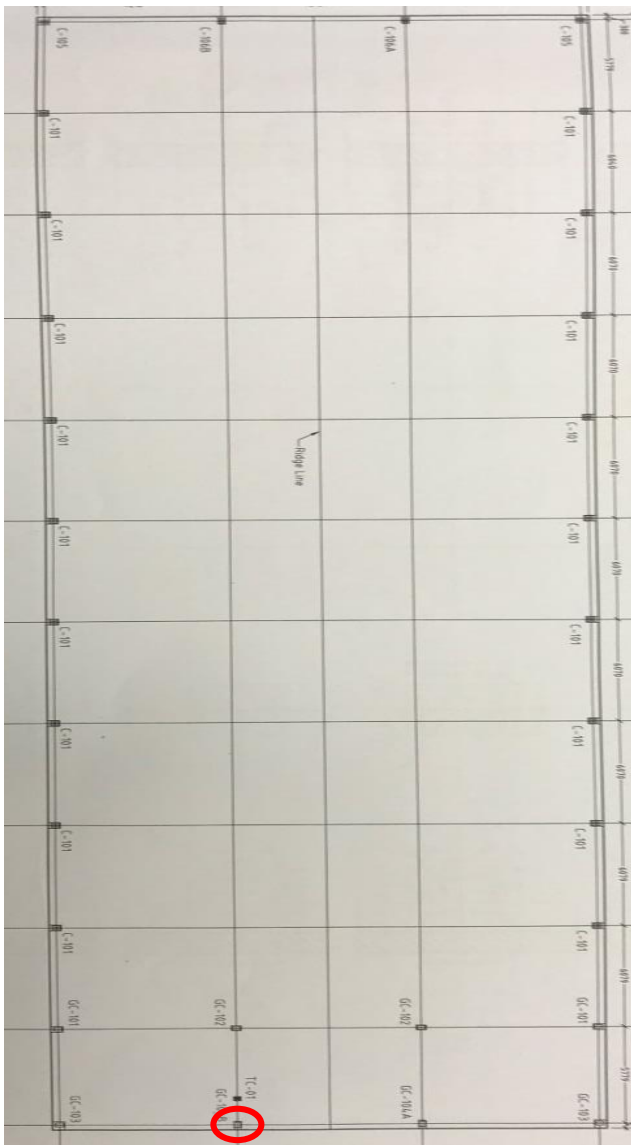
Steel column layout in drawing

Connection of column and rafter was found different than drawing

10nos. Bolt was shown at column-rafter joint in grid 12-D whereas 8nos bolt was found on site. The connection is required to revise in drawing according to the on site condition

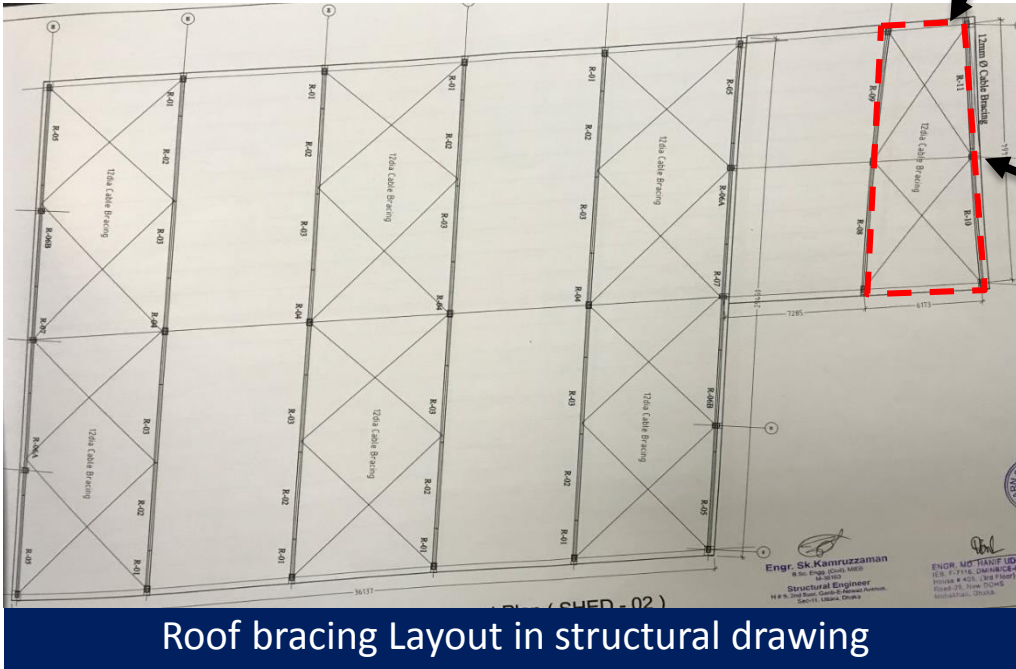
Roof bracing Layout in structural drawing

Roof bracing not found in the marked location

Vertical and roof bracing layout did not match with drawing and FEM model. Factory is required to justify the bracing requirement and install accordingly.

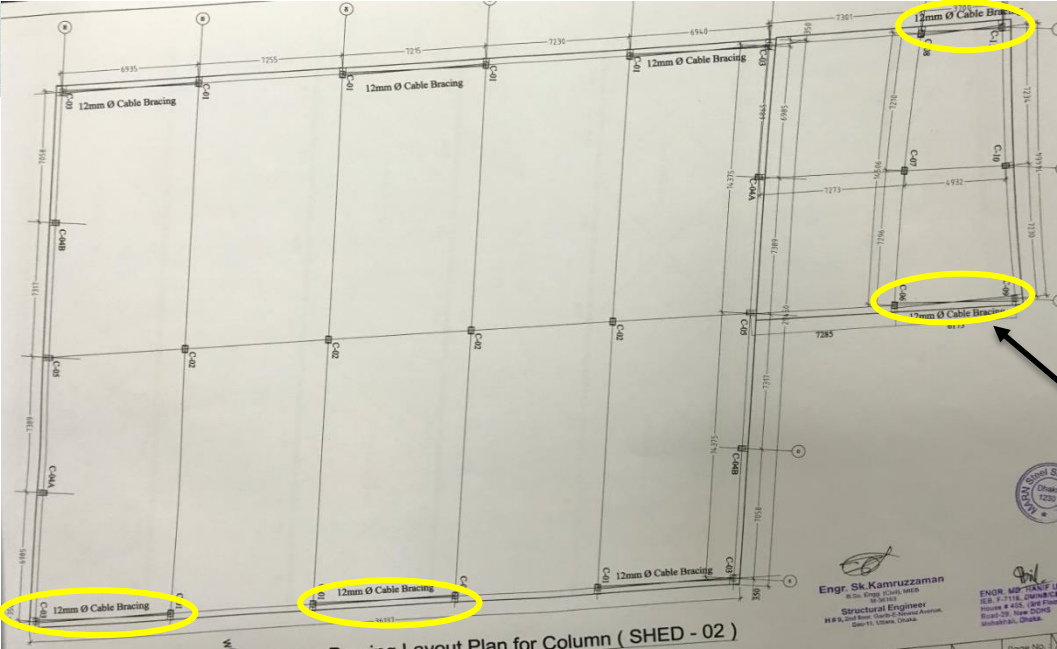
Vertical bracing Layout in structural drawing

Vertical bracing not found in the marked location
