# Rose Intimates Ltd.

Baroipara, Ashulia, Savar, Dhaka, Bangladesh  
(24.021676N, 90.243656E)

8<sup>th</sup> and 21<sup>st</sup> January 2019

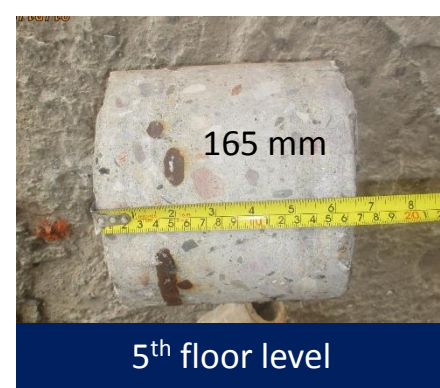
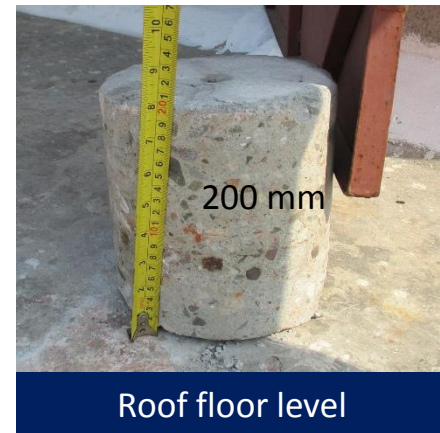
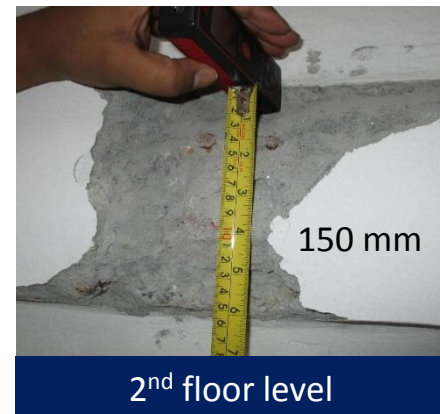
The floor slab thickness was not matched with provided drawings.

150mm (6") slab thickness was shown in drawings. But it varies floor to floor from 150mm to 200mm.
