# United Costume Limited R.N. Knit Tex Ltd.

Malancha Nagar, I/A, R # 02, West Isdair, Fatullah, Narayanganj  
(23.633561N, 90.481962E)

7<sup>th</sup> January 2019

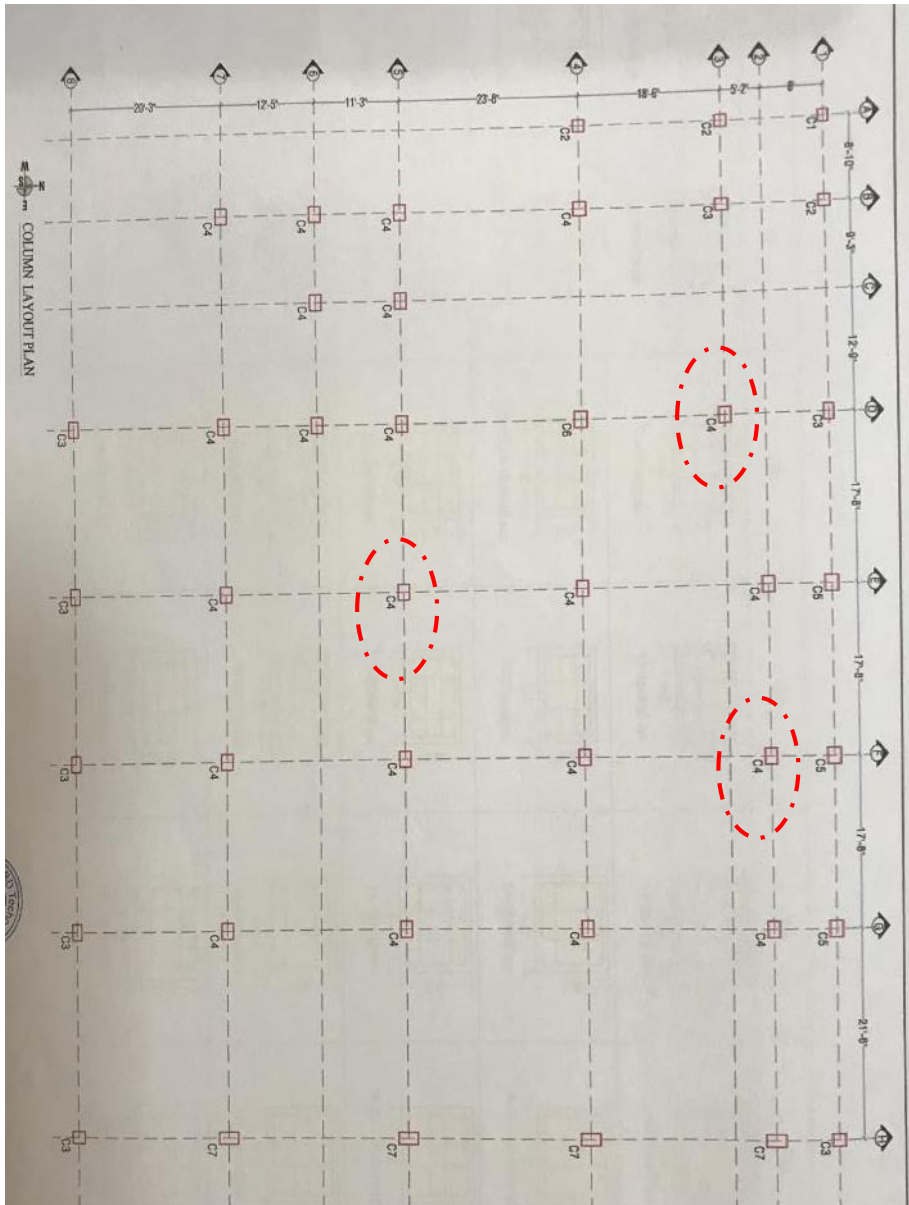
Column Layout

The number of rebar of C-4 column was found 5 number in 1'-8" face instead of 6 number as shown in the as-built drawing. The rebar number of the column is required to be confirmed in column schedule and layout.

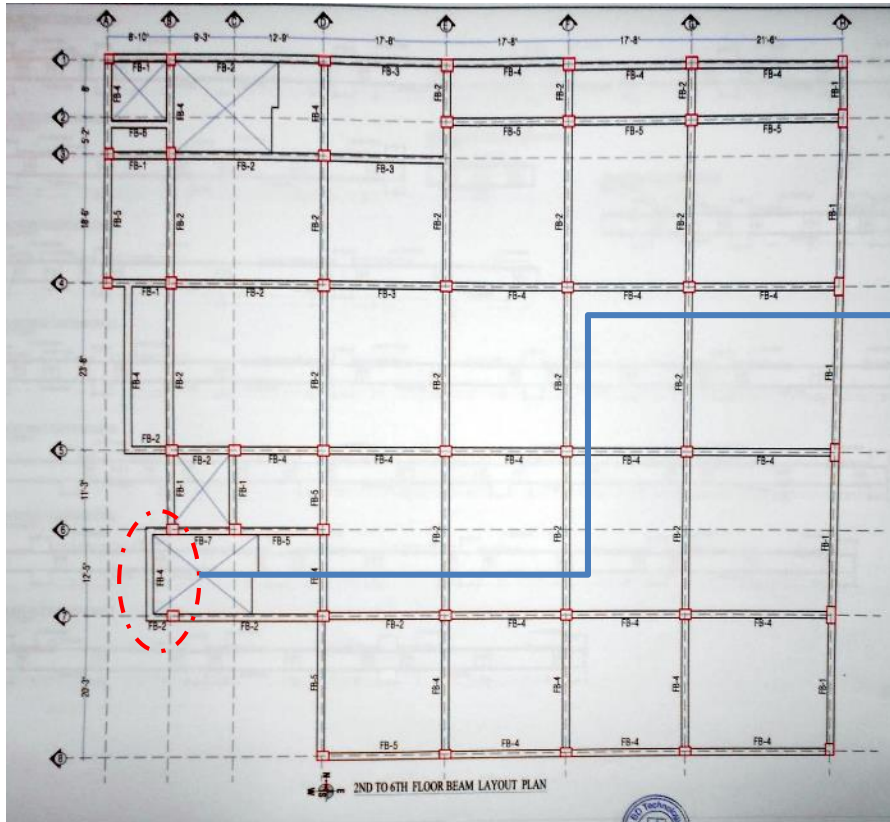
On the marked location in typical beam layout, no beam was found in any floor except ground floor whereas the beam was shown in as-built drawing.
