Orbitex Knitwear Ltd Debonair Ltd

Gorat, Sarker Market Road, Ashulia, Dhaka - 1341
(N23.943, 90.305E)

01 June 2014

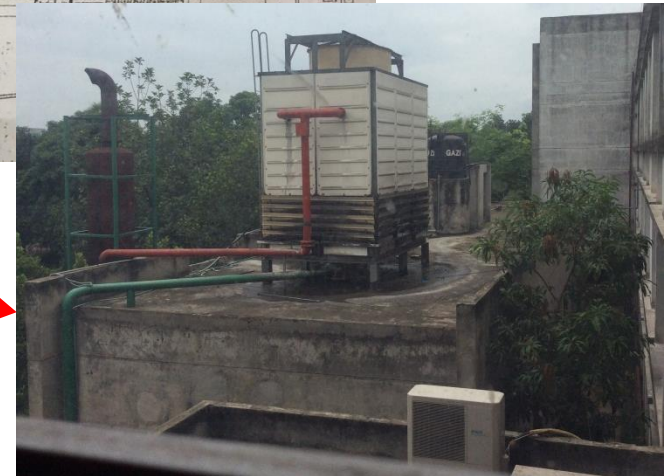
Storeys allowed to be constructed according to Permit Drawings

It is noted that the building has permit approval for 3 additional storeys. Any proposed additions to the existing building structure should be reviewed by the Building Engineer

The Building Permit drawings allow for 6 storeys. 3 Storeys plus a shed at roof level are presently constructed.

ITEM 4: It is noted that the building has permit approval for 3 additional storeys. Any proposed additions to the existing building structure should be reviewed by the Building Engineer.

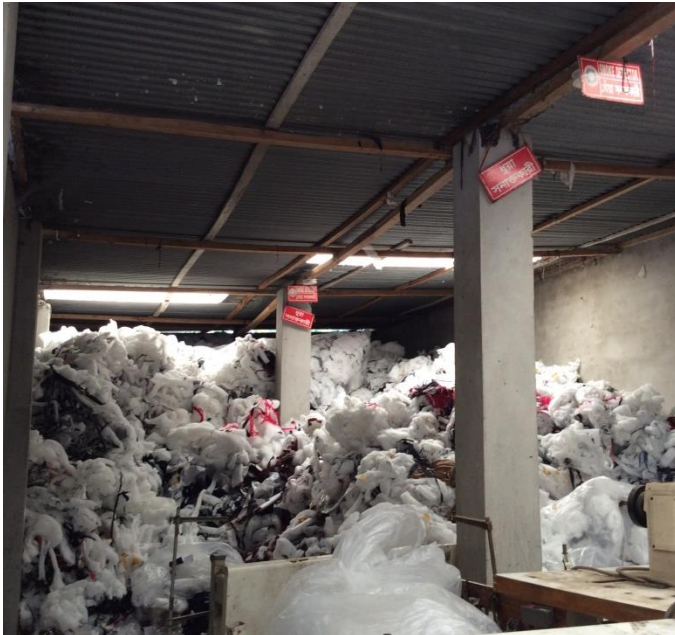
Various steel roof structures across the site.

Storage Shed – steel roofing on timber purlins positioned on concrete columns

Item No.	Observation	Recommended Action Plan	Recommended Timeline
7	Design check for the light steel roofs to the Dining/ Prayer Room/ Storage Building.	The Building Engineer is to assess the structural adequacy of the light steel roof structures to resist lateral wind loading (pressure, suction and uplift).	6-months
8	Design check for the light steel roofs to the Dining/ Prayer Room/ Storage Building.	Any works deemed necessary following the above assessment to be implemented on site and overseen by the Building Engineer.	6-months
9	Edge protection to the stairs and roof drainage	The Building Engineer is to design an appropriate edge protection system and to oversee its construction on site.	6-months
10	Edge protection to the stairs and roof drainage	The Building Engineer is to design and oversee the construction of an appropriate rain water drainage system for the roofs to prevent water damage to the building.	6-months
