Shinest Apparels Ltd

Azim Tower, Plot No. 217/1, Beribadh, Mohammadpur, Dhaka, Bangladesh
(23.768754N, 90.345978E)
24 May 2014

Observations

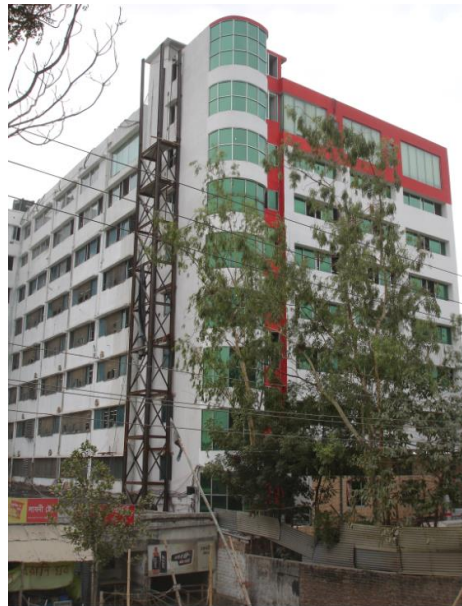
Small column sizes leading to high column stresses

As-built column grid

The columns in general, but in particular the ones under the water tank, are highly stressed due to their small size and the high number of storeys.

Item No.	Observation	Recommended Action Plan	Recommended Timeline
1	Small column sizes leading to high column stresses	Release all water from RC water tank on the roof and restrict loads to 1.0kN/m ² on the roof, to 1.5kN/m ² in 8th to 1st floor and to 2.0kN/m ² in ground floor, pending the outcome of the Detail Engineering Assessment.	Immediate - Now
2	Small column sizes leading to high column stresses	Building Engineer to review design, loads and columns stresses in all columns.	Immediate - Now
3	Small column sizes leading to high column stresses	Verify insitu concrete stresses either by 100mm diameter cores or existing cylinder strength data for a minimum of 4 columns.	Immediate - Now
4	Small column sizes leading to high column stresses	A Detail Engineering Assessment of the building to be carried out immediately, see attached scope.	Immediate - Now
5	Small column sizes leading to high column stresses	Produce and actively manage a loading plan for all floor plates within the building, giving consideration to floor capacity and column capacity.	6-weeks
