# Teen Age Modern Fashion Ltd Matri Ghor Ltd

Aajan Tower, Purbahati, Hemayetpur, Savar, Dhaka

3<sup>rd</sup> March 2015

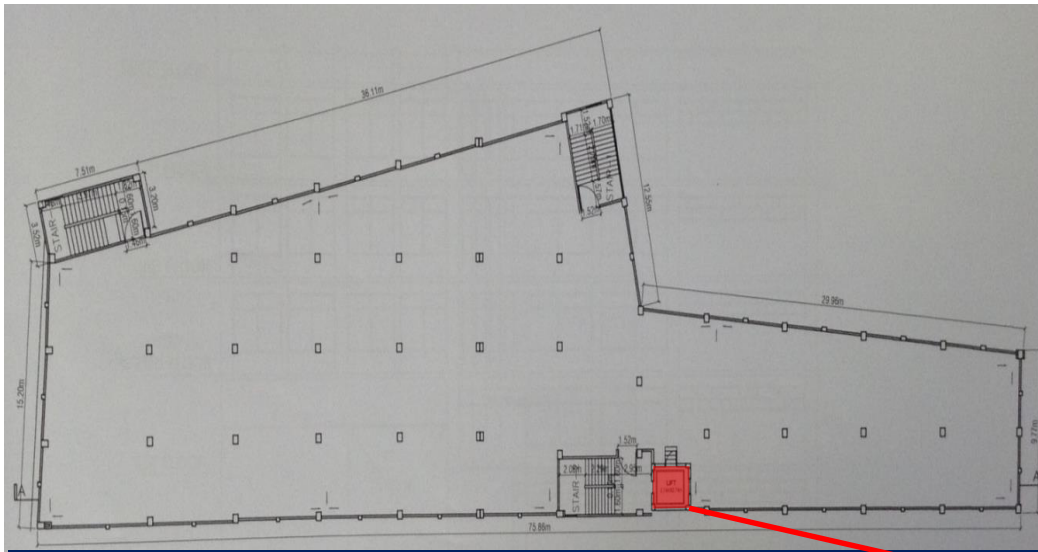
Typical layout plan

# Heavily-loaded lift roof slab and additional lift room

- The lift plant room is situated on the top of the lift.
- The heavy lift machinery is sitting on the slab without connections to the main vertical load bearing structure.
- The slab is also weakened by many openings.
- Large brick aggregate was noted.
