Nipa Knitwear Company

Selina Tower-04: Islambag, Holan Road, Dhakhin khan, Dhaka-1230

18th February 2015

Observations

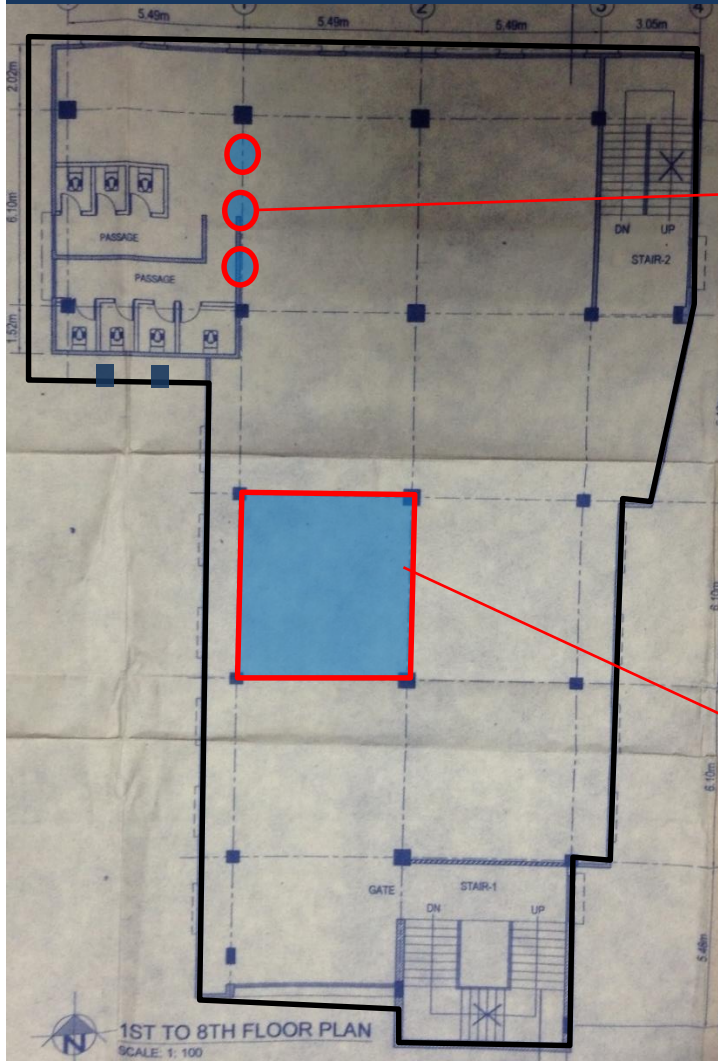
Production Building – Typical floor plan

Heavy loading from water tanks

3 Water tanks on roof – 5000 litres each (total 1500 kN)

Tank is not a full floor height, so it has an additional slab. Dimension 3.05m x 2.75m x 1.75m.

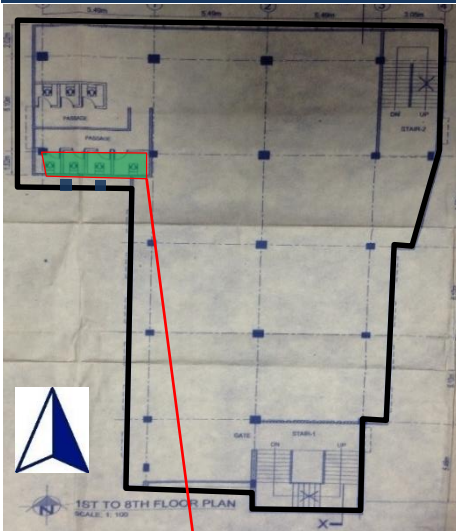
8th floor plan

Toilet build-up

Build-ups 250mm

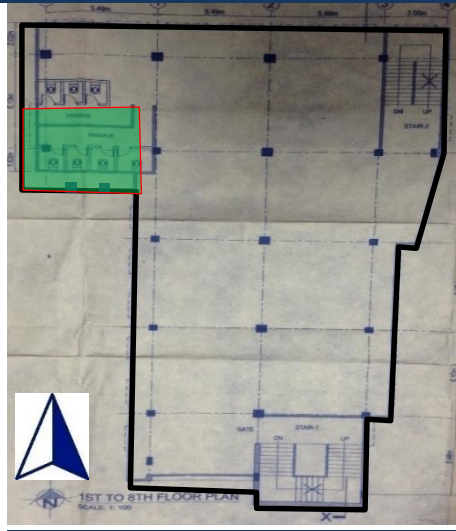
2nd, 4th, 5th, 6th, 7th floor

150 mm build up on every floor

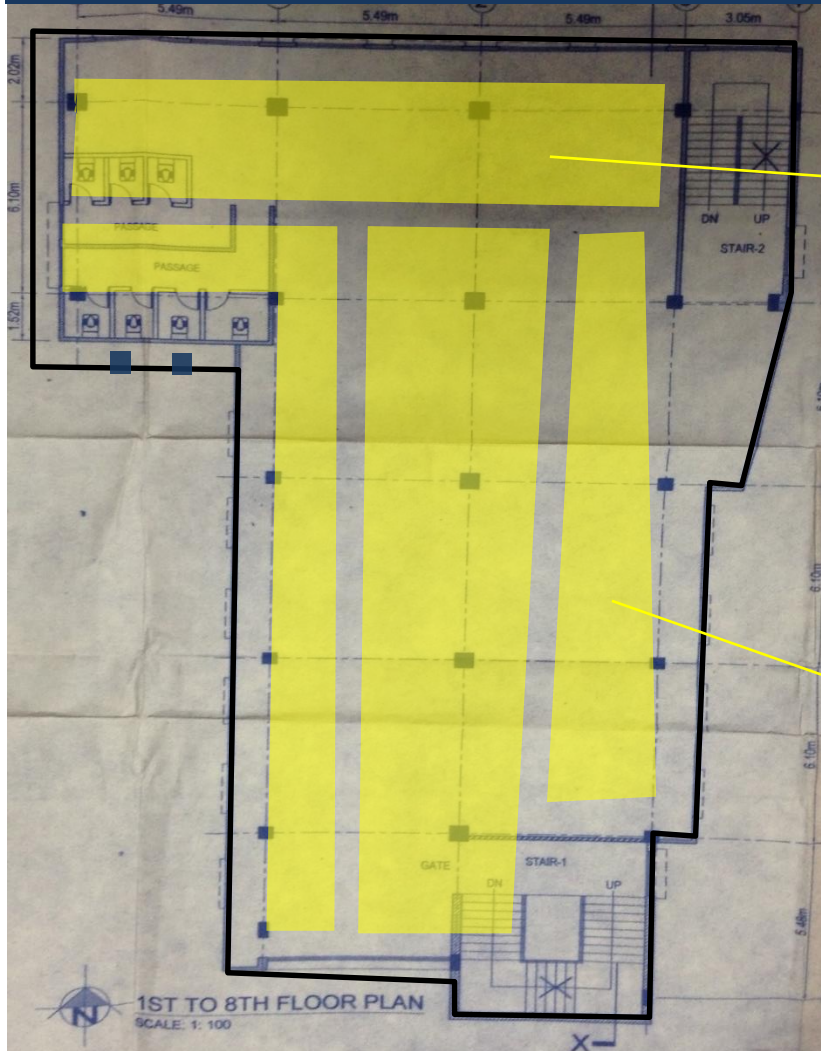
Ground and 1st floor loaded area

Heavily-loaded storage

1.5m high boxes on entire 1st floor

1.3m high fabric roll on entire ground floor

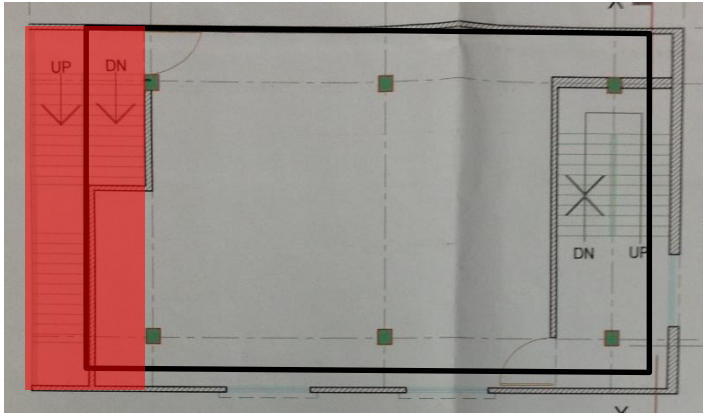
Typical floor plan

Apparently non-engineered lightweight steel stair structures
