# Interloop BD Ltd. (9994)

Plot 146, Khatian no. 40, Mouza 86 Soydana, PS-Joydevpur Dist., Gazipur, Dhaka  
(+23.961626N, 90.380531E)

18.MARCH.2014

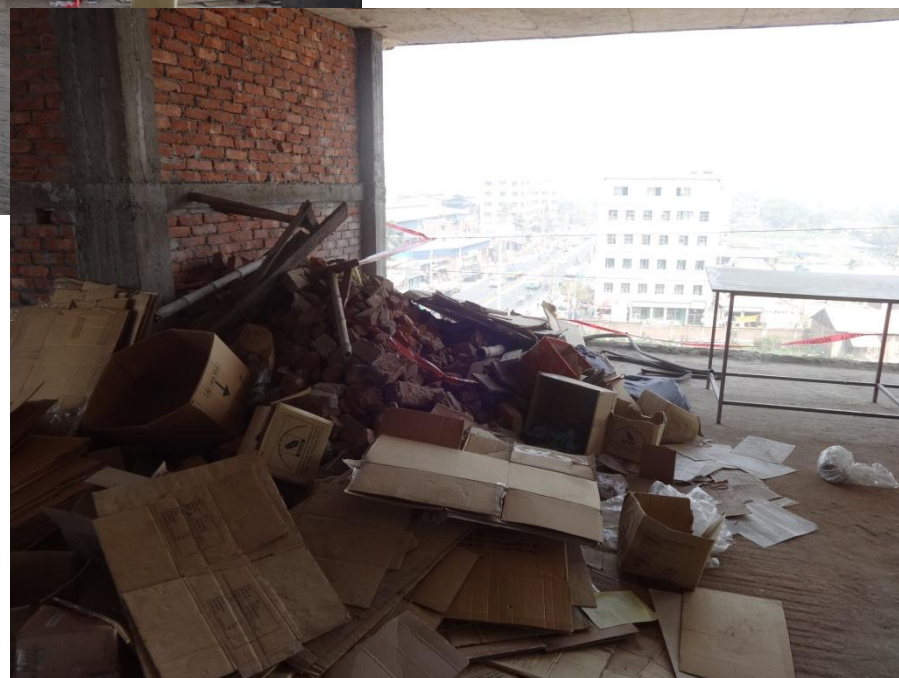
## Priority 1 Concern

Uncontrolled and potentially very heavy piles of waste materials and bricks during construction.

Any waste should be immediately removed to ground level, and materials necessary for construction should be spread out so as to not exceed design loading.

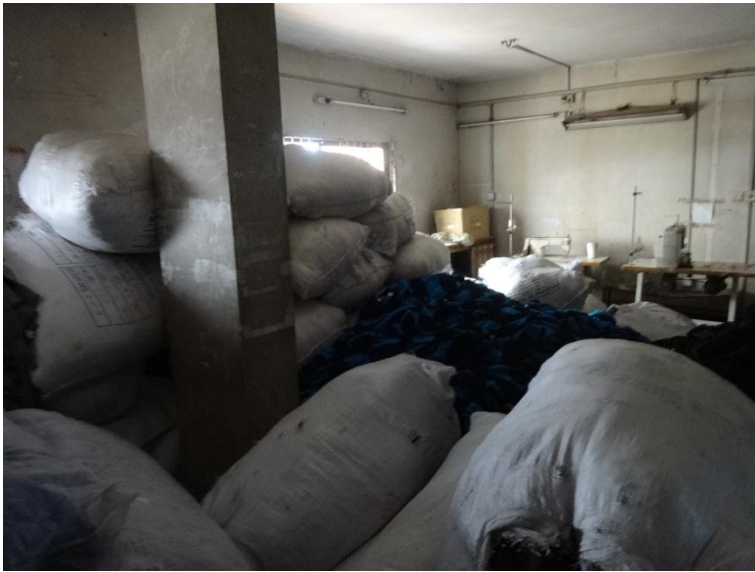
Uncontrolled and potentially excessive loading at 1<sup>st</sup> and 3<sup>rd</sup> floor levels (not occupied by Interloop BD Ltd.).

Steel walkway between factory and adjacent building; requires proper structural analysis.

Apparently insufficient lateral stability system; requires thorough analysis.

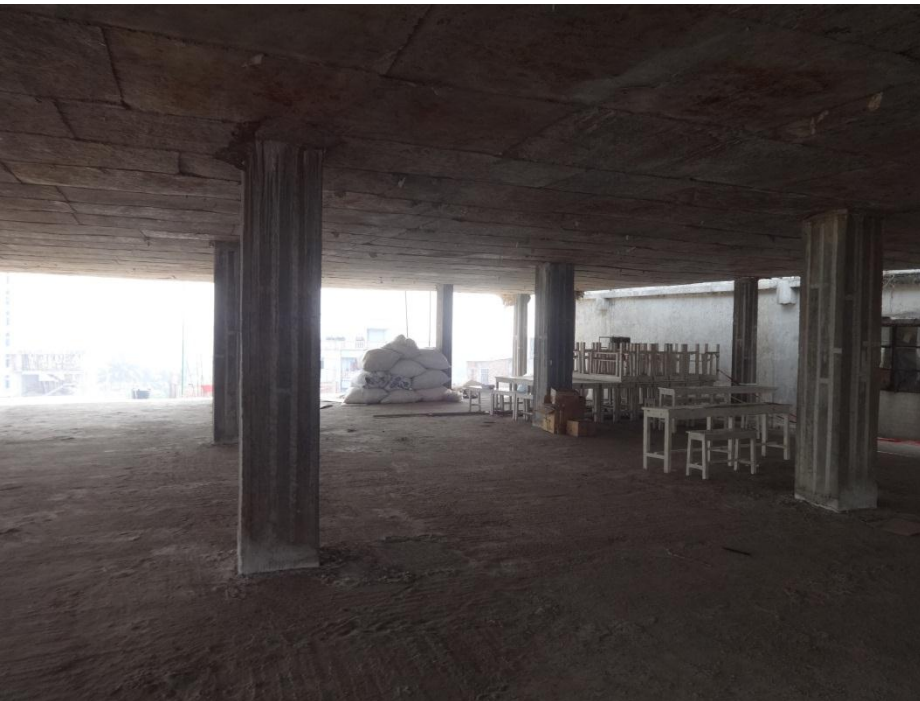
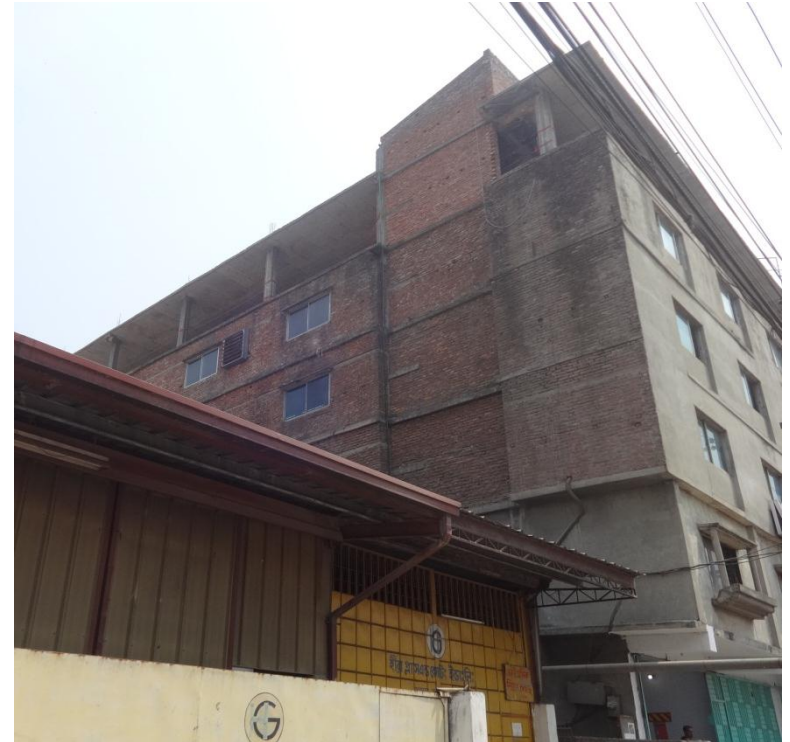
3<sup>rd</sup> Priority 2 Concern

No sufficient lateral stability system was observed, either in the drawings or through the existing structure.

These images clearly show the flat slab construction employed, but it can also be seen to the right that the stair cores (one shown) are only of masonry construction and do not constitute shear walls.
