# Nippon Garment Industries Ltd.

93, Auchpara, Tongi, Gazipur - 1712  
(23.915849N, 90.393507E)

25<sup>th</sup> February 2015

# Observations

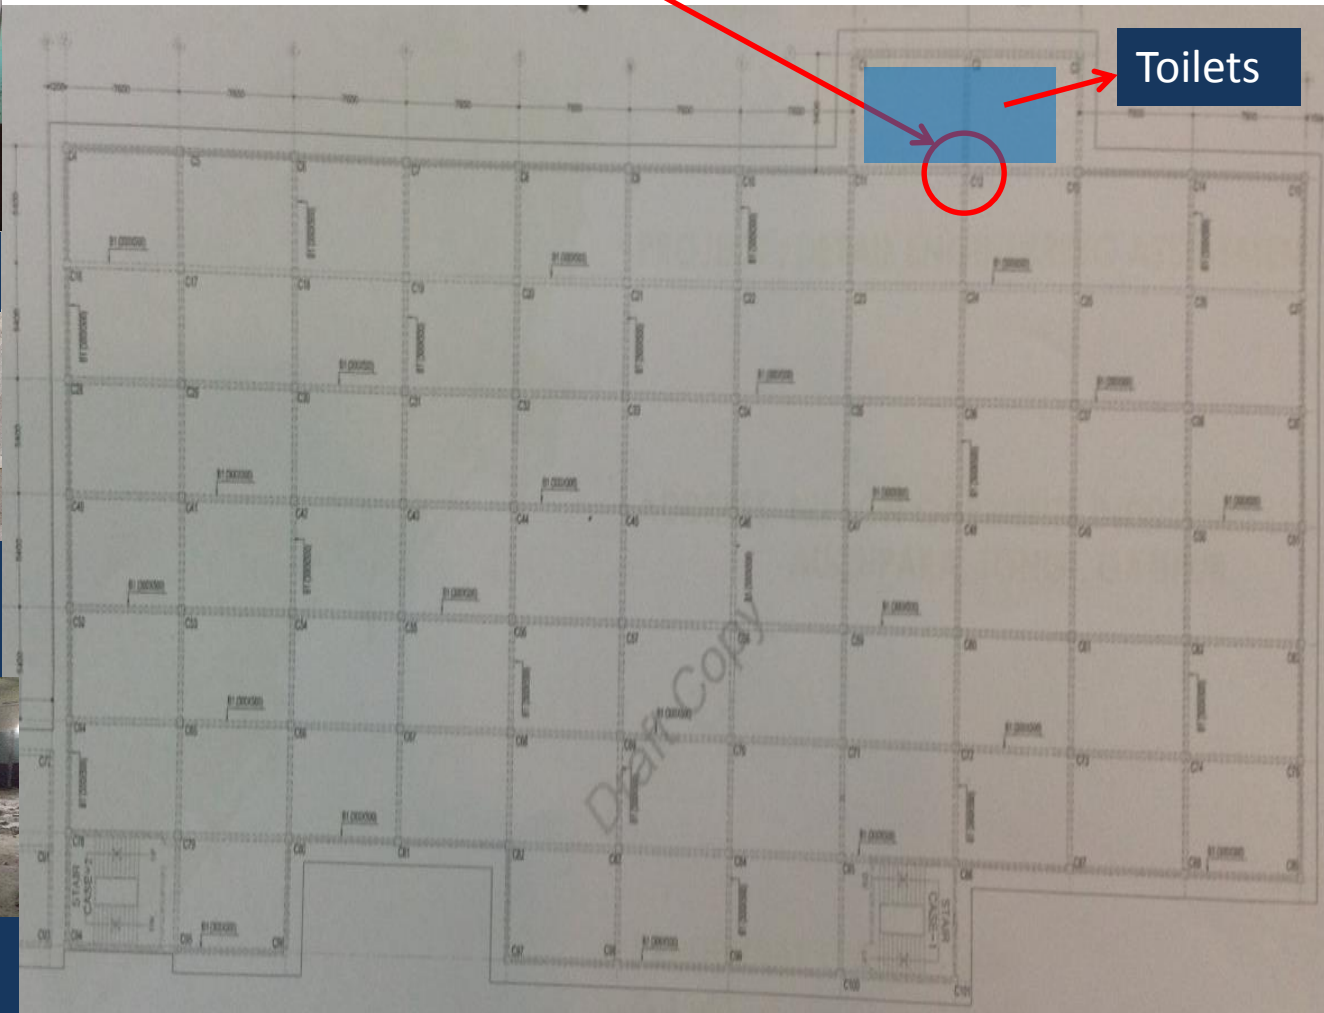
**Toilets**

**High stress level in column around toilet  
on Ground Floor from floor build up in  
toilets at first and second floor.**

Cursory calculations indicate column (marked with red circle) at the Ground Floor is highly stressed under their current loading condition.

**Female Toilets  
2nd floor**

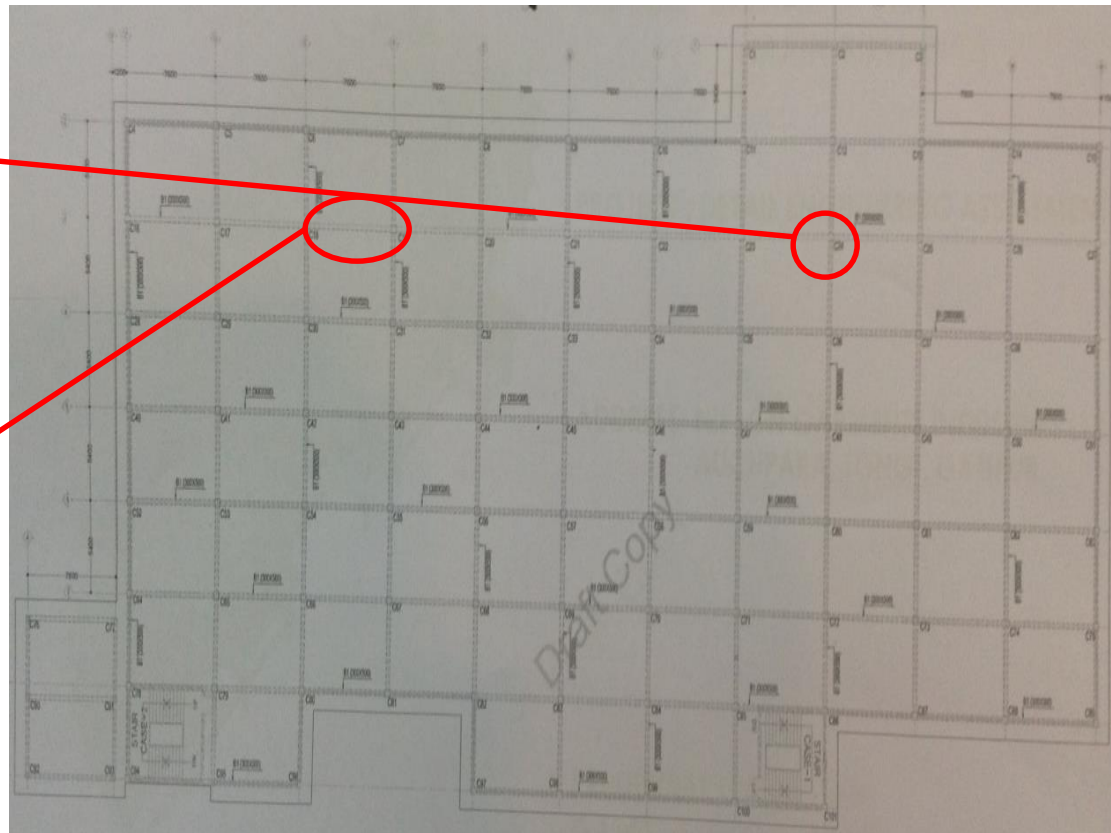
**Cracking on beam at first floor**

| Item No. | Observation | Recommended Action Plan | Recommended Timeline |
|---|---|---|---|
| 6 | Cracking on beams and columns | As part of the DEA noted in Item 1 the Building engineer is to investigate the cracking in the beams | 6-weeks |
| 7 | Cracking on beams and columns | Building Engineer to expose surface of the concrete beam in a number of locations to determine if the cracking extends through the finish into the beam. Also beams repaired with epoxy to be checked in case of reoccured cracks and make recommendations for remedial measures if required. | 6-weeks |

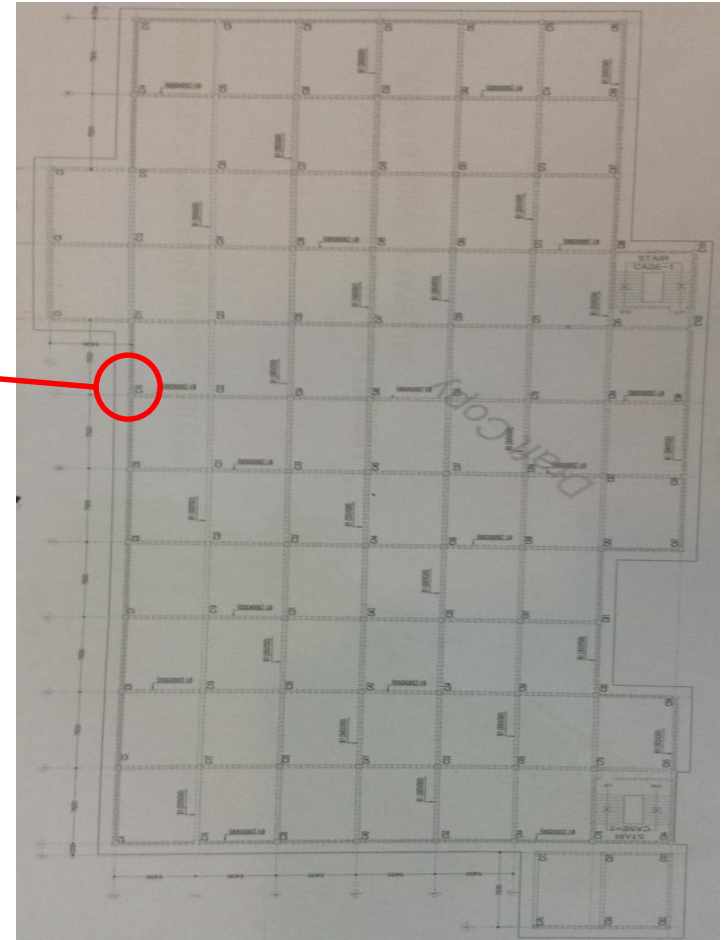
Ferroscan indicated 3 bars in each face (i.e. 8 bars in total). Drawings indicate 12 bars

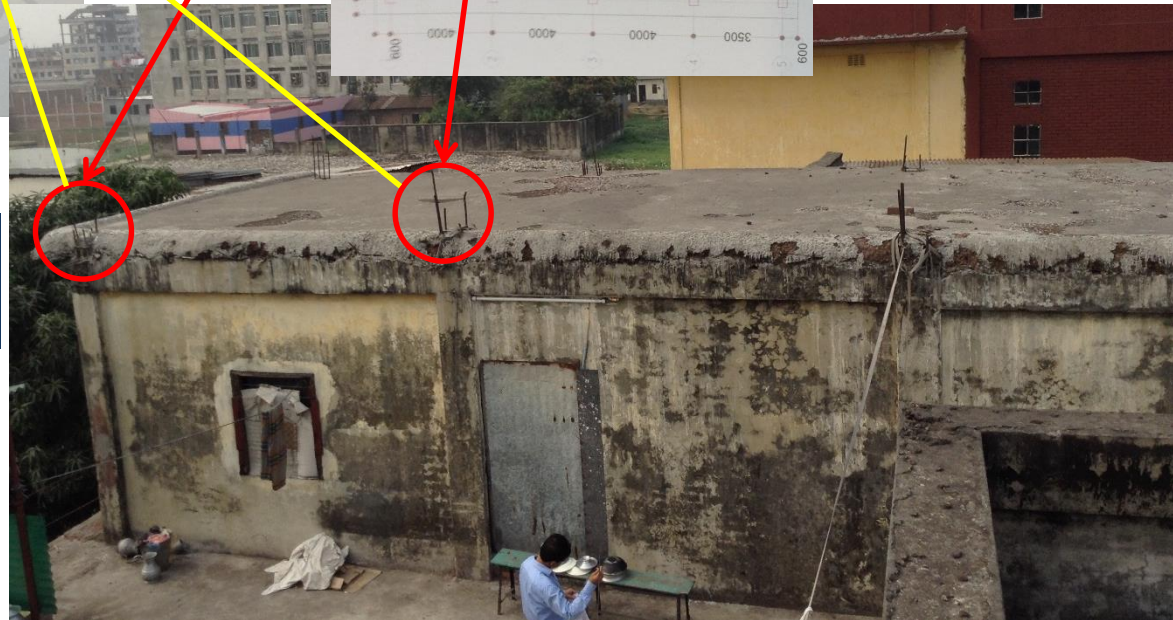
Only 6 rebars were observed on site. Drawings show 10 bars.

Column dimensions were measured as 300mmX300mm excl. plaster
