# Esquire Knit Composite Ltd

Plot # B-34, BSCIC 1/A, Kanchpur, Sonargaon, Narayangonj.  
(23.699169, 90.528957)

25<sup>th</sup> February 2015

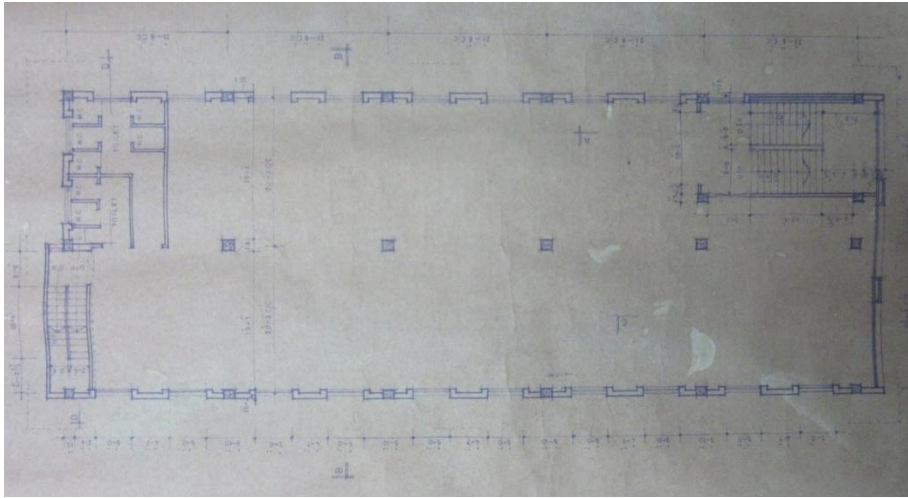
Typical Floor Plan

**Columns appear to be stressed in excess of normal design limits**

Preliminary calculations indicate that working stress is at a level that warrants review for all columns.

**ITEM 1:** Columns appear to be stressed in excess of normal design limits

A Detail Engineering Assessment of the building should also be carried out immediately in order to ascertain the adequacy all columns (see attached Scope).

Item No.	Observation	Recommended Action Plan	Recommended Timeline
1	Columns appear to be stressed in excess of normal design limits.	Factory Engineer to review design, loads and columns stresses in all columns.	<b>Immediate - Now</b>
2	Columns appear to be stressed in excess of normal design limits.	Verify insitu concrete stresses by taking 100mm diameter cores from a minimum of 4 columns. Verify grade of steel reinforcement used.	<b>Immediate - Now</b>
3	Columns appear to be stressed in excess of normal design limits.	A Detail Engineering Assessment of Factory to be commenced, see attached Scope.	<b>Immediate - Now</b>
4	Columns appear to be stressed in excess of normal design limits.	Detail Engineering Assessment to be completed.	<b>6-weeks</b>
5	Columns appear to be stressed in excess of normal design limits.	Make structural alterations as advised by Engineer.	<b>6-weeks</b>
6	Columns appear to be stressed in excess of normal design limits.	Update as-built drawings to reflect the actual structure	<b>6-weeks</b>
