## **R. B. Knitwears**

65/11, Nayamati, Narayangonj. (23.61205N, 90.50308E) 01 March 2015

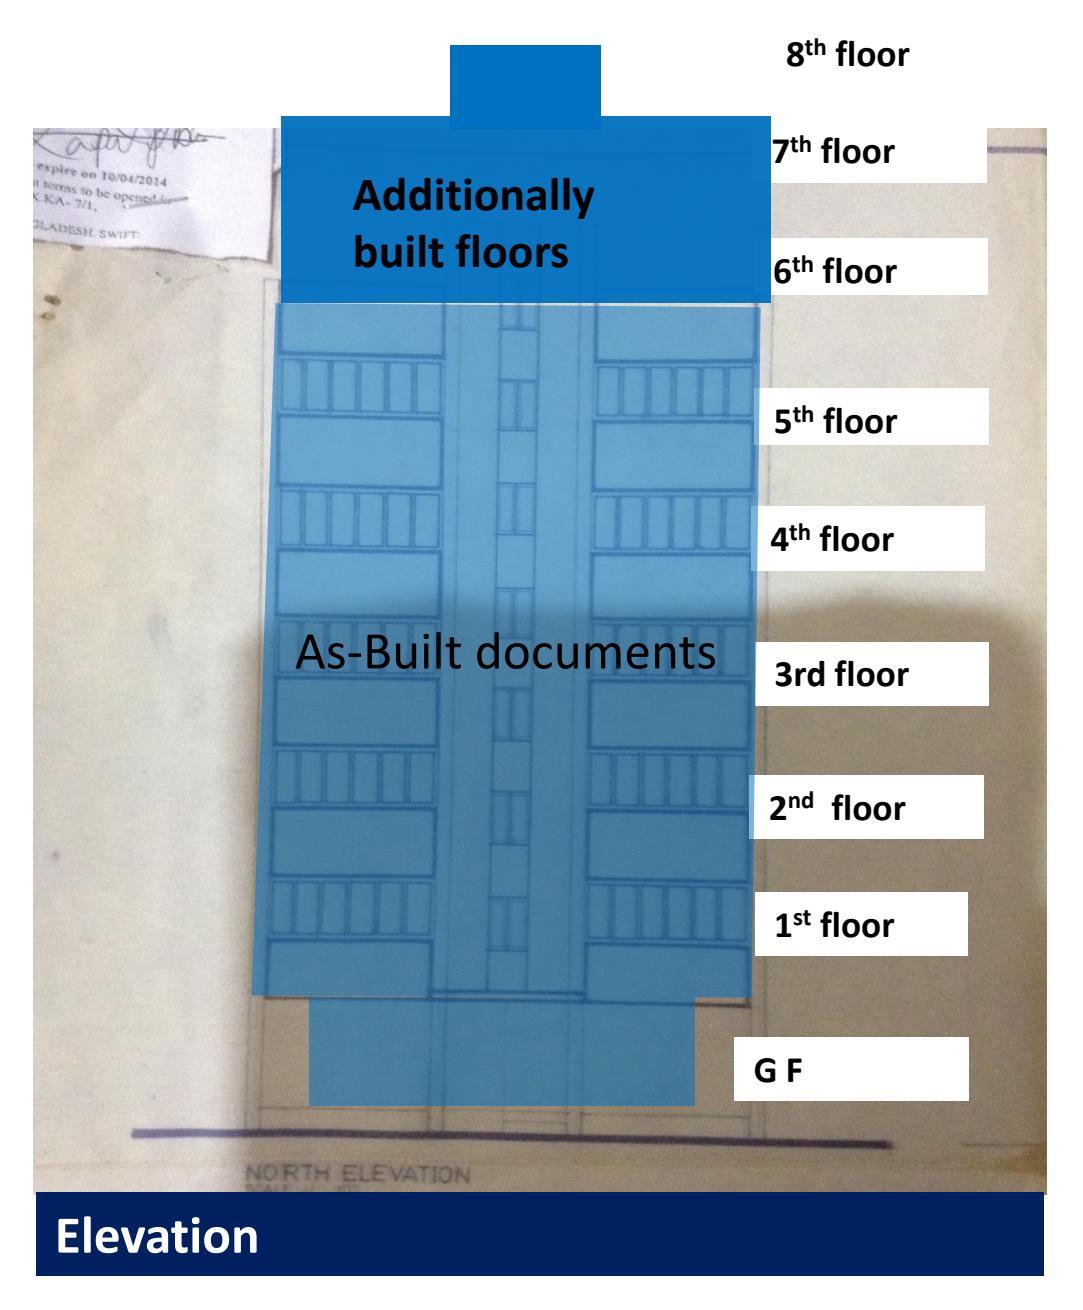
# Discrepancies between drawings, the As-built structure and the construction of 3 additional floors.

Item No.	Observation	Recommended Action Plan	Recommended Timeline
10	Discrepancies between drawings, As-built structure and the construction of 3 additional floors	As part of the Detail Engineering Assessment (see Item 1), Building Engineer to survey the as-built structure, including as-built roof structures and floor finishes thickness. The engineering robustness and stability of the additional extensions to be investigated as well their effect on the supporting structures.	6-weeks
11	Discrepancies between drawings, As-built structure and the construction of 3 additional floors	Building Engineer to produce accurate as-built drawings.	6-months
12	Discrepancies between drawings, As-built structure and the construction of 3 additional floors	Repair or remove the additional rooftop structures as directed by the Building Engineer.	6-months
13	Discrepancies between drawings, As-built structure and the construction of 3 additional floors	Carry out any structural works as required.	6-months

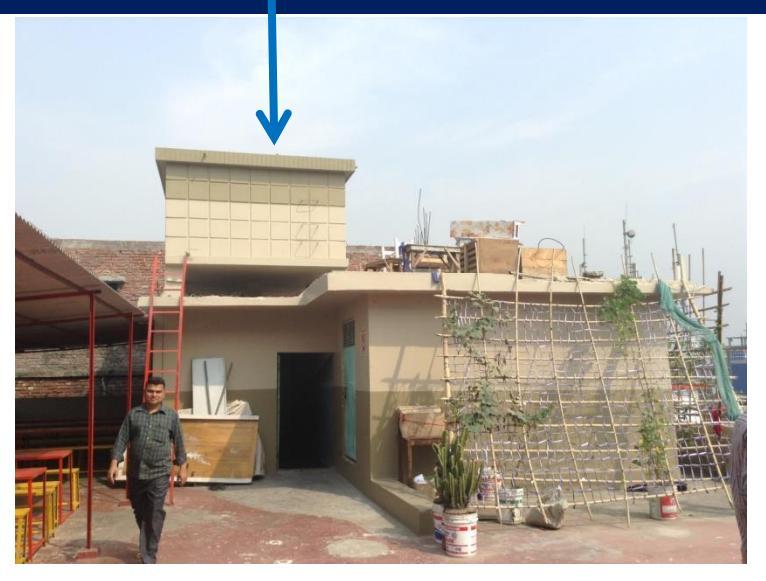
Roof – concrete water tank 15 000L capacity on top of the stairs case

14	Uncontrolled storage and heavy loading	Pending the outcome of the Detail Engineering Assessment, live loads to be removed or reduced as noted in Item 1	Immediate - Now
15	Uncontrolled storage and heavy loading	As part of the Detail Engineering Assessment (see Item 1), Building Engineer to confirm design loading of slabs and incorporate it into the loading plan for all floor plates within the Building.	6-weeks
16	Uncontrolled storage and heavy loading	Continue to implement the load management plan	6-months

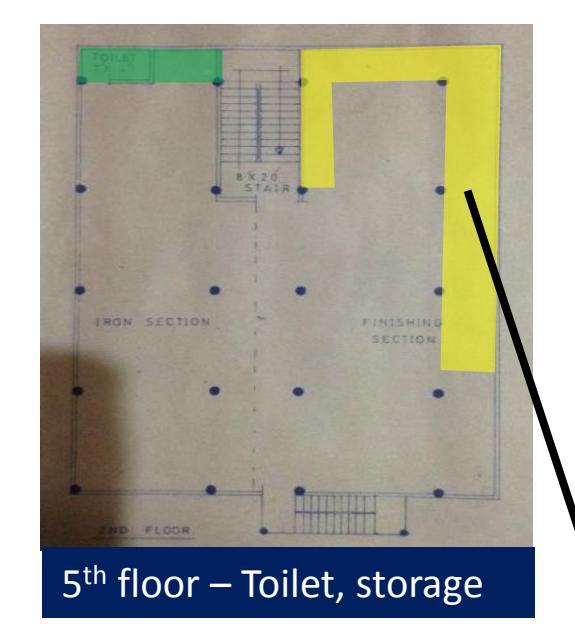
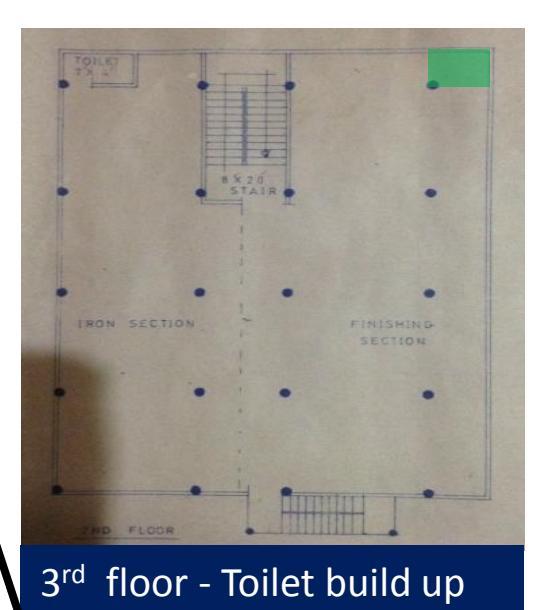
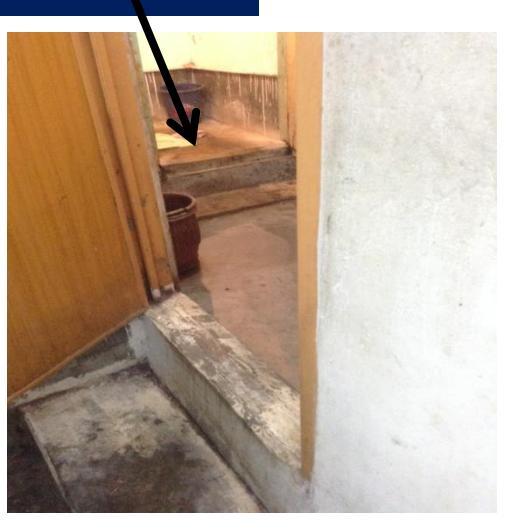
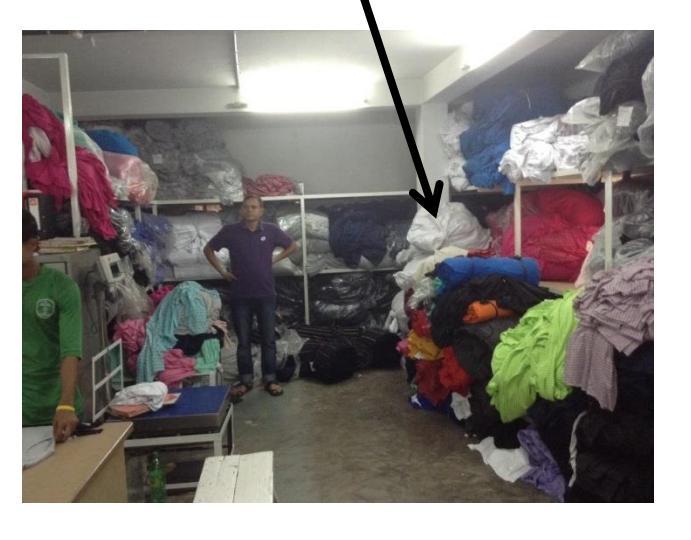
6<sup>th</sup> floor - Toilet build up 200mm

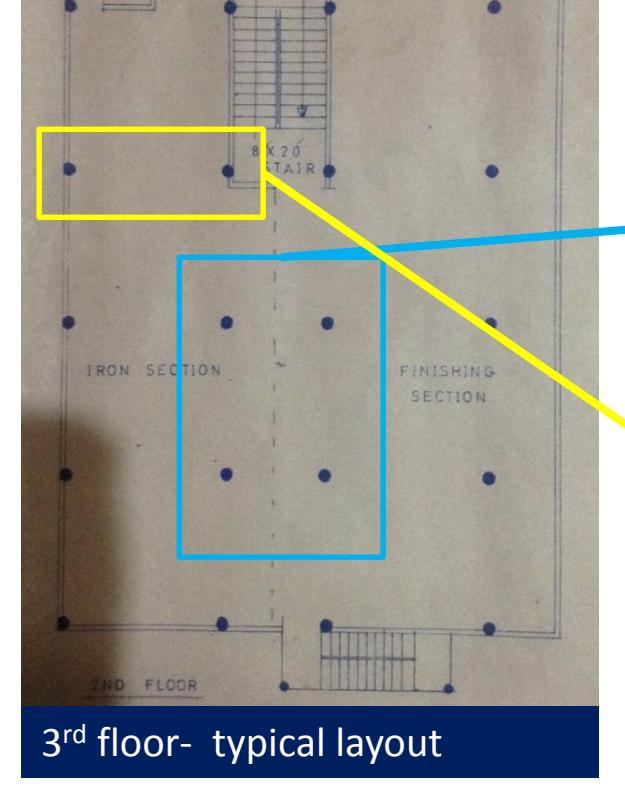
# Possible modifications to structural elements on the 3rd floor

Some of the structural elements have possibly been modified - these could indicate issues with the existing structure.

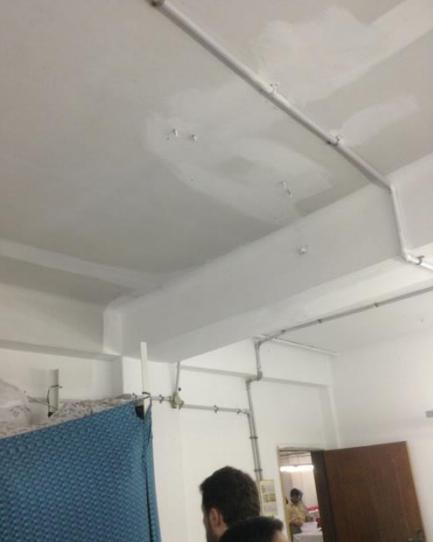
Apparently larger column
