# M.T Sweaters Ltd. Banga Fashion Ltd.

Plot # 1703-1704, Gacha, Gazipur Sadar, Dhaka  
(23.93638N, 90.37576E)

12 March 2014

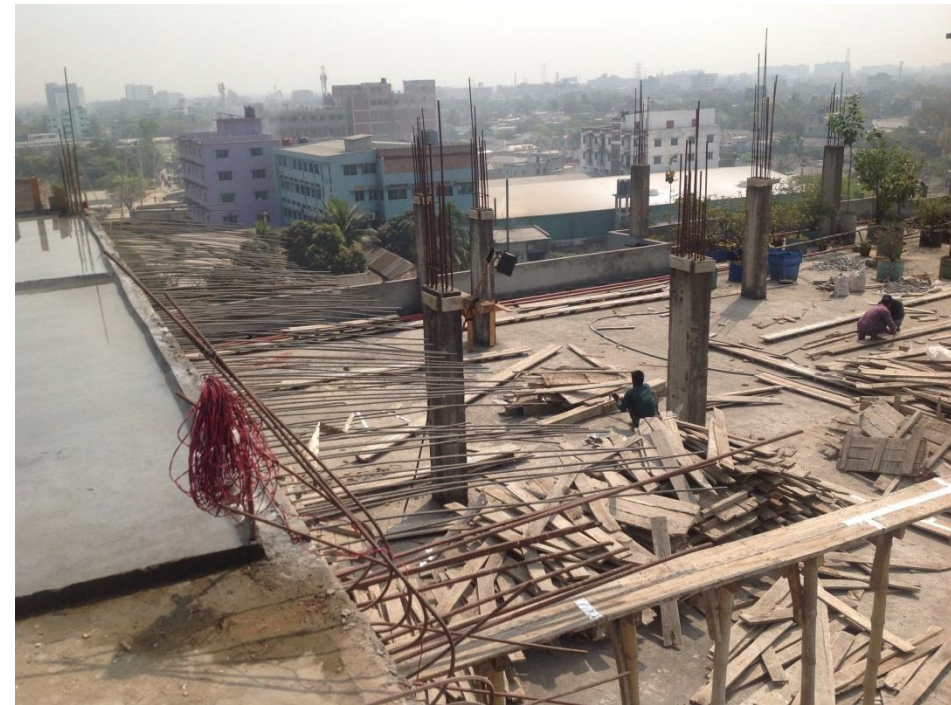
**6<sup>th</sup> storey under construction.  
Construction progressing from  
north to south.**

**Column design check to consider if the additional  
storey can be supported by the building columns  
within the design code specified parameters.**

1. **All construction works should be halted pending confirmation by the Building Engineer that the structure, including columns and foundations, is adequate to carry these additional loads.**
2. **Loads to be reduced in the areas highlighted on the following sheet pending verification of column capacity by the Building Engineer.**
3. A Detail Engineering Assessment of the as constructed **Factory Building** is requested and this should be commenced immediately to the requirements of the scope attached and addressing the concerns as noted.
