FIRE SAFETY INSPECTION REPORT

PACIFIC CASUALS LTD.

ACCORD ID: 23763

Date: 05 August, 2019

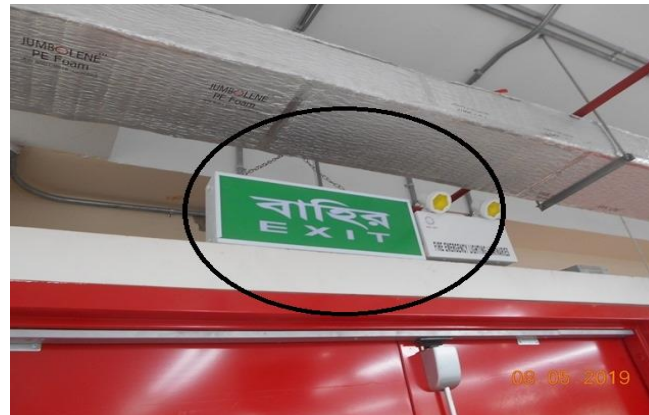
F-20	Non-Working Exit Signs	Exit signage not illuminated (burned out, broken, etc.). Location: stair-1 on 3rd floor.	Regularly inspect all exit signage and replace/install lights as needed to illuminate signs	Within 1 month
------	------------------------	---	---	----------------
