FIRE SAFETY INSPECTION REPORT

Factory Name: Disney Sweater Ltd. (Extension)

ACCORD ID: 23720

Date: 29 July, 2019

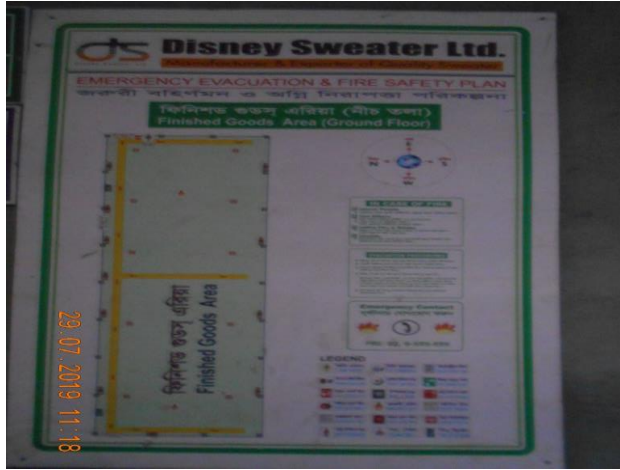
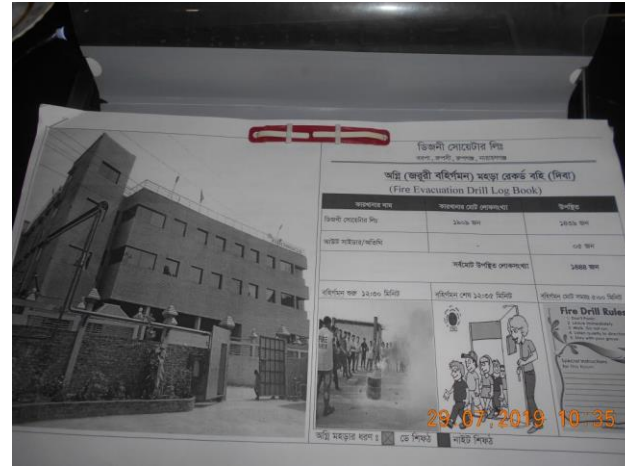
Emergency Evacuation Plans Provided (Accord 13.3)	No	
Fire Drills Conducted & Records Maintained (Accord 13.2)	Yes	
Smoking Prohibited (Accord 13.5)	No

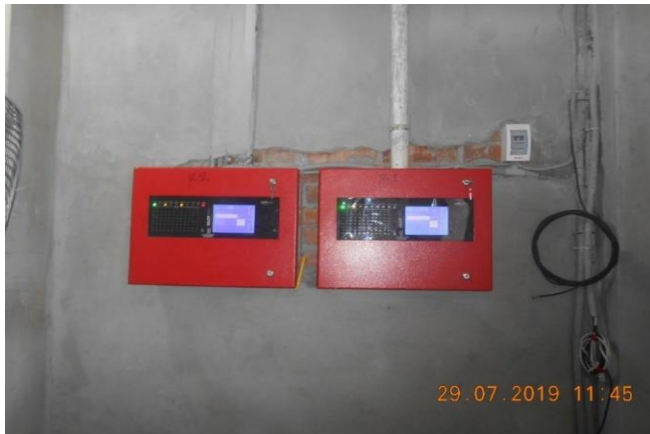
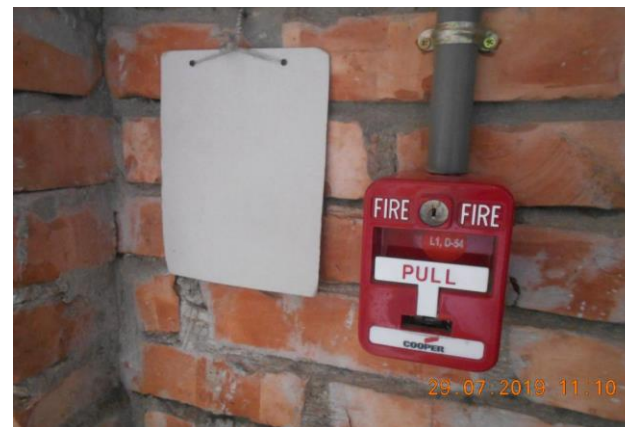
Visible Notification Per NFPA 72	To be verified during functional test	
Audible Notification Per NFPA 72	To be verified during functional test	
Alarm Annunciation	No	
ITM per NFPA 72	No	
Functional Test Conducted	No

SI No.	Category	Findings	Required Action	Remediation Time Frame
15	Fire Alarm & Detection System	<p>The fire alarm and detection system is antiquated, not a listed system, and does not provide alarm and notification features consistent with acceptable standards.</p> <p>Note: Installation of addressable fire alarm system is going on without having approval from AHJ.</p>	<p>Replace the fire detection system with a new, listed addressable fire detection system in accordance with NFPA 72.</p>	<p>Design within 2 months, Install/Modify within 6 months</p>

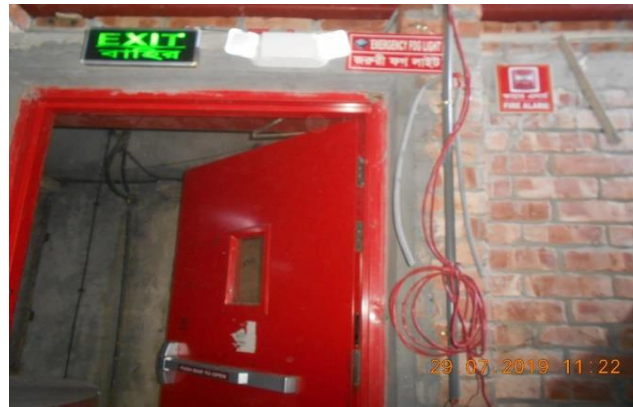
Installation of addressable fire detectors are in progress.

Type of Detector	Addressable, Under installation	
Smoke Detection Per NFPA 72	No

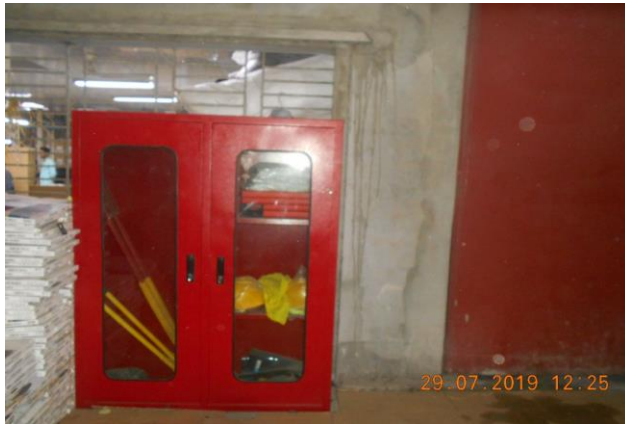
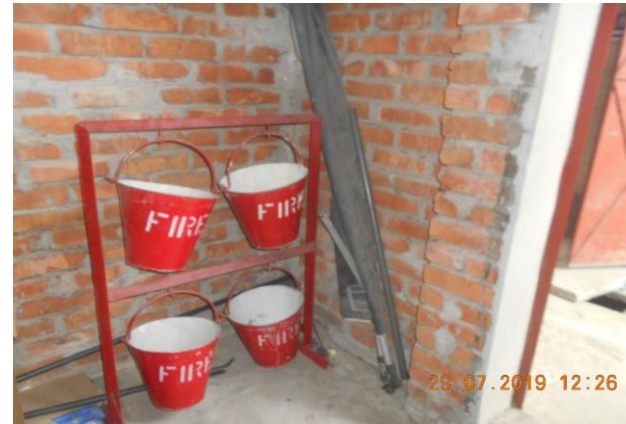
Manual fire fighting equipment's staged near the floor exits. Types of manual fire fighting equipment provided included: Extinguishers, buckets, escape hoods, bolt/lock cutters, shovels, stretchers and personal protection equipment.

Types Provided	Buckets, escape hoods, bolt/lock cutters, shovels, stretchers and personal protection equipment etc.	
Location of Equipment	Near exits

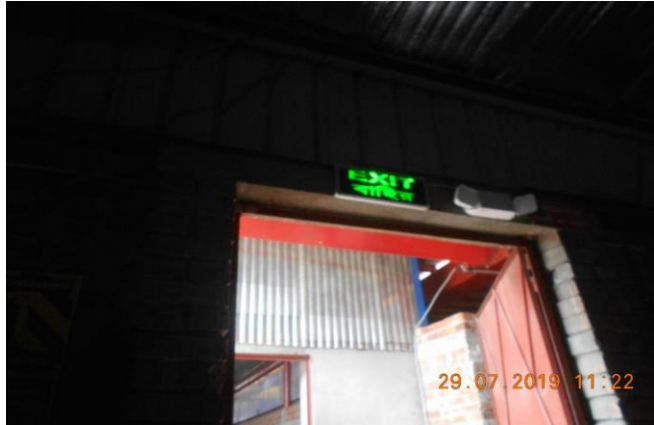
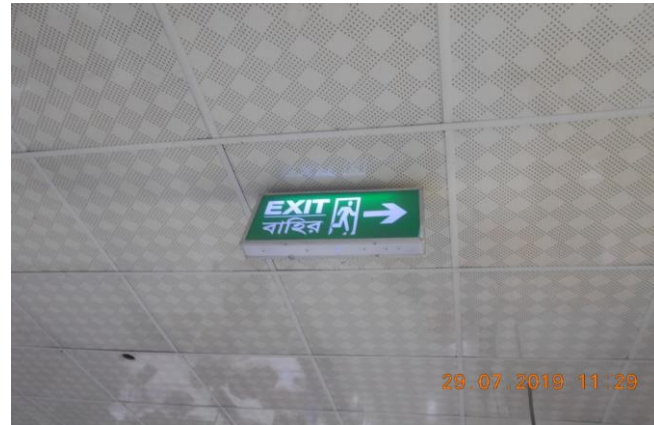
Exits and Exit Access Properly Marked with Exit Signage	No	
Emergency Power	Yes	
Adequate Emergency Lighting for Exits & Exit Access	No	
Adequate Inspection / Testing (Accord 10.12)	No

13	Egress Lighting	Based on the number and location of emergency lights observed, adequate illumination levels are not anticipated along egress routes.	Test the emergency lighting system on each floor and provide additional emergency fixtures to provide adequate illumination along the means of egress. Provide a minimum illumination of 10 lux at the floor level within exit stairs and exit discharge paths and minimum 2.5 lux along exit access aisles.	Within 3 Months

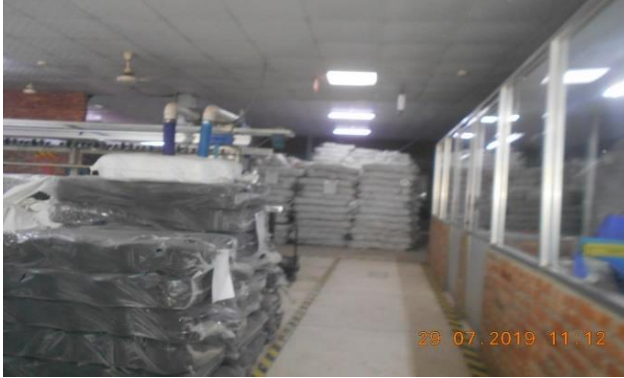
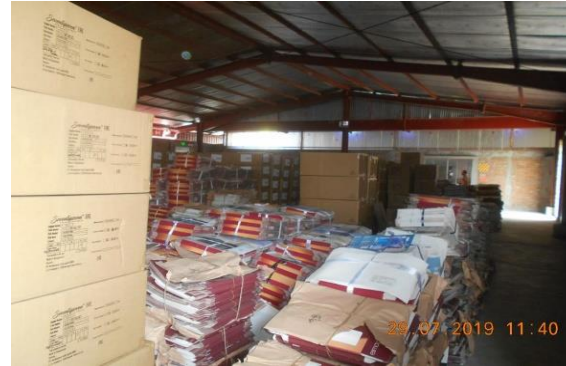
Storage rooms are found in the following area: Shed-A (Bonded ware house, Finished goods area 1, Yarn storage) & Shed-B (Finished goods area-2) without proper fire rated separation. In process storage areas were not observed within limit.

Open Storage Within Limits (Accord 3.4.2.1.6)	No	
Storage Areas Separated from Exit Stairs & Discharge Paths	No

2	Fire rated construction	<p>Rooms used for storage of combustible materials are not separated from the surrounding. Location: Bonded wear house, Yarn store, Finished Goods Store 1 & 2.</p>	<p>Rooms used for storage of combustible materials shall be separated from the surrounding occupancy with a minimum 1 hour construction.</p>	<p>Within 3 months</p>
