# Shafi Knit Ltd.

Natun Para, Baipail (beside DEPZ-2), Ashulia, Savar, Dhaka  
(23.945646N, 90.277794E)

12<sup>th</sup> May 2019

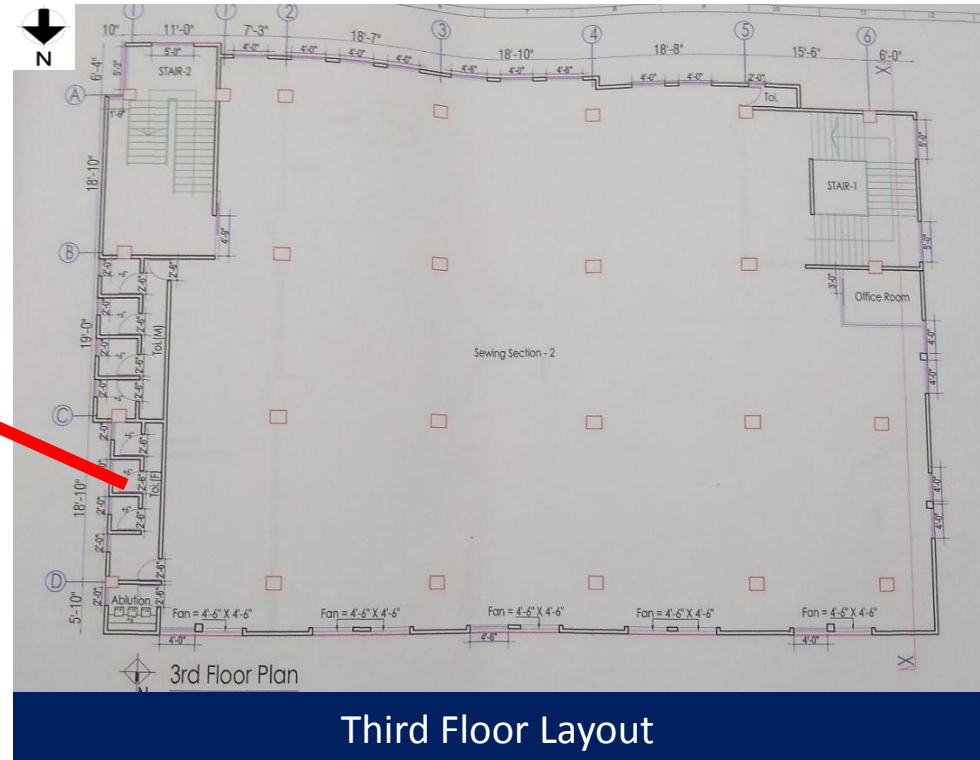
Toilet Zone

Number of toilets did not match with as-built drawings. Six nos. of female toilets were found on site where as-built drawing shows three nos.

| Item No. | Observation | Recommended Action Plan | Recommended Timeline |
|---|---|---|---|
| 1 | Discrepancies between provided drawings and on-site condition | Building Engineer to survey the structure and prepare accurate as-built drawings. | 6-weeks |

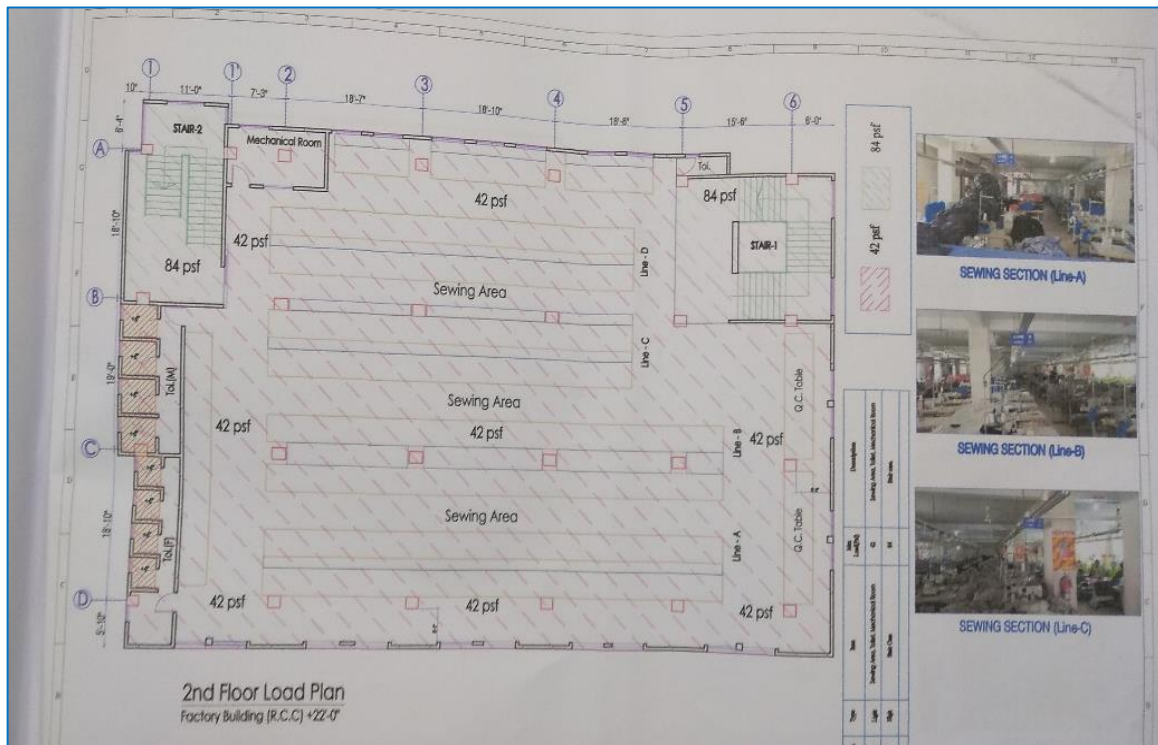
Floor loading

The provided Load Plan shows 2 kPa loading. As the second phase of construction started in July 2015 and ended in March 2016 up to roof top shed the Load Plan must be in accordance with BNBC Standard.

During inspection no over loading was found. FoS calculation for internal & external columns were found satisfactory considering 3 KPa allowable floor live loading for all buildings.

Factory is required to revise the DEA including Load Plan as per actual onsite condition and submit to Accord.

| Item No. | Observation | Recommended Action Plan | Recommended Timeline |
|---|---|---|---|
| 3 | Load plan & design reports required to be revised and submitted to Accord for further review | Produce and actively manage a loading plan for all floor plates within the factory, considering floor, column and foundation capacity as per BNBC provision. | 6-weeks |
