Laila Styles Ltd.

Bahadurpur, Gazipur.
(24.077527, 90.369504)
27th January 2019 & 04th February 2019

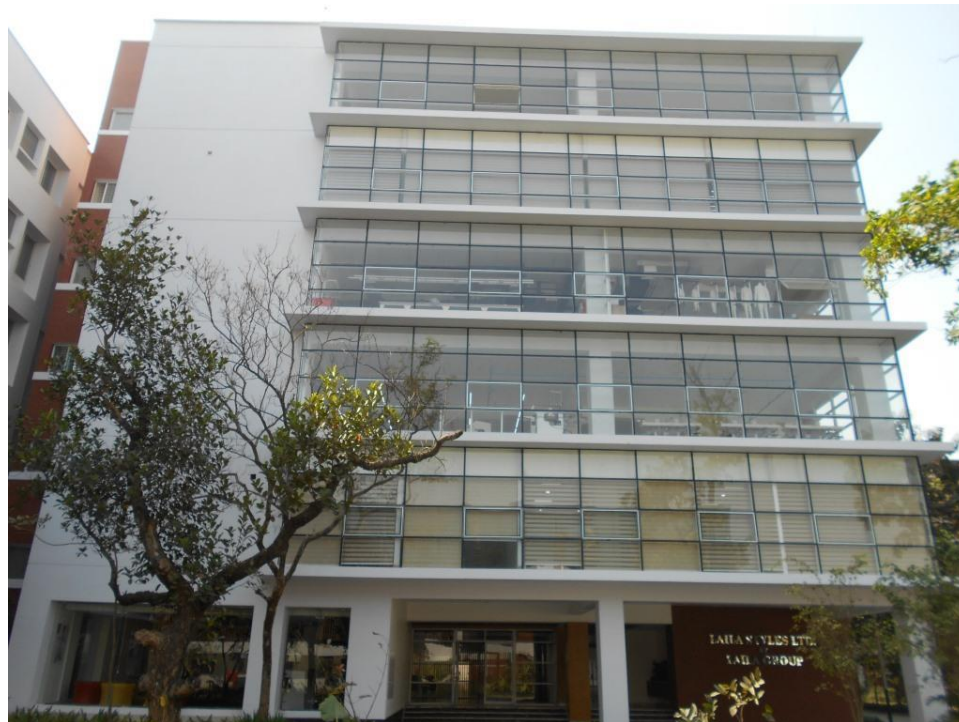
Load plan is required to be reviewed

We have checked the column capacity based on minimum concrete strength and found that the column stresses exceed above normal design limit considering the provided load plan. But considering 3 Kpa live load and minimum concrete strength, the column stresses are within normal design limit. The provided load plan was based on 4000 psi concrete strength of column. Insufficient number of cylinder test result from column were provided. Strength of two of the cylinder test result for column were found to be 4102 psi and 4303 psi which were not adequate for evaluation of the design concrete strength of column. Factory engineer is required to review the provided load plan.

Item No.	Observation	Recommended Action Plan	Recommended Timeline
1	Load plan required to be reviewed (Building-1 Production Building)	Maintain 3 Kpa load on all floors.	6-weeks
2	Load plan required to be reviewed (Building-1 Production Building)	Produce and actively manage a loading plan for all floor plates within the factory giving consideration to floor capacity and column capacity if loading above 3kpa is considered.	6-weeks
3	Load plan required to be reviewed (Building-1 Production Building)	Continue to implement load plan.	6-months
4	Discrepancy in as-built drawing (Building-1 Production Building)	Building Engineer to prepare accurate as-built structural drawing.	6-weeks
5	Columns susceptible to vehicle impact (Building-2 Warehouse Building)	Install safety guard to protect the columns from vehicular impact.	6-weeks
6	Implement the provided load plan (Building-2 Warehouse Building)	Maintain the load plan and ensure that the workers understand the loading requirements	6-weeks
