# Time Sweater Limited

Survey Date: 13<sup>th</sup> April 2015

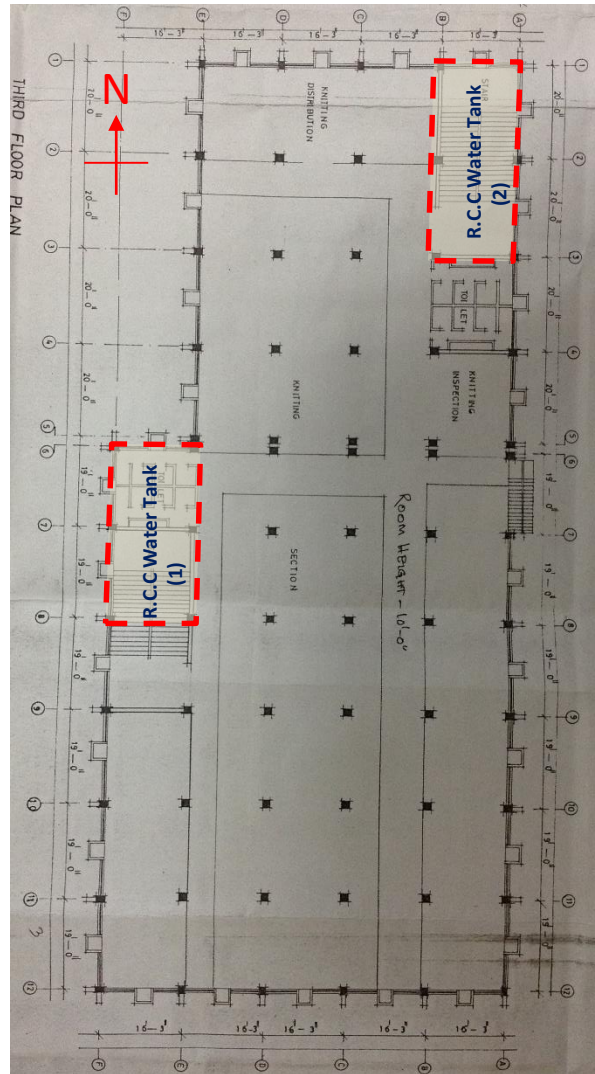
Architectural Permit Drawing

## Water tanks at Roof Level

| Item No. | Observation | Recommended Action Plan | Recommended Timeline |
|---|---|---|---|
| 1 | High Column stress<br>Water tanks at Roof Level | Empty Water tanks on roof. Provide isolated small plastic water tanks distributed in the roof area as directed by the Factory Engineer. | Immediate - Now |
