# Apex Textile Printing Mills Ltd

Chandora, Kaliakoir, Gazipur, Dhaka  
(+24.043819N, 90.260622E)

14 December 2013

# Building Observations

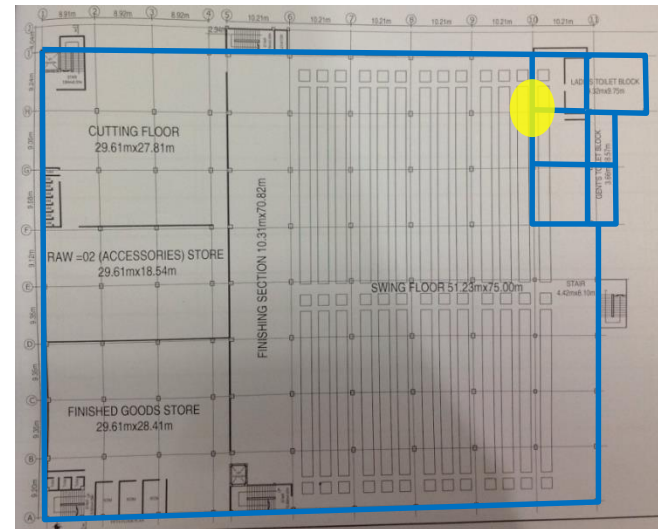
**Cracking pattern to concrete  
beams and drop heads on the  
underside of 6<sup>th</sup> floor slab**

**Crack in beams, slabs and drop heads at area highlighted in yellow – u/side 6<sup>th</sup> floor**

| Item No. | Observation | Recommended Action Plan | Recommended Timeline |
|---|---|---|---|
| 6 | Cracking to underside of concrete beams, slabs, drop heads and partitions. | Sections of plaster finish to beams/slab to be removed to investigate if cracks penetrate the building structure. | 6-weeks |
| 8 | Cracking to underside of concrete beams, slabs, drop heads and partitions. | Building Engineer to carry out design check on beams/slab to confirm that these cracks are non-structural. | 6-months |
| 9 | Cracking to underside of concrete beams, slabs, drop heads and partitions. | Building Engineer to issue details of repair works to be completed | 6-months |

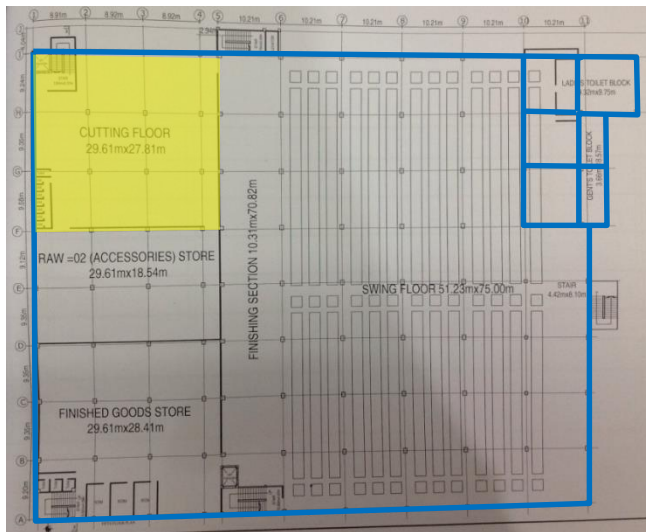
**5<sup>th</sup> floor**

**Crack in slab at the movement joint at area highlighted in yellow – u/side 6<sup>th</sup> floor**

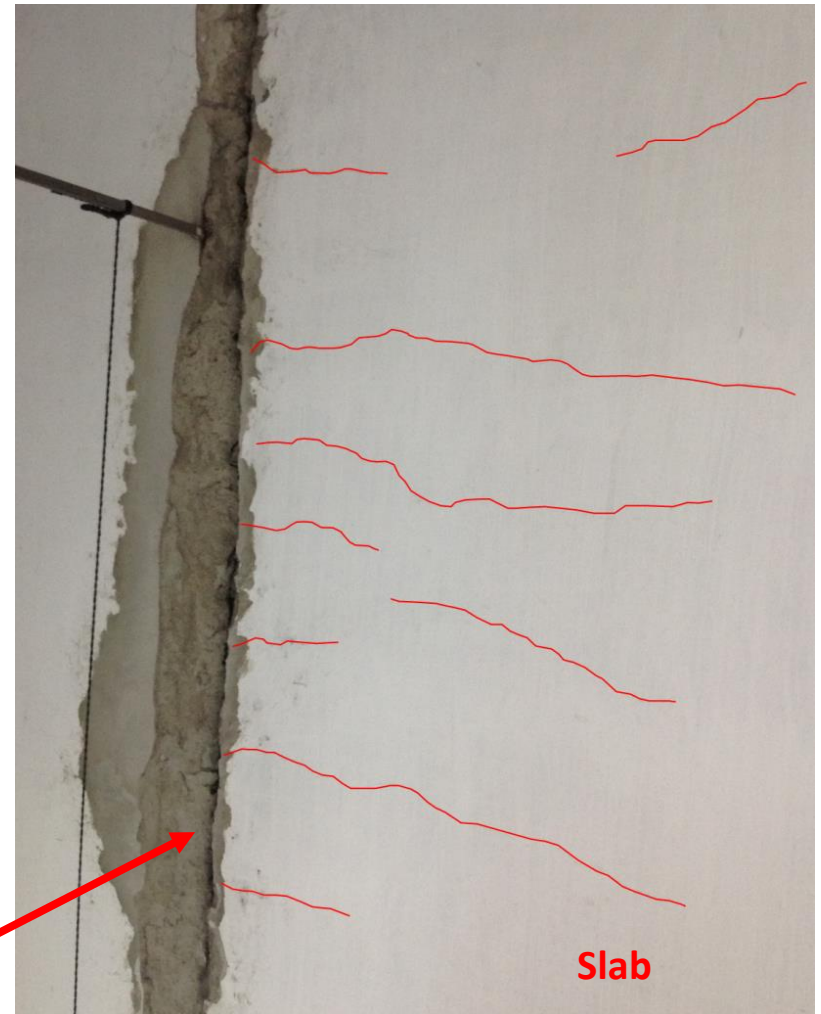
**Building  
Movement  
Joint**

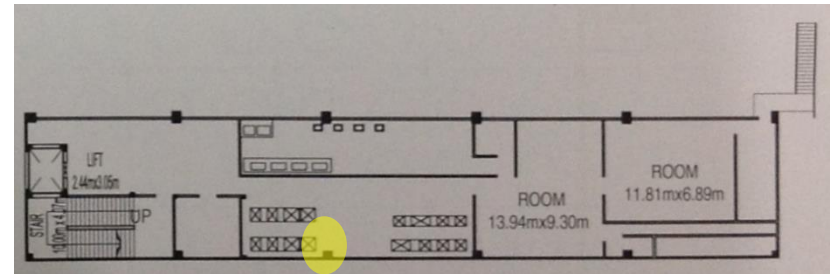
**Horizontal crack in column –  
Ground Floor Mezzanine**

## Crack in column

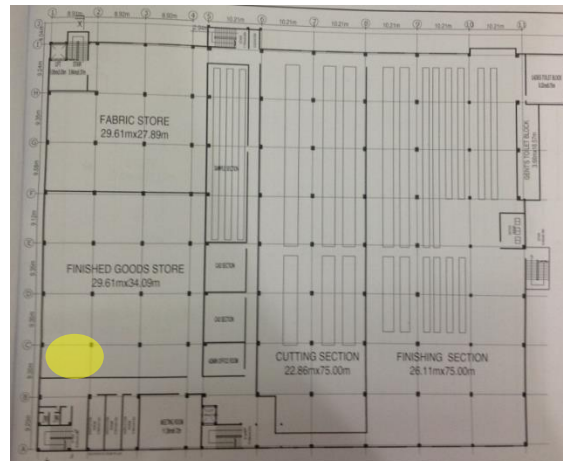
**2<sup>nd</sup> floor**

**Crack in partition – 2nd floor**

| Item No. | Observation | Recommended Action Plan | Recommended Timeline |
|---|---|---|---|
| 7 | Cracking to underside of concrete beams, slabs, drop heads and partitions. | Cracks in brick wall to be reviewed to identify the cause and confirm that it is non structural | 6-weeks |
