MM Knitwear Ltd

Gazipur
(24.013868N, 90.321500E)

14 December 2013

Building Observations

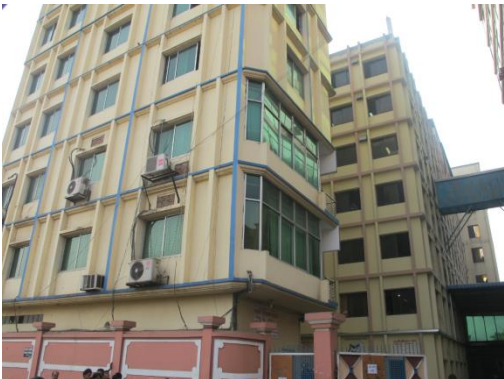
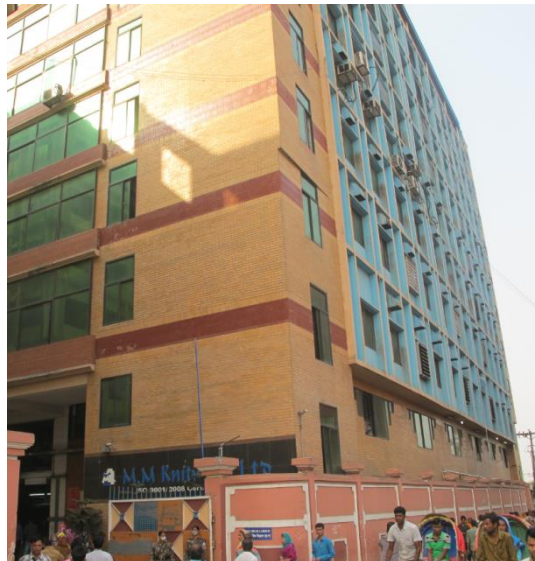
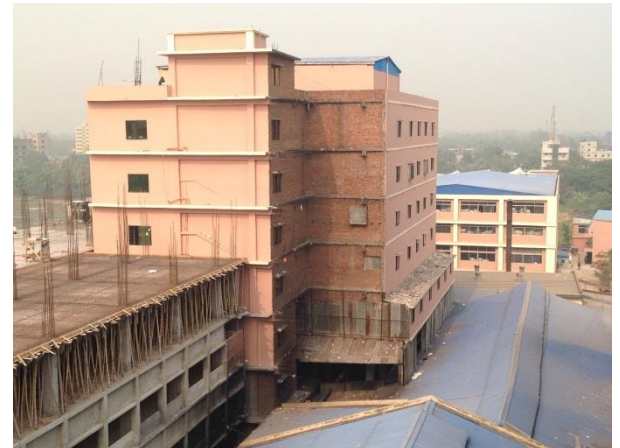
Building 1

Limit density of loading in storage areas

Uncontrolled loading

Plan and height restrictions to be introduced to prevent future overloading. (Loading plans in line with design loads from engineer)
