# ELECTRICAL SAFETY INSPECTION REPORT

INTERFAB SHIRT MANUFACTURING LTD (UNIT-2)

STOFFATEX FASHIONS LTD

**Inspected on:** July 28, 2019

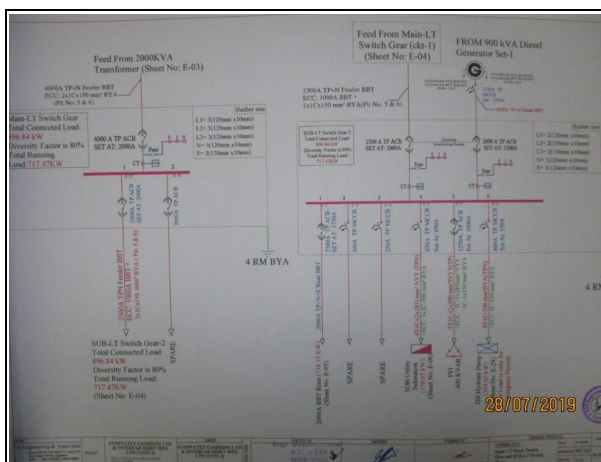
Single Line Diagram (SLD)

| <b>FINDING:</b><br>SLD is not amended properly (busbar dimension, connecting busbar rating from main bus to MCCB and load details missing). | |

| <b>RECOMMENDATION:</b><br>Draw as built electrical SLD mentioning all required information by qualified engineer and get it reviewed by Accord. Electrical SLD must be updated properly when electrical system is modified. | |
