# Target Denim & Casual Wear Ltd.

Islampur Road, Kodda, Nadun, Gazipur

27<sup>th</sup> January and 4<sup>th</sup> February 2019

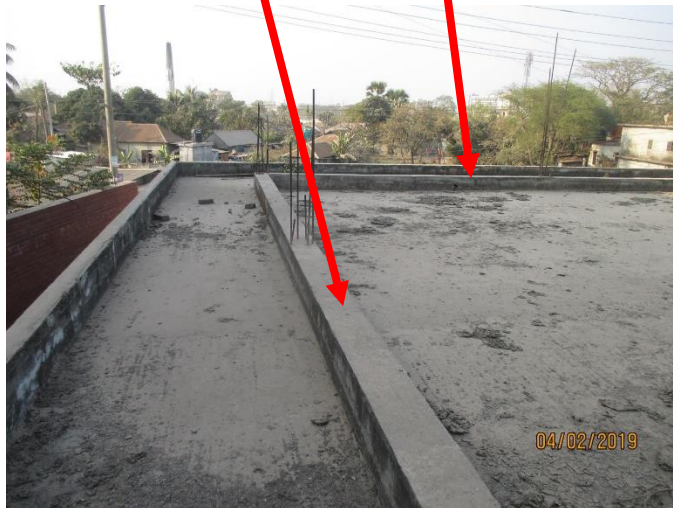
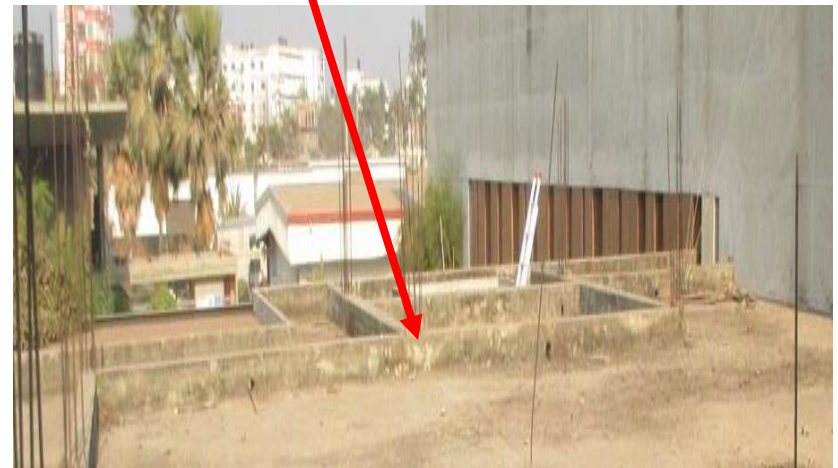
# **Lack of water proofing membrane and exposed rebar on roof**

Signage of water ponding was found at roof level

Column re-bar was found exposed at roof level
