# LOGOS Apparels Ltd.(New buildings)

TELIRCHALA, MOUCHAK, KALIAKOIR, GAZIPUR  
(24.016202, 90.305371)

29<sup>th</sup> January 2019 & 5<sup>th</sup> February 2019

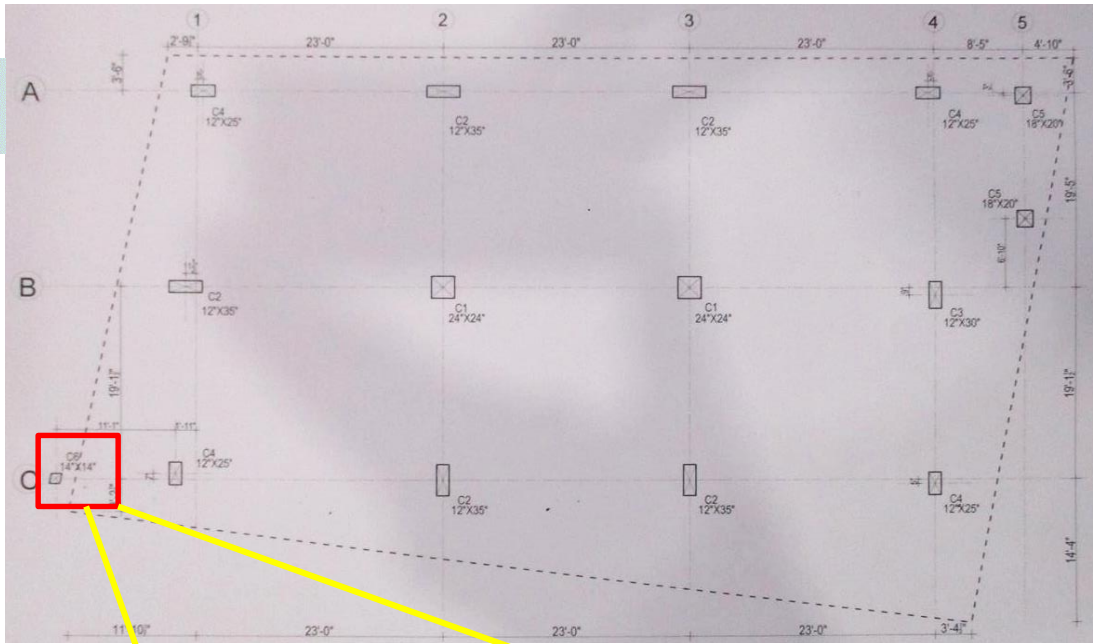
C6 column was found at basement level only but shown up to roof level in as-built drawing.

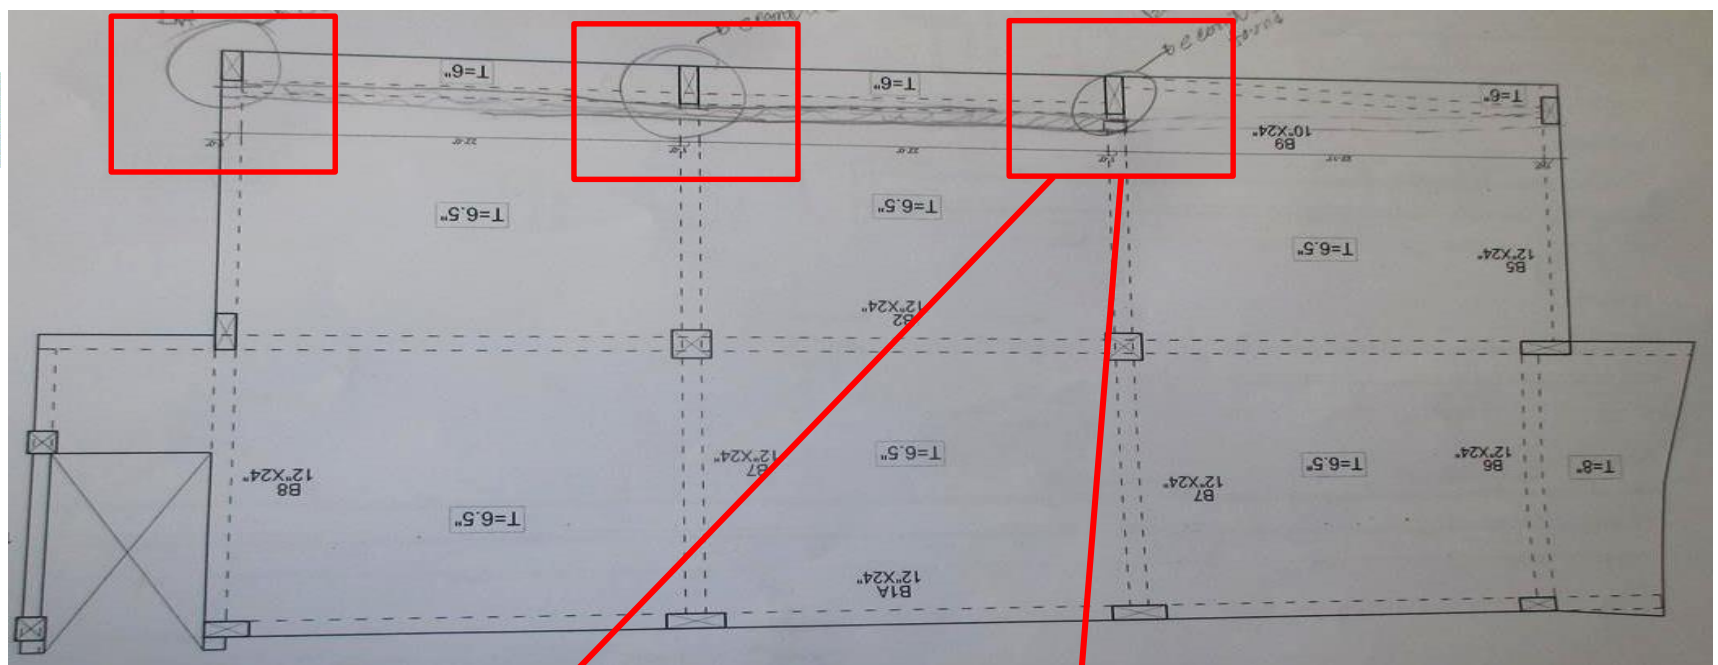
Eccentric connection at beam-column joint (marked Locations)

| Item No. | Observation | Recommended Action Plan | Recommended Timeline |
|---|---|---|---|
| 3 | Discrepancies between provided drawing and as-built condition (Building#2) | An engineering assessment of the factory building is required to be carried out considering vertical & lateral loading. | 6-weeks |

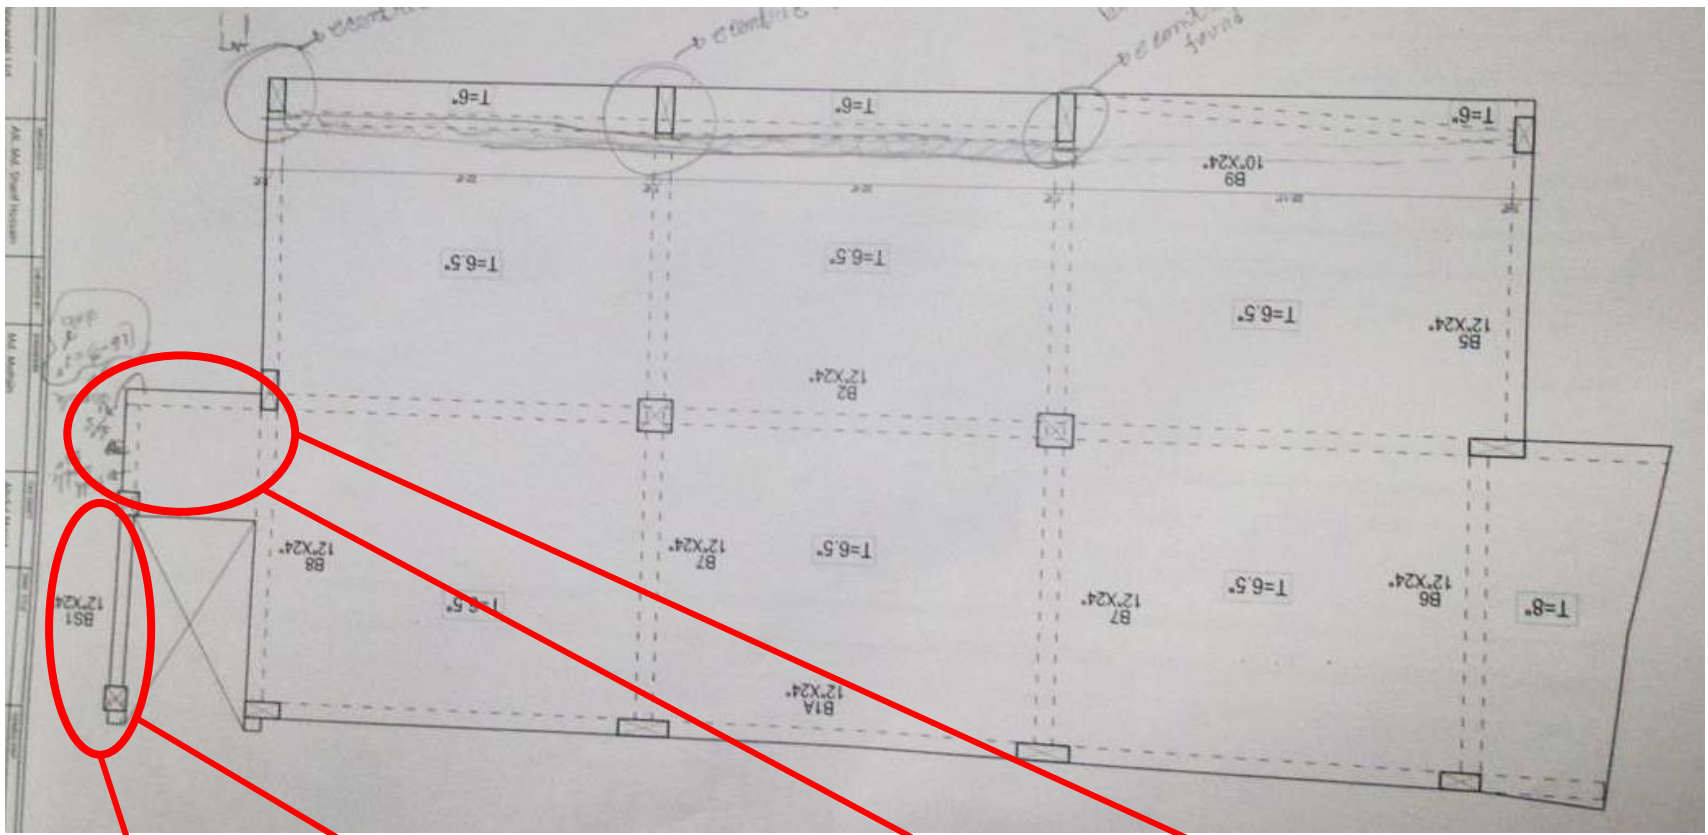
Beam layout Plan

Full Depth  
found 400 mm  
instead of 600  
mm

Down stand  
depth of Beam  
was found  
250mm.

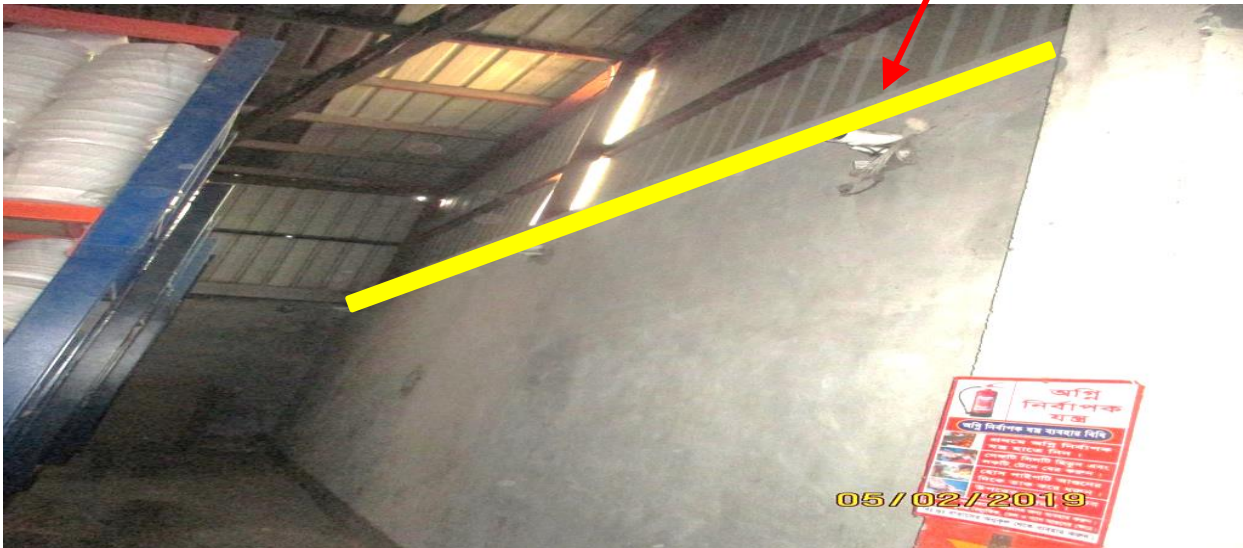
Arrangement and number of the truss member do not match with actual site condition. Total number of vertical member was found 10 nos in each side instead of 13 nos. Diagonal members were found in the pattern shown in red mark.

| Item No. | Observation | Recommended Action Plan | Recommended Timeline |
|---|---|---|---|
| 11 | Discrepancies between provided drawing and as-built condition (Shed#1) | Factory Engineer to survey the structure and update the full set of architectural and structural “as-constructed” drawings. | 6-weeks |

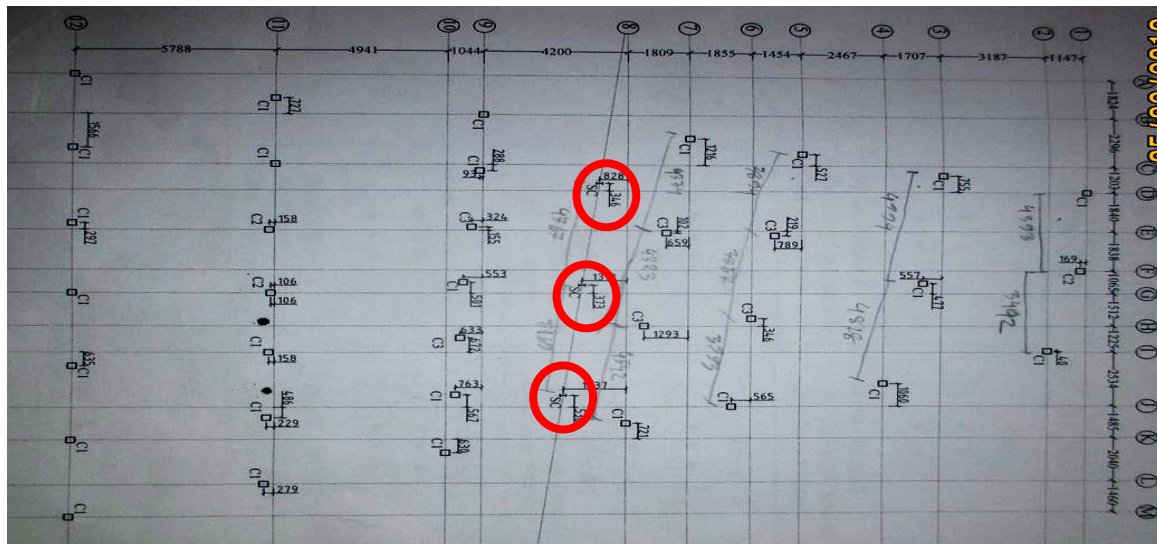
Column Layout Plan for 1<sup>st</sup> floor

Three steel column started from 1st floor to 2nd floor level. No adequacy check of slab was found. Factory engineer is required to check adequacy of the slab to bear load from steel column.

| Item No. | Observation | Recommended Action Plan | Recommended Timeline |
|---|---|---|---|
| 17 | Three steel column constructed on 1st floor slab (Shed#2) | Complete remedial works as per the recommendation of engineering assessment. | 6-months |

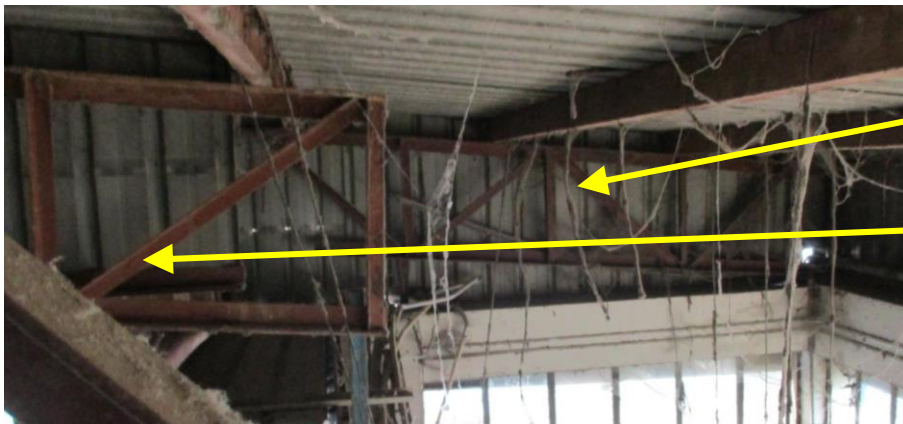
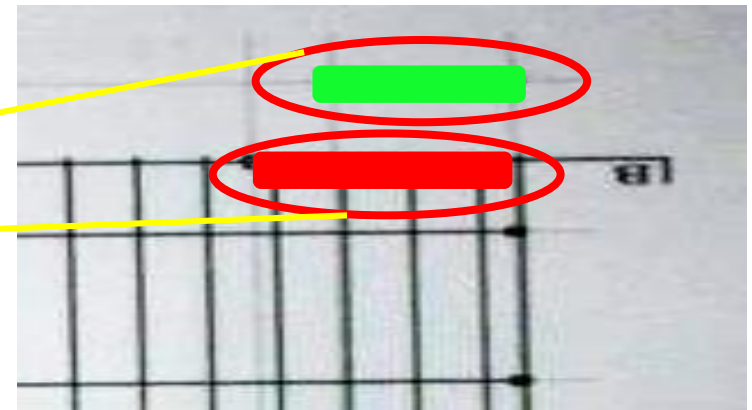
Truss layout plan; Additional truss found at grid 10 instead of Grid-9 at marked location. Truss was found at green marked location instead of red marked location.

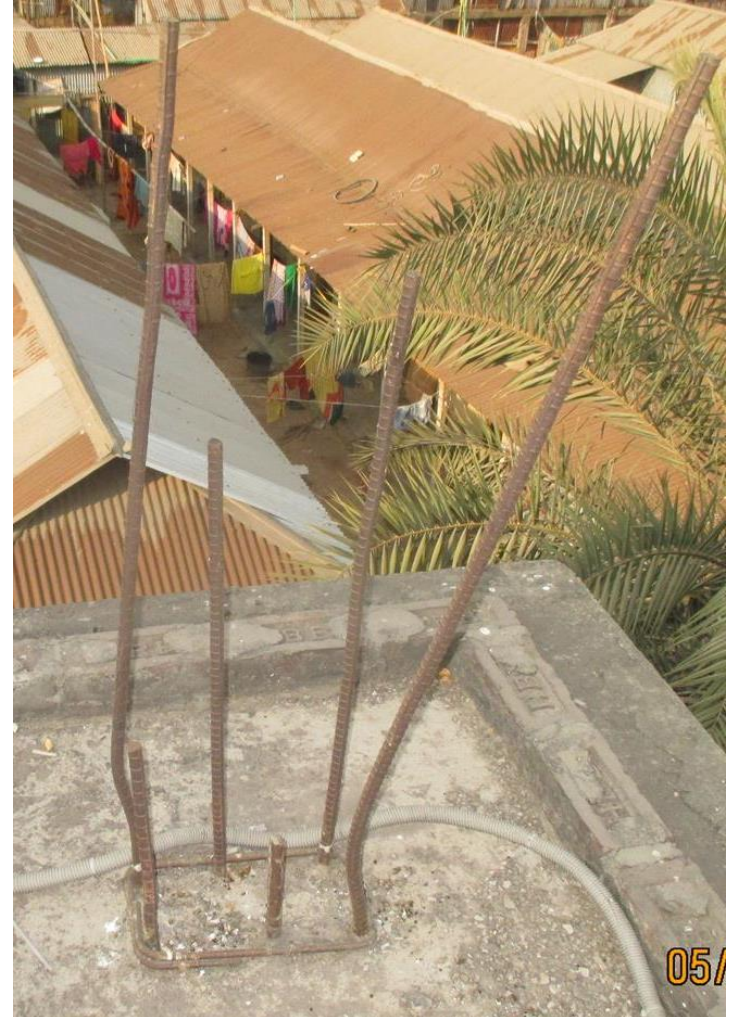
Exposed re-bar was found at roof level. Factory is required to take necessary measure to prevent corrosion in exposed re-bar
