## Cotton Dyeing & Finishing Mills Ltd

10 May 2014

## Structural Inspection Report

### Observations & Actions

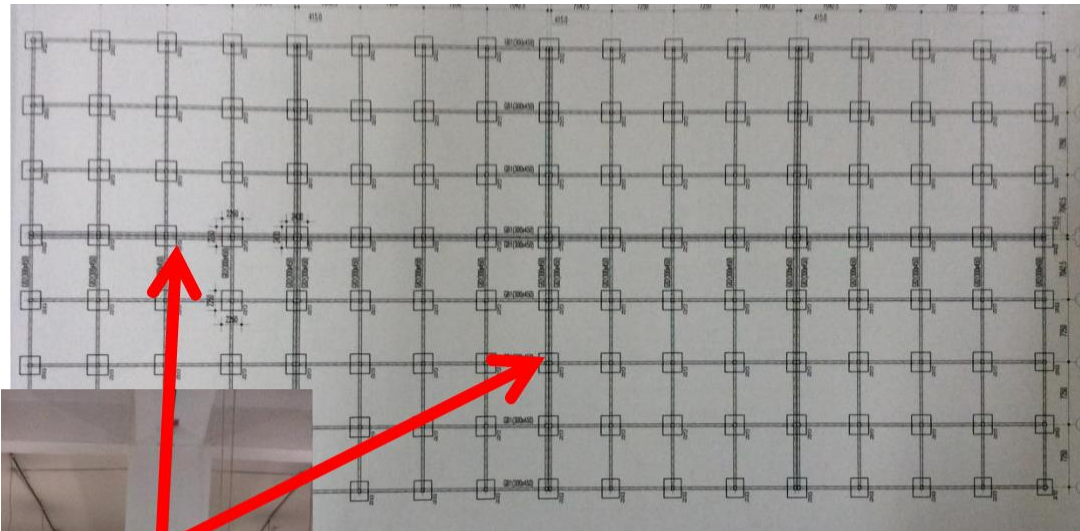
**Structural Joint**

**Structural joint as shown in figure.**

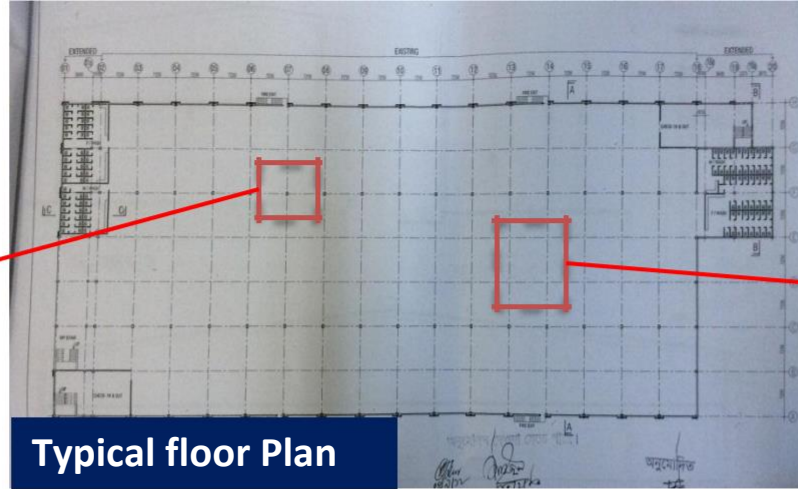
**Typical floor Plan**

# **Cracking of floor finishes/slab and management of floor loads**

**Cracks in 1<sup>st</sup> floor slab**

**Cracks in Ground floor slab**

**Building Engineer to prepare controlled loading plans, based on floor slab and column capacity, for all floors which will designate allowable storage density and where storage may be placed. Crack repairs to be carried out as necessary.**

- Produce and actively manage a loading plan for all floor plates within the factory giving consideration to floor capacity and column capacity.
- Building Engineer to review typical floor finish cracks at ground and 1<sup>st</sup> floors and confirm that cracking is in finishes only. Where required, remedial works to be carried out.

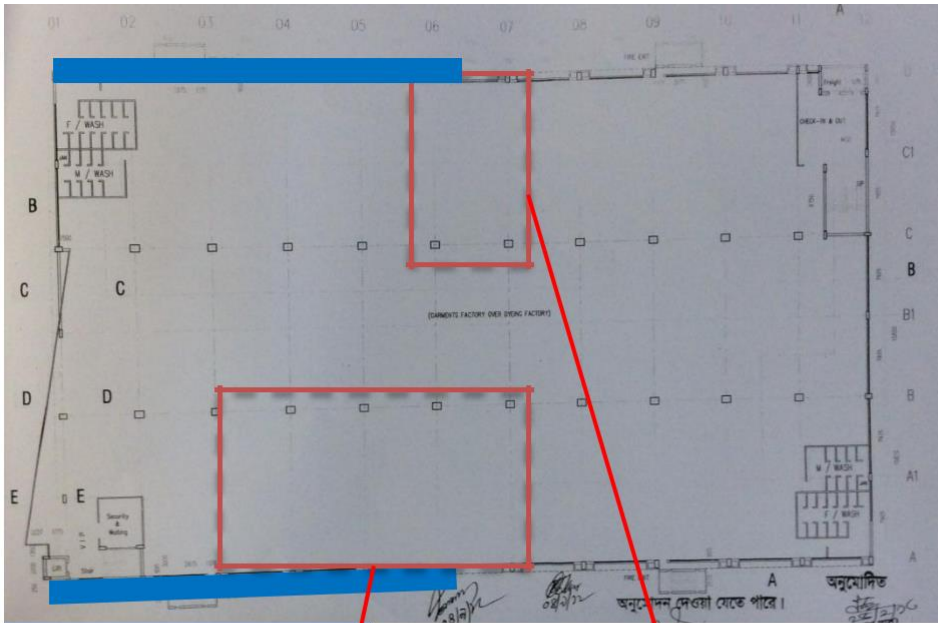
**Typical Floor Plan**

# **Cracking of floor finishes/slab and management of floor loads**

**Cracking of floor finishes/slab  
and management of floor loads**

**Building Engineer to prepare controlled loading plans, based on floor slab and column capacity, for all floors which will designate allowable storage density and where storage may be placed. Crack repairs to be carried out as necessary.**

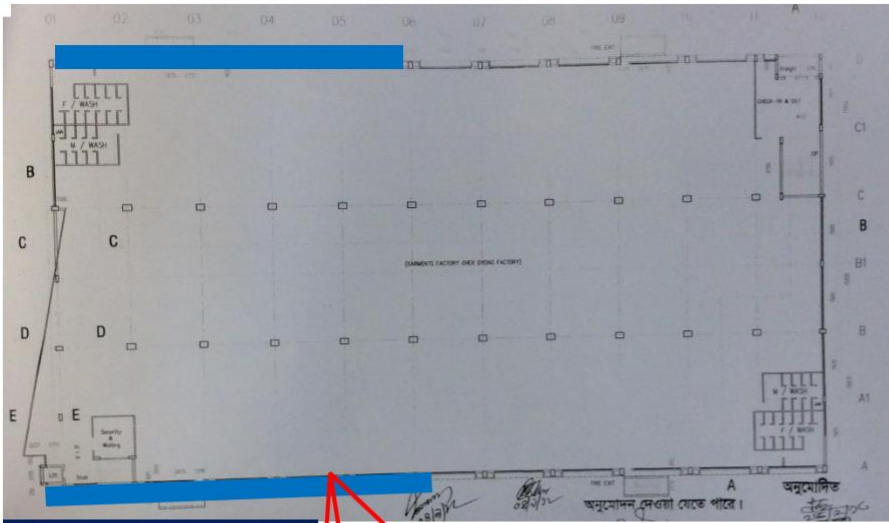
**Typical Floor Plan**

# **Cracking of external cantilever slab and building façade**

**Façade cracking**

**Building Engineer to investigate reasons for cracking and implement repairs as necessary**

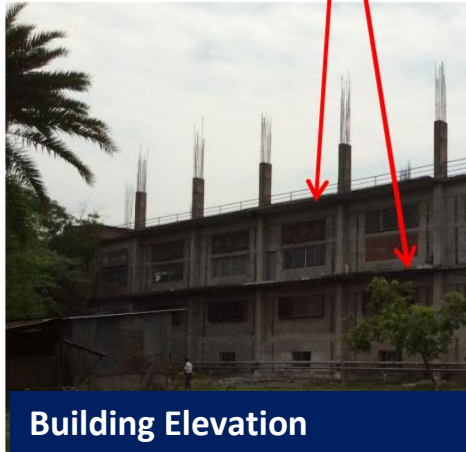
**Building Elevation**

**Cracks on the lower level cantilever**

**Cracks on the upper and lower cantilevers propagating from the column towards the tip of the cantilevers**

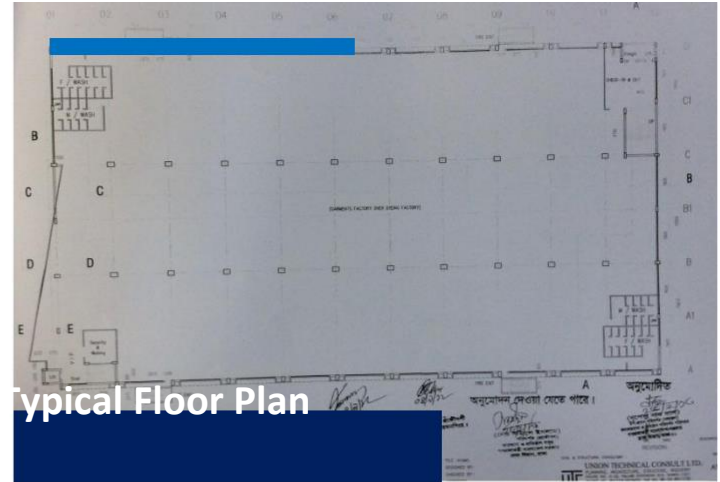
**Typical Floor Plan**

Mezzanine is shown covering 2 full bays at the west end of the building on the RC drawing. As constructed it only covers 1 bay at the middle section of the mezzanine.

**Discrepancies between the drawings and as constructed**
