# Sublime Greentex Ltd. Executive Intimates Ltd.

Gilarchala, Sreepur, Gazipur  
(24.194254, 90.425146)  
25<sup>th</sup> February 2018

# Observations

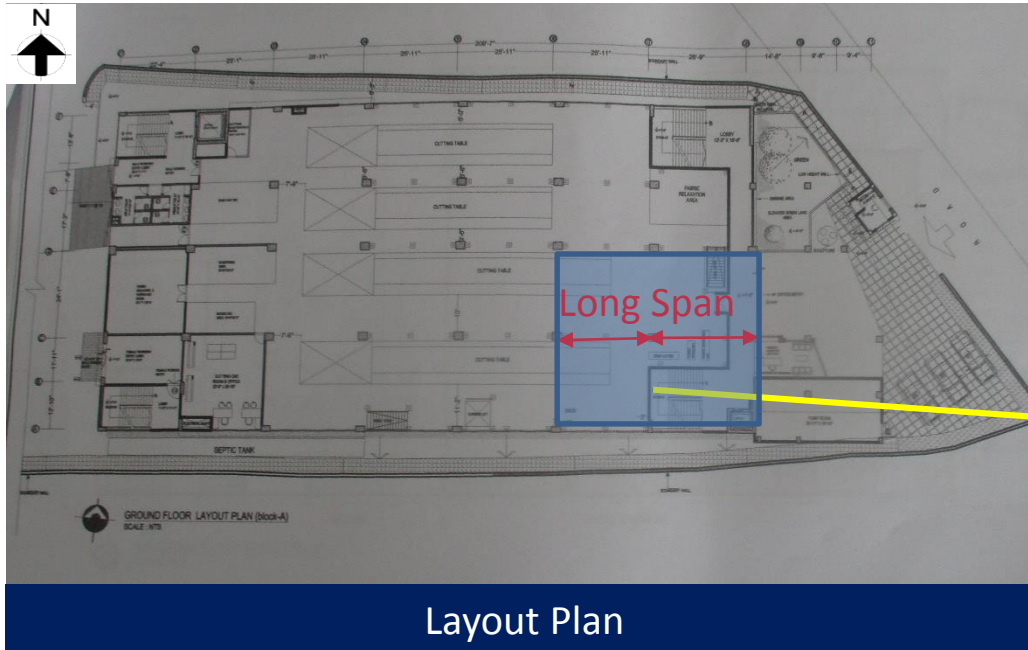
Layout Plan

# Column to be stressed above normal design limits

Cursory calculations indicate that the working stress of the columns at Ground Floor level are above normal design limits.

Long span

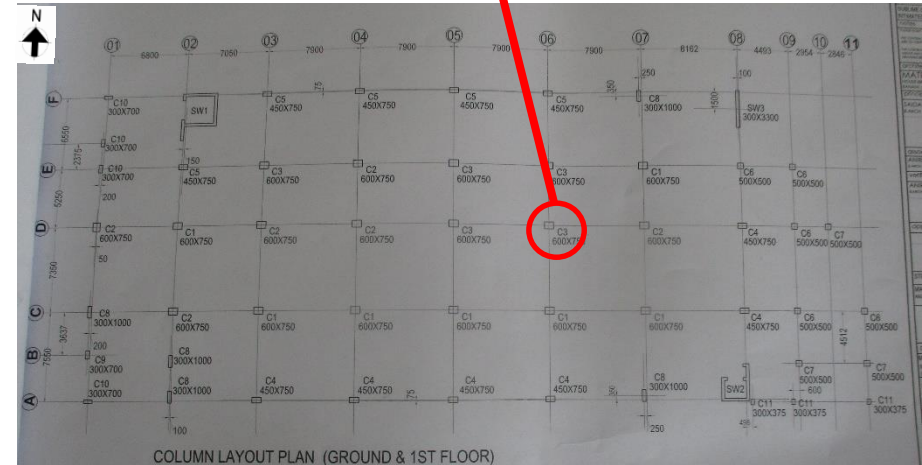
Column layout plan

Beam layout does not match with as built condition. Cantilever beams at front are not shown properly on drawings.

| Item No. | Observation | Recommended Action Plan | Recommended Timeline |
|---|---|---|---|
| 6 | (Production Building)<br>Discrepancies between provided drawings and on site condition. | Building Engineer to survey as-built structure and prepare accurate as-built survey information for the building. | 6-weeks |

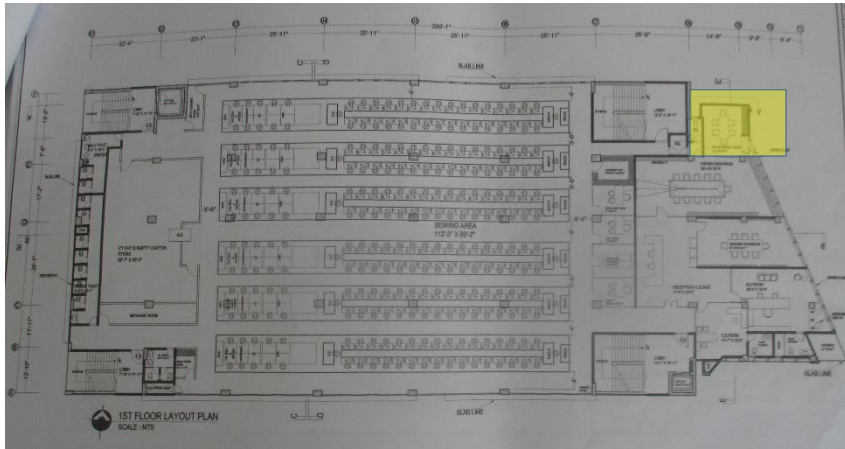
Floor layout

# Large floor cantilevers at East

Large cantilever beam was observed at the front side of the building. Building Engineer to check structural adequacy of the cantilever and propose any remedial actions if required.

Cantilever at East

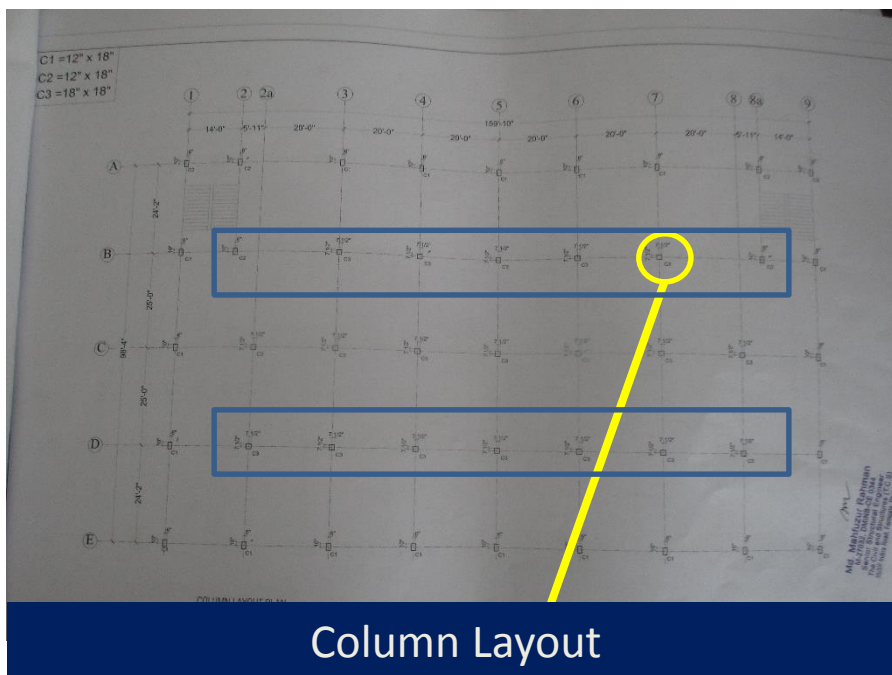
375 mm instead of 450 mm

C-3 type column section was found (375 X 375 mm) instead of (450mmX450mm) along grid B & D. Building engineer to verify sizes of each column and prepare accurate as-built drawings.

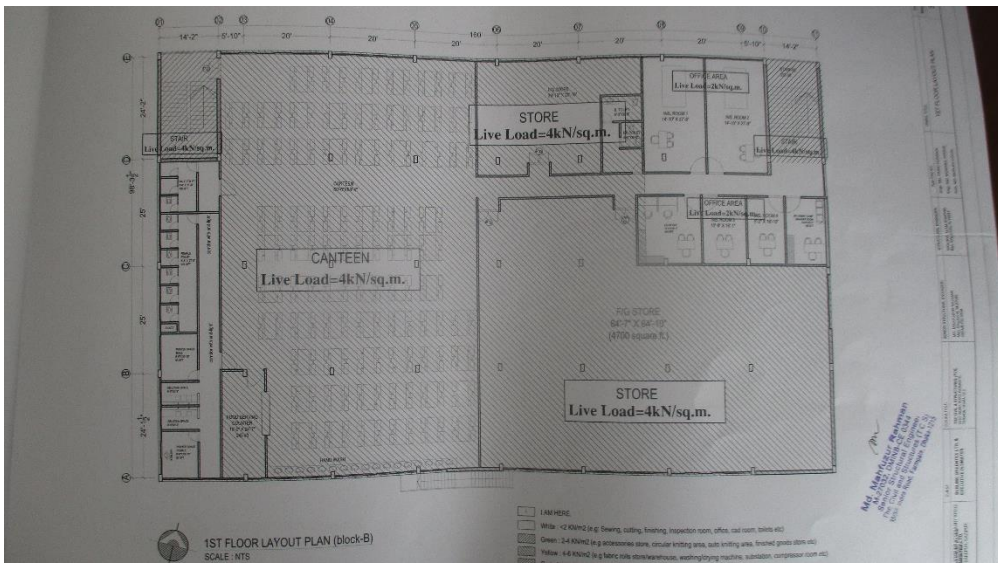
**Prepared load plan required to be  
verified**

During inspection no over loading was observed on floor. Factor of safety calculation for internal column was found satisfactory considering 3 kpa allowable floor live loading for existing structure.

Factory engineer has prepared a load plan considering 4kpa allowable floor loading for 1<sup>st</sup> floor. Design report is required to review if the factory management intends to implement the prepared floor load plan (above 3 kPa).
