Pacific Casuals Ltd.

Plot: 31-32, Sector: 1, CEPZ, Chattogram
(22.292645, 91.774568)
05th August 2019

Observations

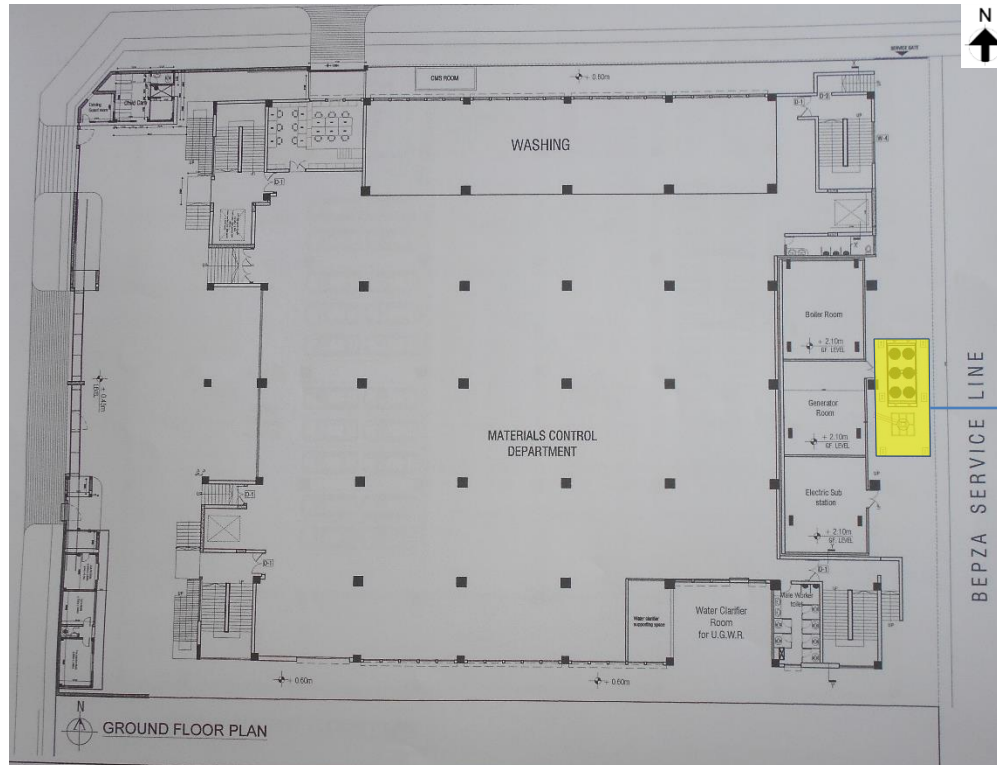
Ground Floor Layout

Corrosion found on steel member of supporting Structure

Excessive corrosion was found in steel member of supporting structure at East. The building engineer to investigate the reason & extent of corrosion and suggest proper remedial measure accordingly.

Item No.	Observation	Recommended Action Plan	Recommended Timeline
1	Columns susceptible to impact loading.	Construct and maintain protection to critical column and continue to assess likelihood of vehicle impact to critical elements.	6-weeks
2	Corrosion found on steel member of supporting Structure	The building engineer to investigate the reason & extent of corrosion and suggest proper remedial measure accordingly.	6-weeks
3	Corrosion found on steel member of supporting Structure	Take necessary measures to prevent further corrosion and repair the corroded steel members as per engineer's suggestion.	6-months
