ARA/Apparel Export Co. Ltd. (10716)

2/C Darussalam rd., Mirpur, Dhaka, Bangladesh

20.MARCH.2014

Identified Priority 1 Concerns

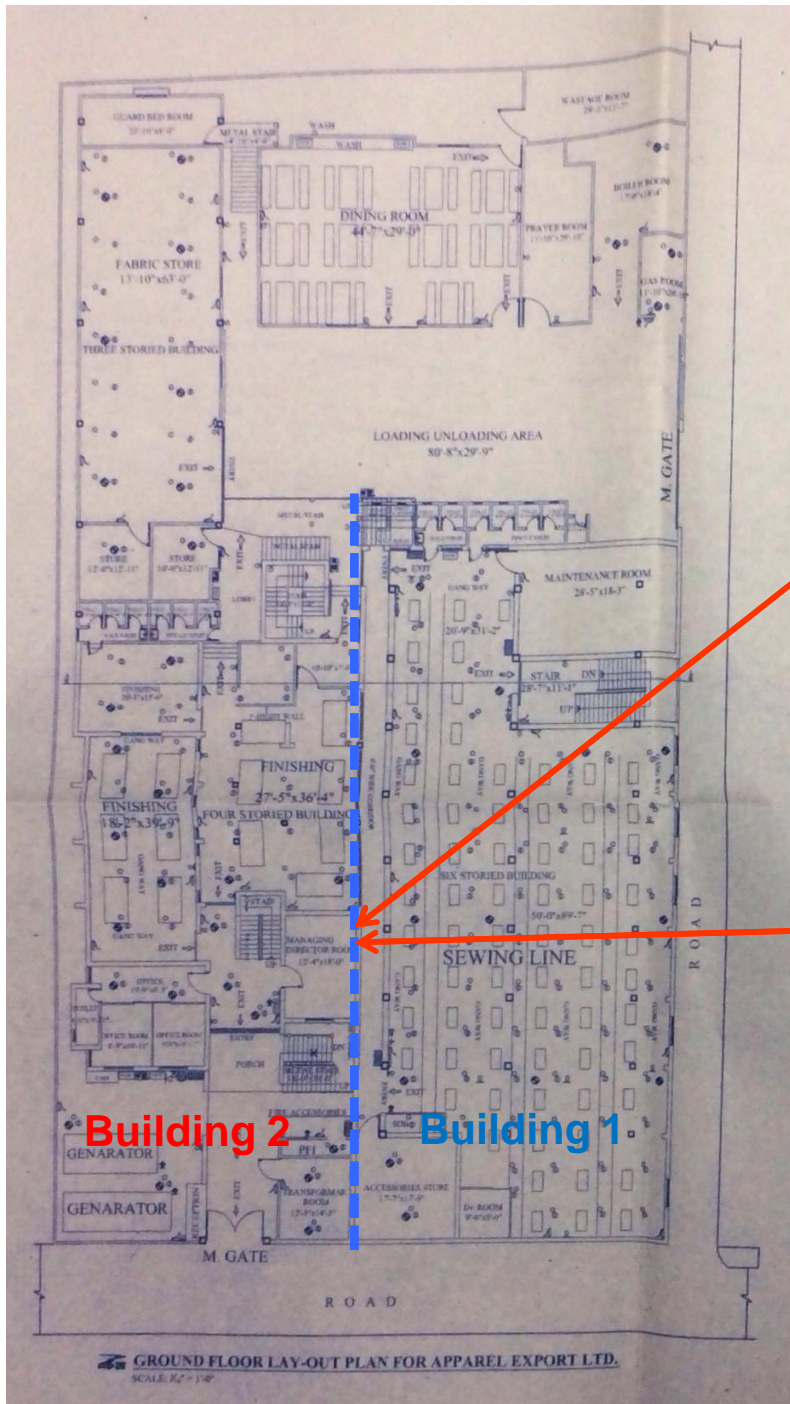
No movement joint properly established
to separate Building 1 and Building 2

No movement joint established properly to separate building 1 and 2. Building assessment including column and foundation capacity check are required.

----- Movement joint to be established properly

- Building assessment including column and foundation capacity check is required.

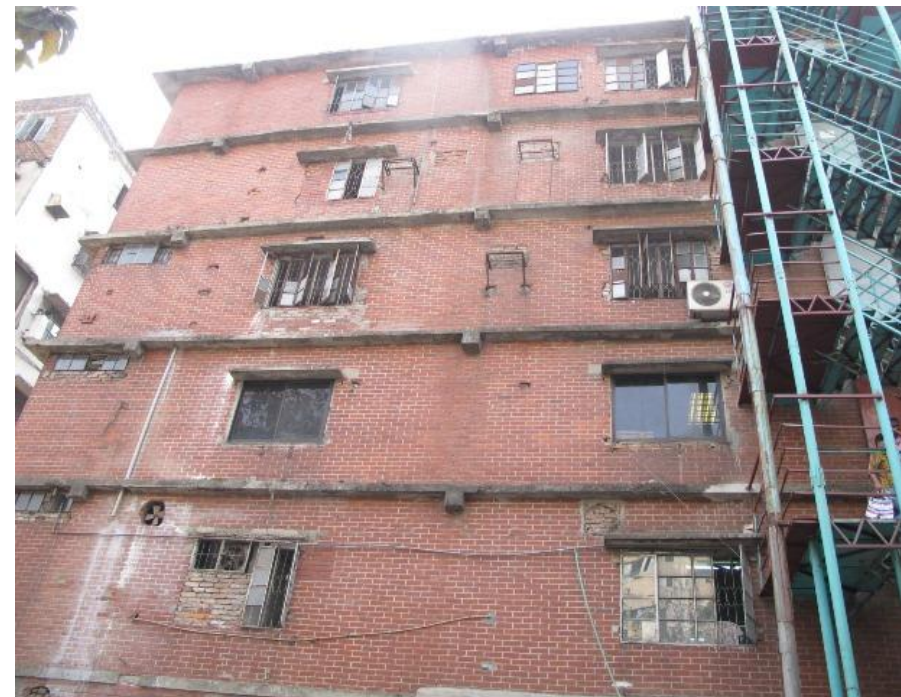
Concerns on the stability system for lateral loading and seismic loading. Façade brickwork with little capacity; lack of moment capacity in connection between columns and beams.

Further Detail Engineering Assessment is required to establish whether such system can resist the lateral load from wind & earthquake.

- Detail engineering assessment to be carried out in particular stability and foundation aspects to be investigated in detail.
