# Fortis Garments Ltd. Extended Building

Holding No-100/1, Block B, Saheed Mosarraf Hossain Road,  
Purbo Chandora, Sofipur, Kaliakoir, Gazipur.

2<sup>nd</sup> September 2019

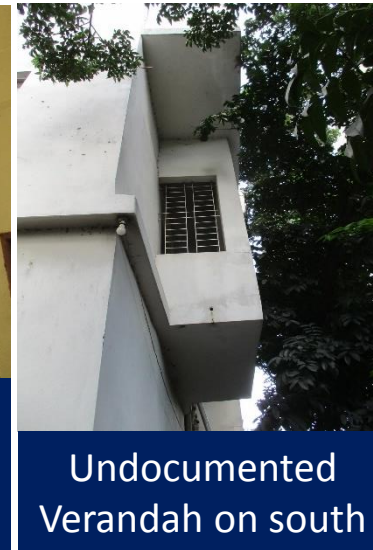
There was no beam layout drawing for the Sub-station Building. Also, discrepancies were found between as-built condition and provided drawings.

1. Development of Full Engineering As-Built Drawings showing Structure, loading, elements, dimensions , levels, foundations and framing on Plan, Section and Elevation drawings .
