H.I Apparels Ltd.

4th August 2019

Observations: Production Building

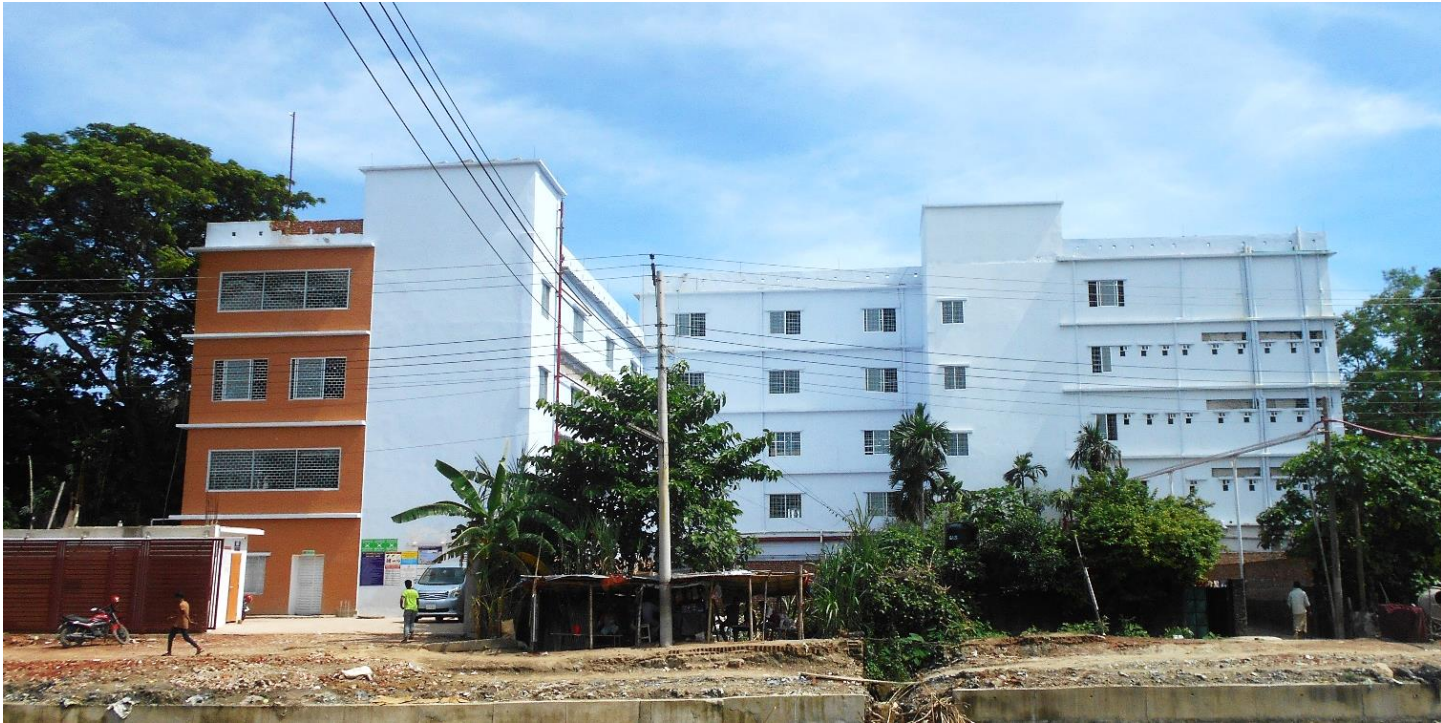
Discrepancies between drawings and on-site condition

Flange thickness of secondary beam at 3rd floor did not match with the provided drawings. Also, C-channel found instead I-beam at north side stair landing. Building engineer is required to produce an “as constructed” drawings with complete structural information.

Item No.	Observation	Recommended Action Plan	Recommended Timeline
1	Discrepancies between drawings and on-site condition	Engage an Engineer to produce an “as constructed” drawings which reflect the actual site dimensions with complete structural information.	6-weeks
2	Connection rigidity of beam-column joint	Connection rigidity and capacity of beam is required to be verified.	6-weeks
3	Connection rigidity of beam-column joint	Carry out strengthening work if required.	6-months
4	Prepared DEA report required to be reviewed	Revise the DEA report and complete the review with ACCORD.	6-weeks
5	Prepared DEA report required to be reviewed	Complete remedial works arising from design report.	6-months
6	Prepared DEA report required to be reviewed	Continue to implement load plan.	6-months
7	Construction fault of deck slab	Factory engineer is required to monitor the deck and keep record.	6-weeks
8	Construction fault of deck slab	Factory engineer is required to confirm that deck has adequate capacity to take the floor load otherwise suggest remedial actions.	6-weeks
