Tropical Knitex Ltd.

Chandra, Kaliakoir, Gazipur-1751, Bangladesh

24th September 2019 , 6th October 2019 & 15th October 2019

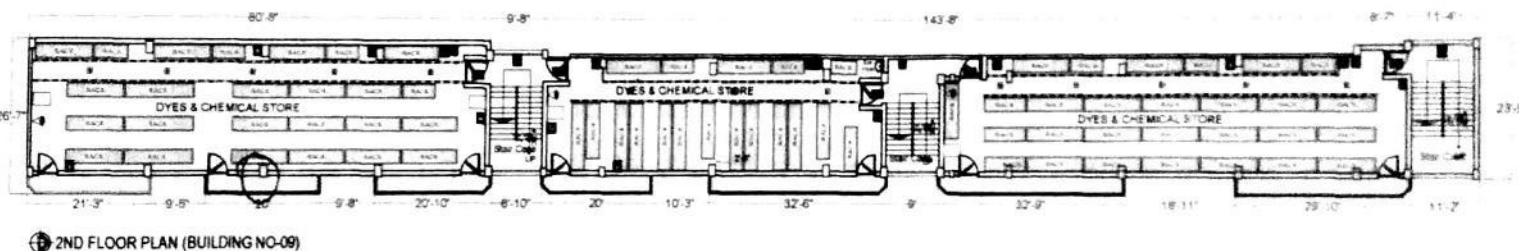
Floor plan

Apparently Building 9 is a slender building. Only one bay in weak direction. Lateral stability check is required.

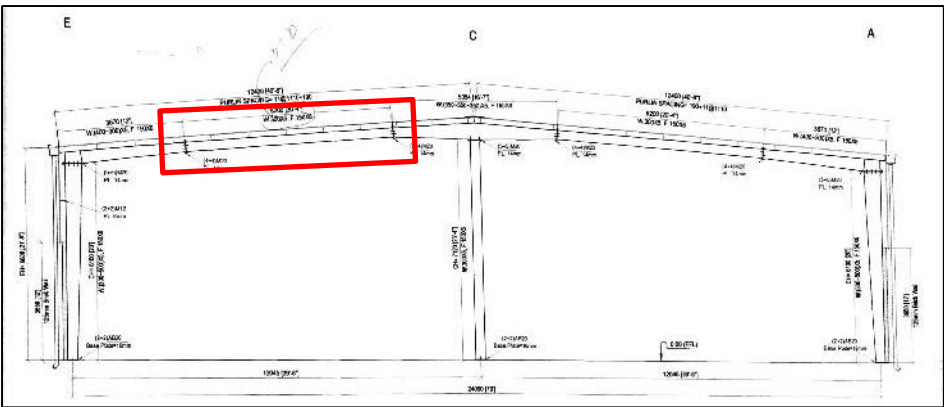
Typical Section

As per drawings, the marked rafters should have a width of 300 mm but on site the rafters width was found 250 mm.

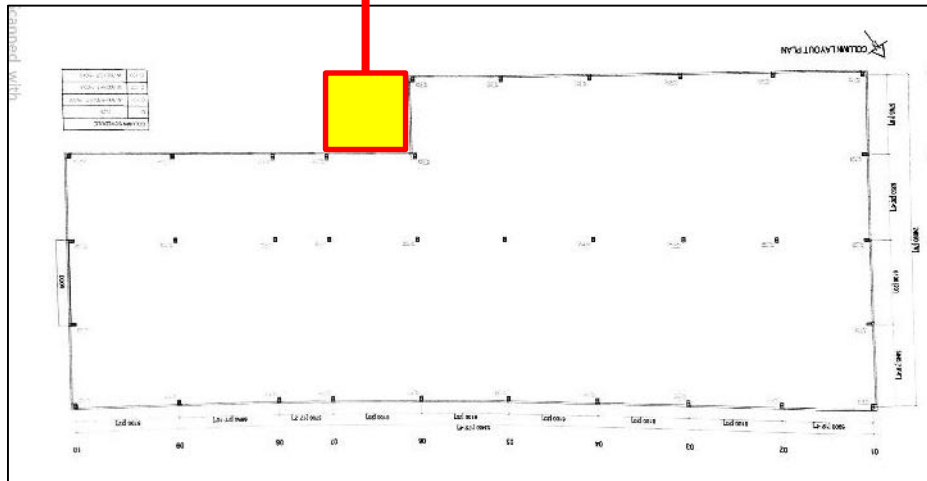
Typical Section

An extra undocumented portion was found which is not shown in the as built drawings.

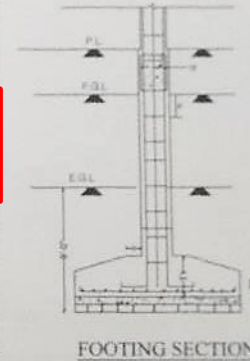
Foundation Schedule

Red marked footing found over stressed

Cursory calculation indicates that the soil below isolated footing appears to be stressed above normal design limit considering the recommended soil bearing capacity in geotechnical investigation report and footing sizes mentioned in the provided drawing. Factory engineer is required to review the adequacy of footings and comply with BNBC.
