Libas Textiles Ltd. (New building)

Nishchintapur, Mouchak, Kaliakoir, Gazipur.

10th July & 5th August 2019

Observations

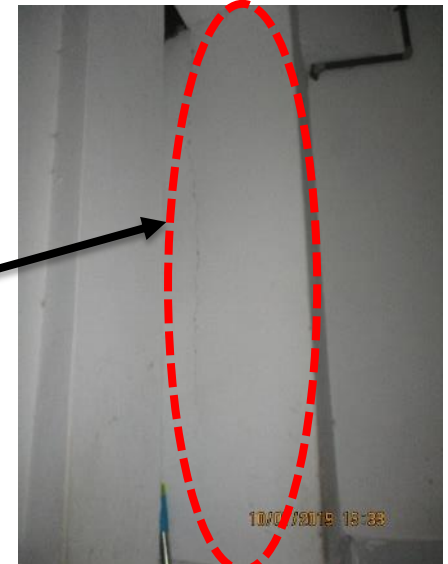
4 nos. 16 mm and 4 nos. 12 mm rebars were found on site in C-4 type column

4 nos. 20mm and 4 nos. 16mm rebar were shown in column schedule for C-4 type column at roof

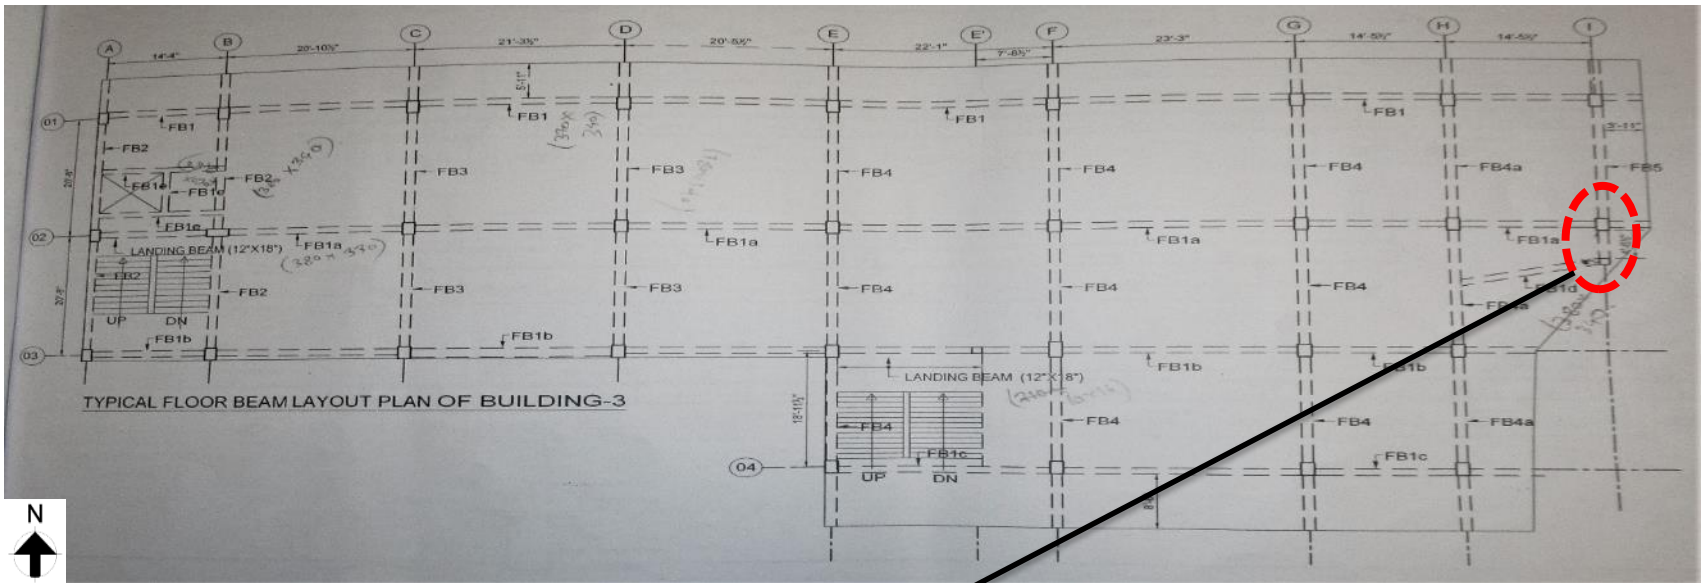
Typical Beam Layout Plan

Beam FB5 was found offset towards west from grid I2'.

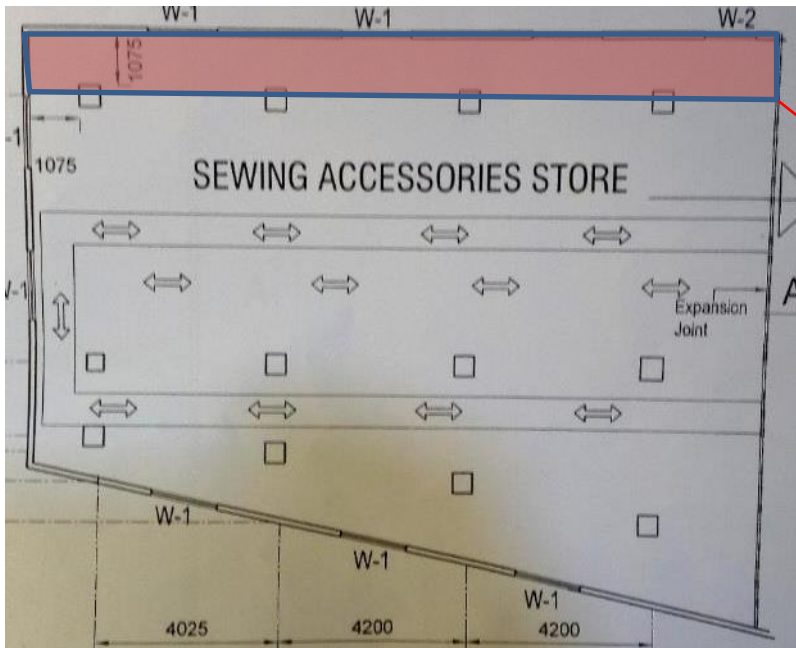
Floor Layout (Cracking zone shown in red)

Cracks under slab soffit & beam

Hairline cracks were observed on slab soffit (cantilever region) and on several floor beams. Sign of water ingress through the cracks on the roof slab was observed.

| Item No. | Observation | Recommended Action Plan | Recommended Timeline |
|---|---|--|---|
| 5 | Cracks found under slab soffit & beam (Building-4) | Crack investigation report is required to be prepared stating the nature of crack and suggesting proper remedial measures. | 6-weeks |
| 6 | Cracks found under slab soffit & beam (Building-4) | Repair cracks as per recommendation of investigation report. | 6-months |

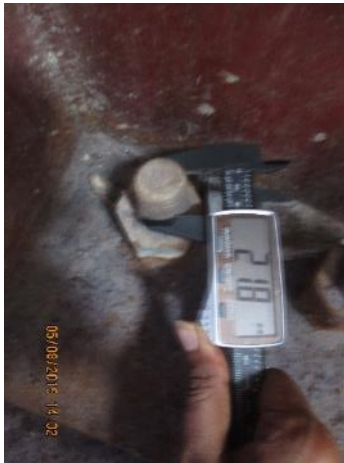
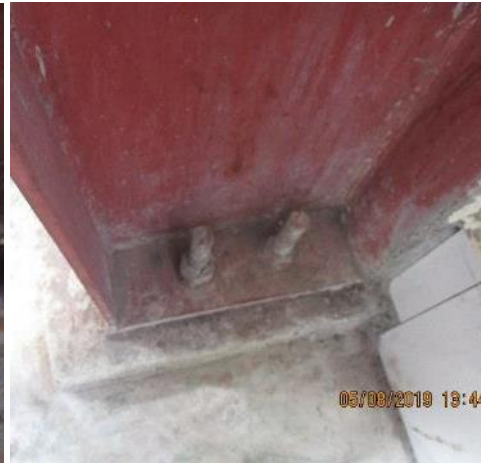
Anchor bolts were 22 mm instead of 25 mm as mentioned in provided as-built drawings.

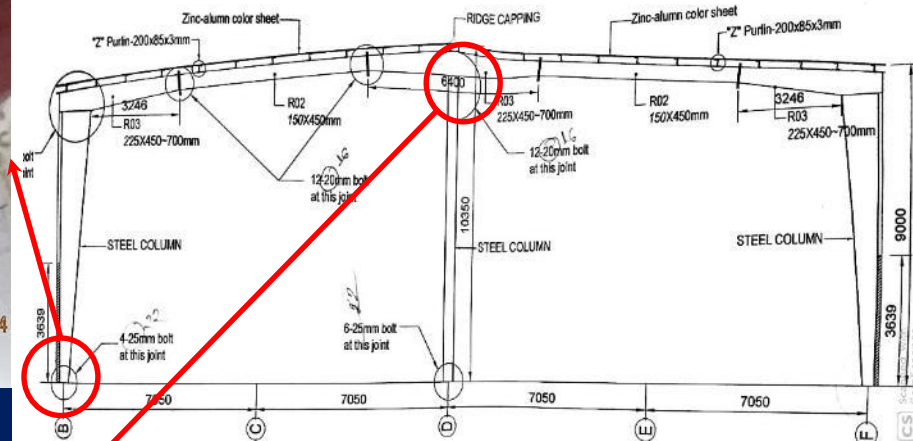
Section drawing

Connection and anchor bolt details provided in as built drawing did not match with on site condition.
Bracing layout or bracing details wasn't incorporated in the as-built drawings.

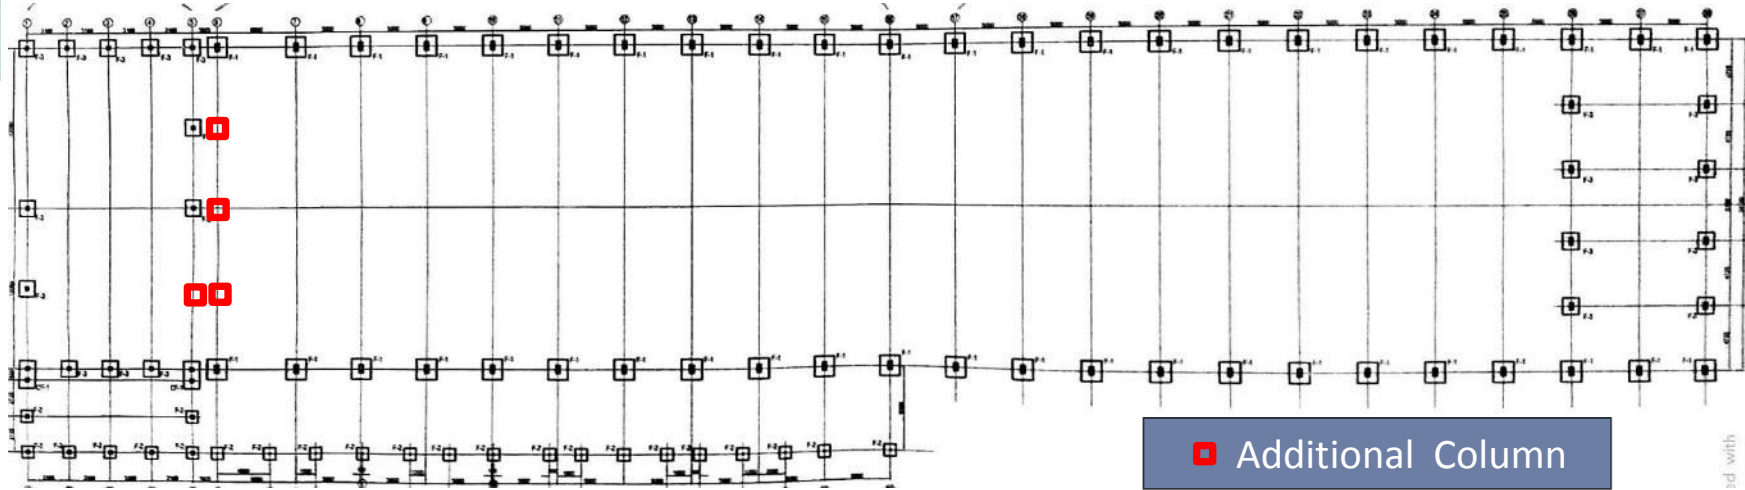
Column layout plan

8-20 mm rebars were found in C1 type columns instead of 12-20 mm rebars.

Number of reinforcement mentioned in the as-built drawing was not representative of on site condition. Column layout also did not match with the drawing.

| Item No. | Observation | Recommended Action Plan | Recommended Timeline |
|---|--|--|---|
| 7 | Incomplete as-built drawings. (Dyeing Shed) | Building Engineer to survey the whole structure and prepare accurate as-built drawings representing actual on-site condition. | 6-weeks |

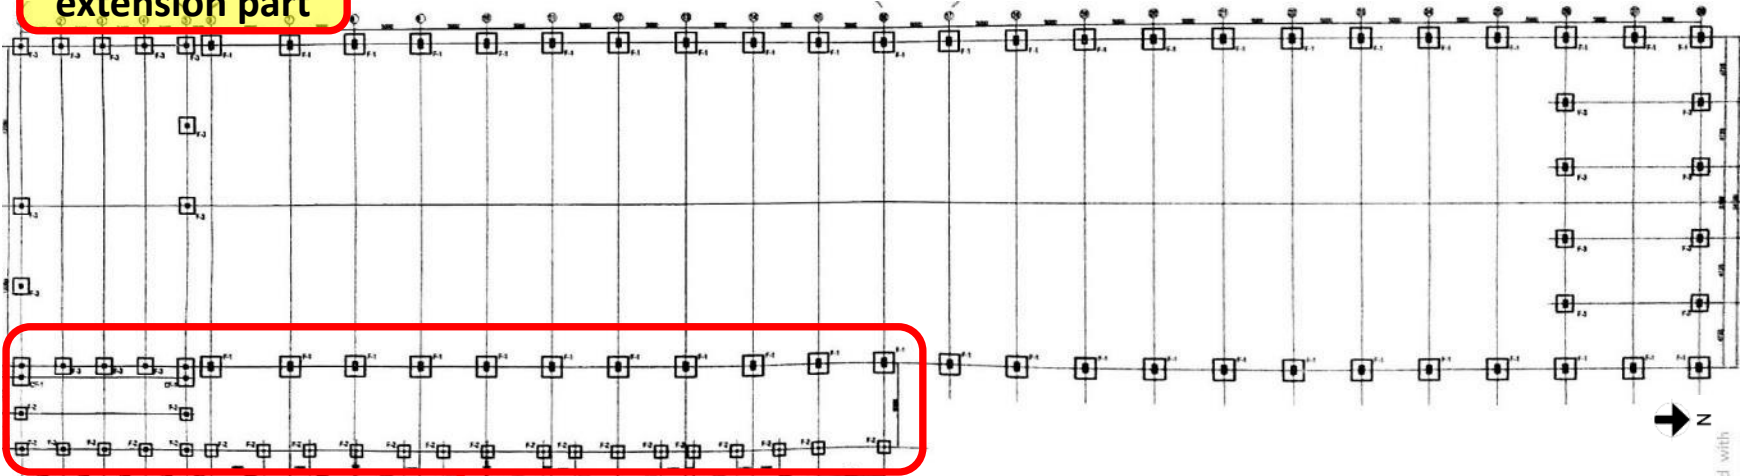
Column layout plan

Extension part in western side of the shed shown in the as-built drawing was not representative of on site condition. There was also an undocumented extension part of the shed.

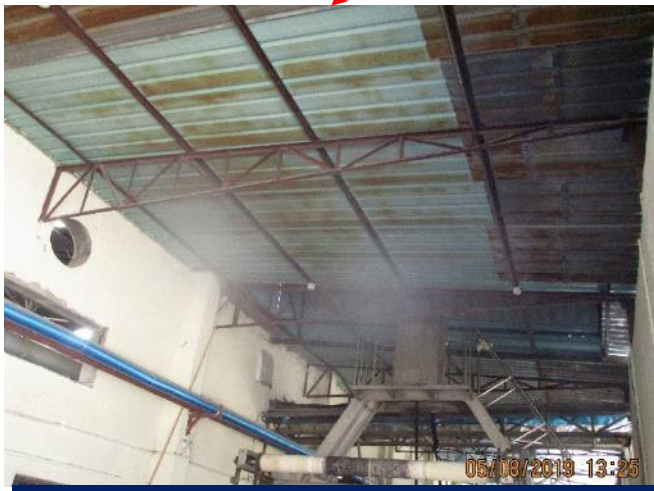
Extension part of the shed mentioned in the drawing

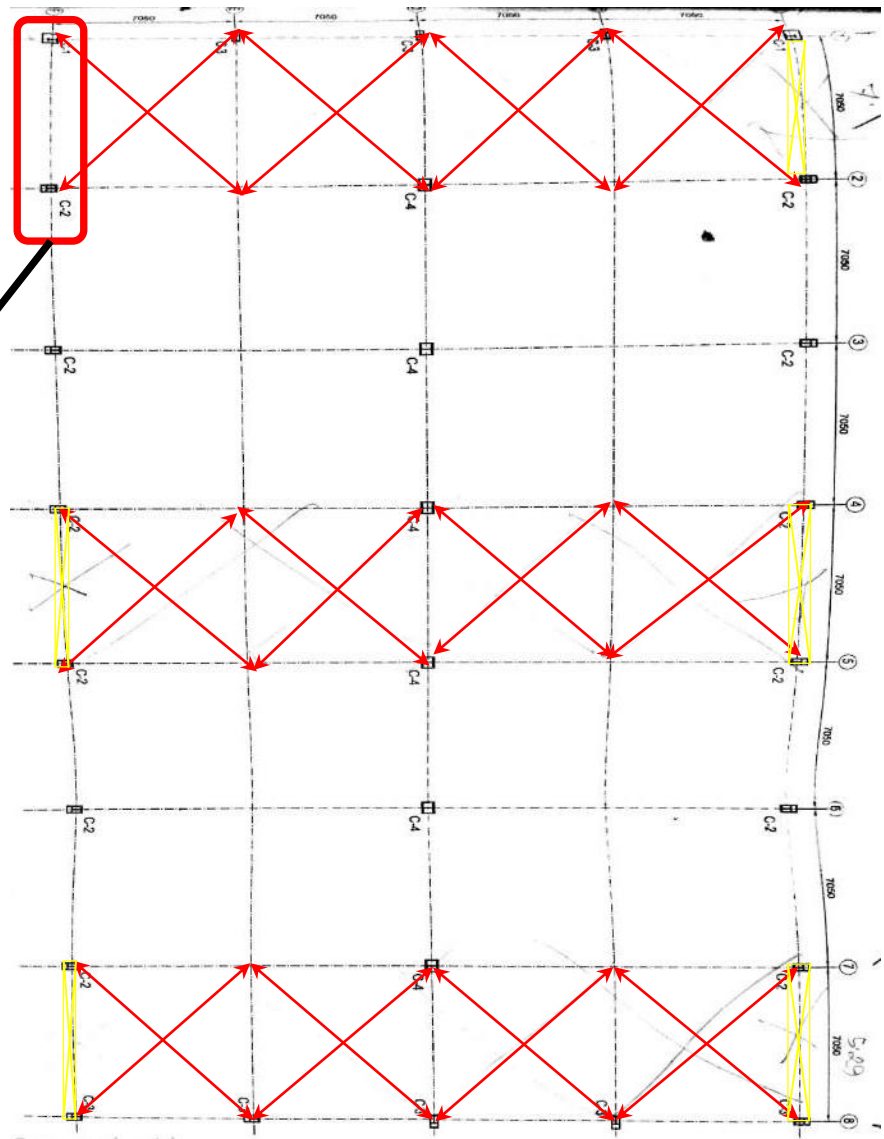
Bracing layout plan (New Part)

Vertical bracing was not found at grid F between 1 & 2.
Bracing layout for new part of the shed was not incorporated in the as-built drawing.

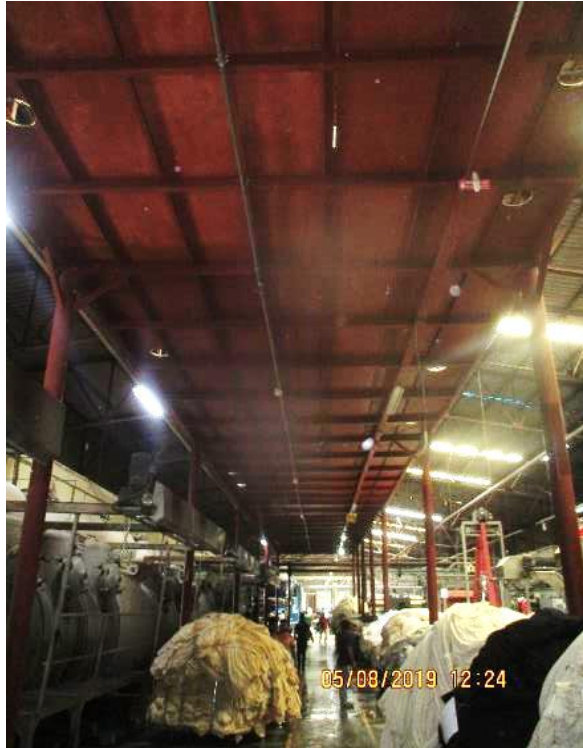
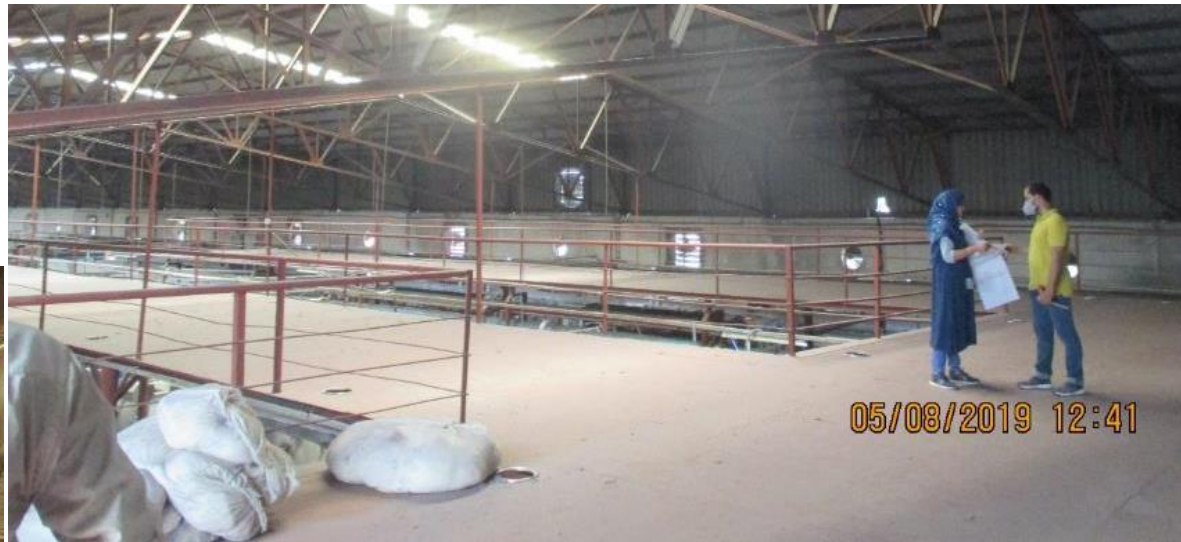
Steel Mezzanine Floor

A self supported steel mezzanine was observed in the shed for proposed store. Apparently inadequate member was observed to carry the proposed storage load. Building Engineer is required to check the adequacy of the mezzanine for vertical loading and prepare a load plan.

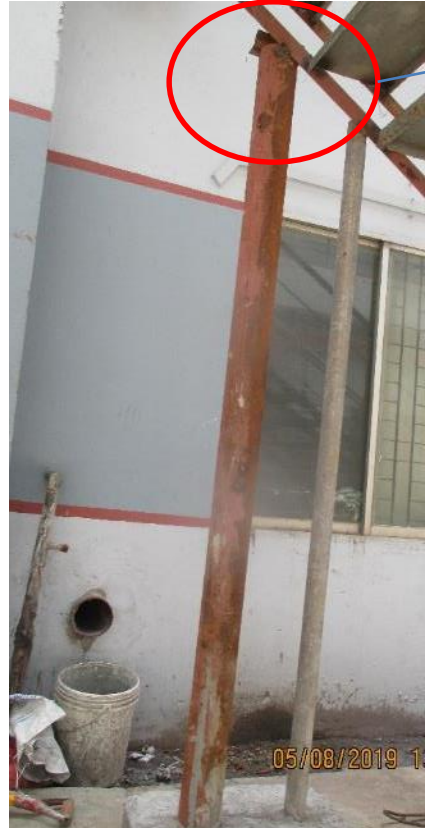
Pipe column

Apparently non-engineered steel stair was observed adjacent to dyeing shed which is used for ascending on steel mezzanine. No drawings were available for those stair. Poor connection between the members was observed.

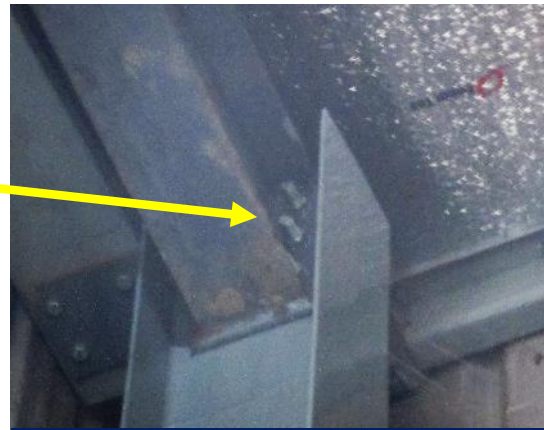
Joint J1 has 8-16 mm bolts instead of 8-20 mm bolts as mentioned in as-built drawings

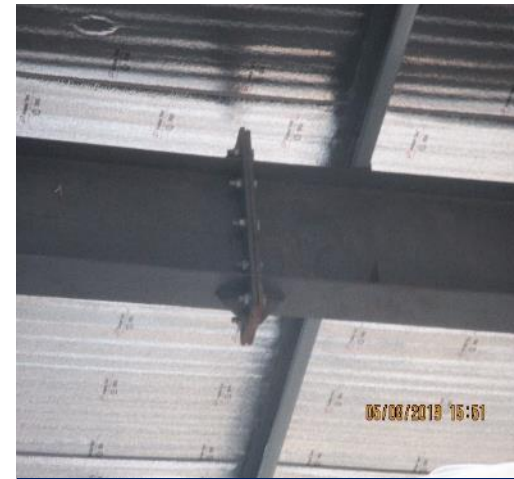
Connection detail was not provided for rafter-rafter joint between grid A to A2

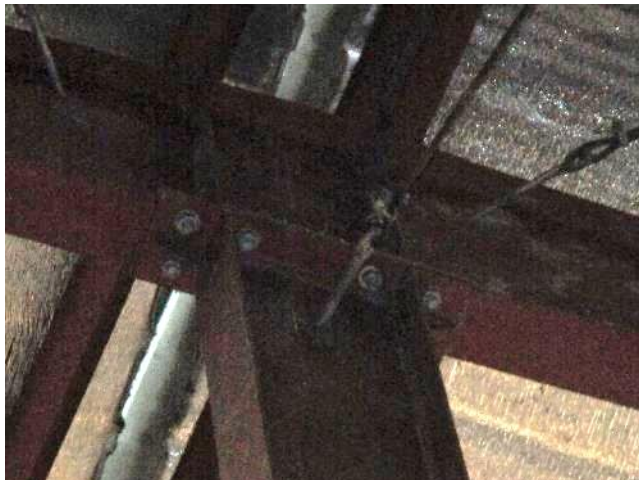
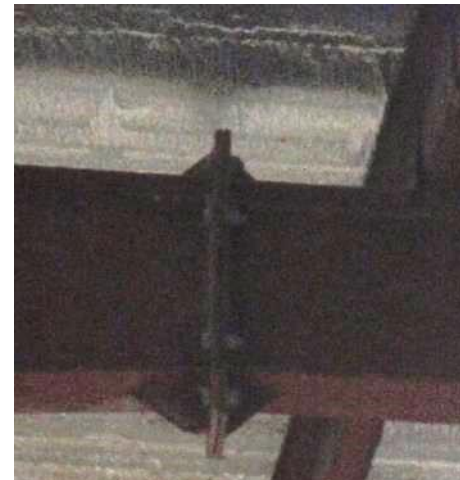
Connection detail for any of the joints was not provided between grid A to E.

No connection details or anchor bolt details was incorporated in provided as-built drawings for joints between grid A to E. Moreover, connection details for grid A to A2 were not complete. Building engineer is required to check for connection adequacy.

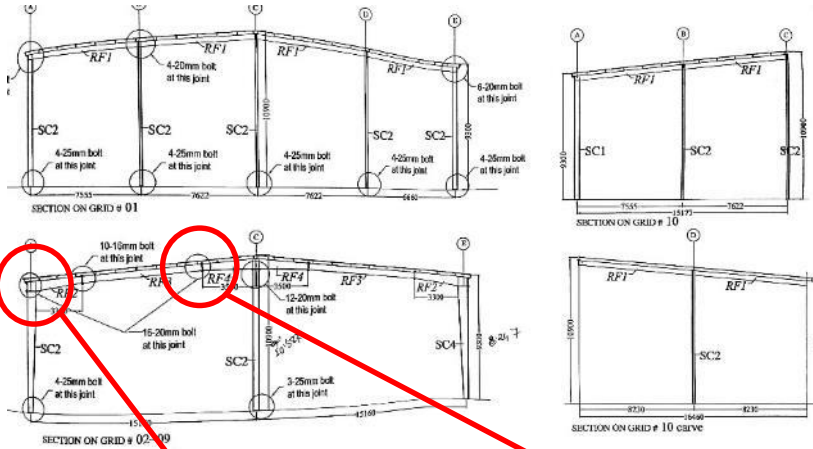
Section drawing

No connection details was provided for Grid 10. Anchor bolt details were not matched with provided drawing. Building engineer is required to survey the whole structure to prepare accurate as-built drawings with actual dimension. Also building engineer is required to check for connection adequacy.

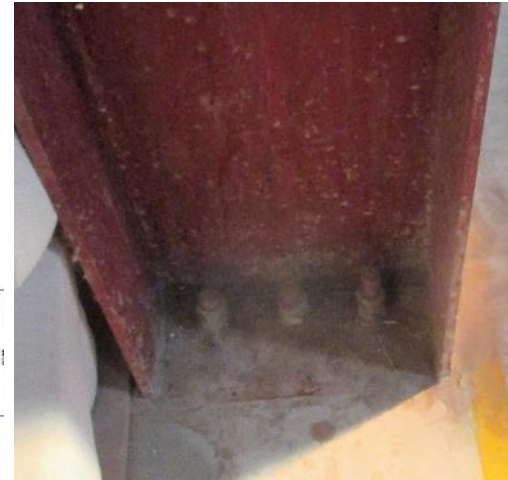
Anchor bolts were 20 mm instead of 25 mm.

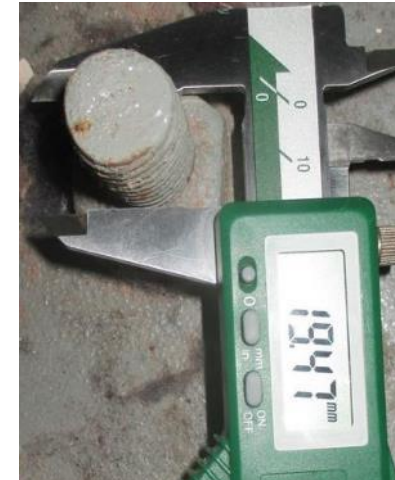
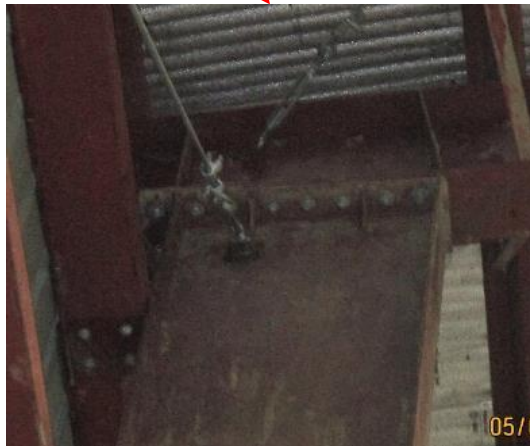
Column-rafters joint has 16-16 mm bolts and rafter-rafters joint has 12-16 mm bolts instead of 16-20 mm bolts as mentioned in as-built drawings.

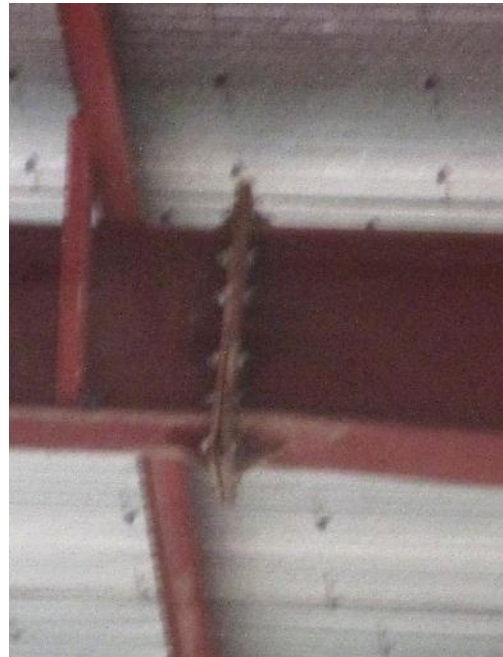
Gap between rafter-rafter connections

Existence of significant gap was observed between column-rafter and rafter-rafter connections at several locations. Building engineer is required to take required remediation to diminish the gaps between the connections.

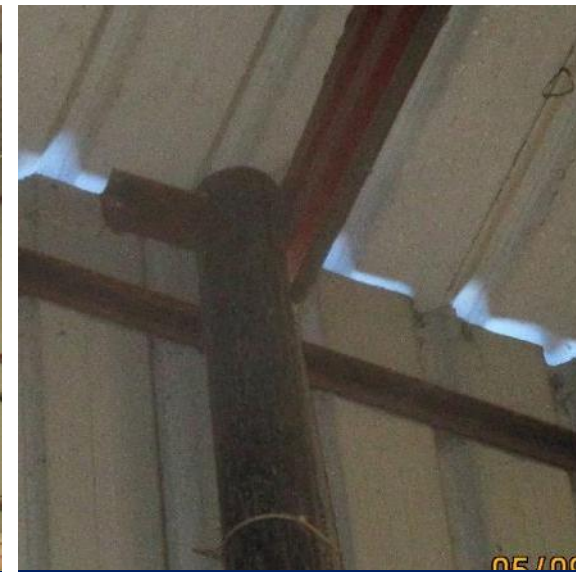
Rafter-column connection

No apparent lateral stability system was observed in Worker Dining, Left-Over Store and Finishing Accessories. The connections between truss and pipe columns appeared to be inadequate in all those sheds.

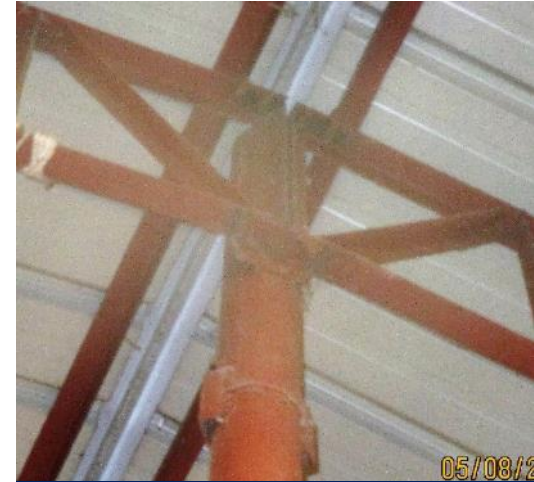
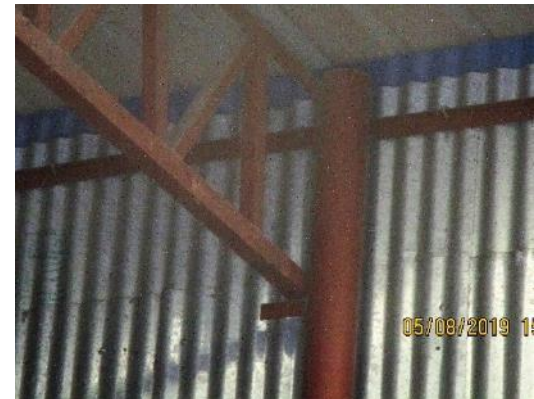
Rafter-column connection

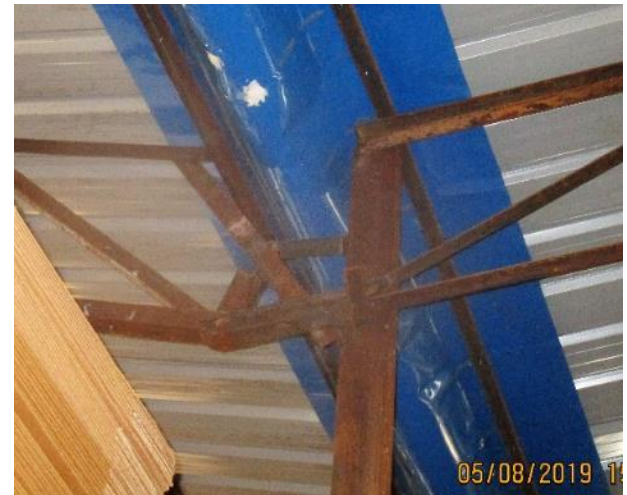
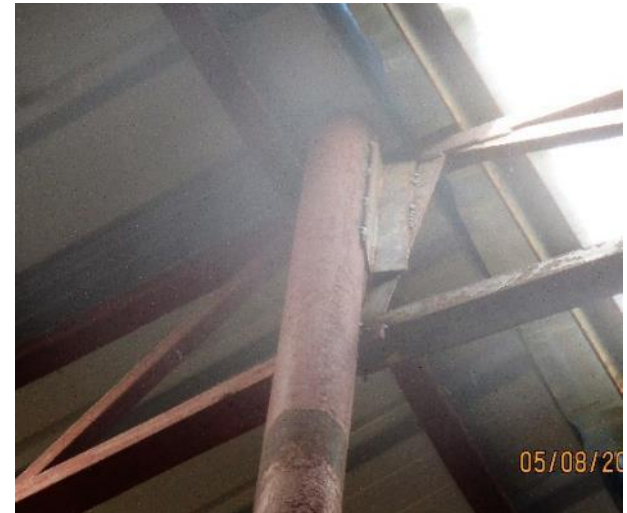
Rafter-column connection

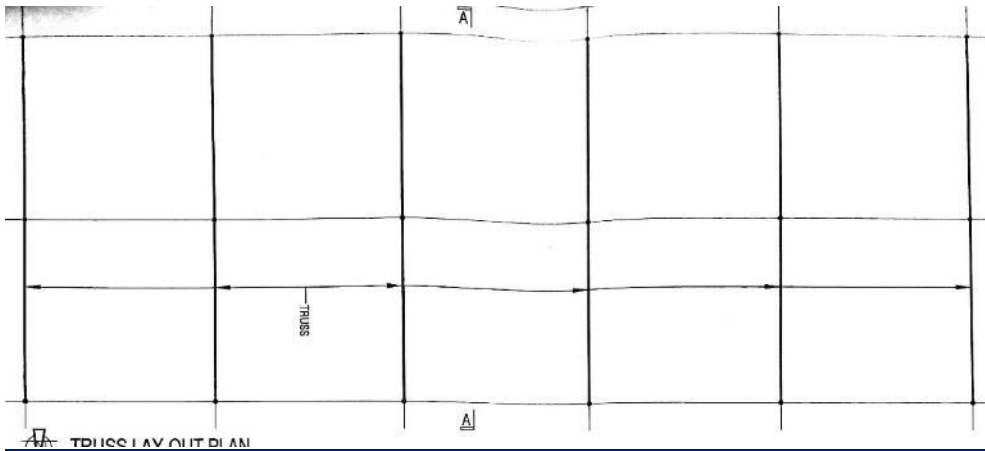
Truss layout plan was provided in the as-built drawing but no truss details was incorporated in it. Anchor bolt details were not matched with provided drawing.

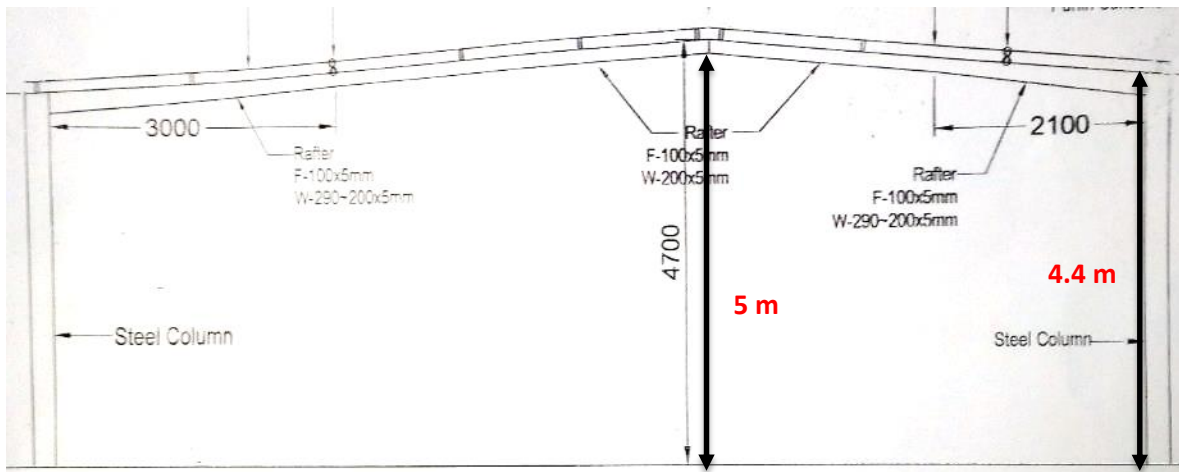
Column layout plan

No anchor bolt details was incorporated in provided as-built drawings. Moreover, section height and grid dimensions mentioned in the provided as built drawing (Shown on the layout) does not match the on site condition.

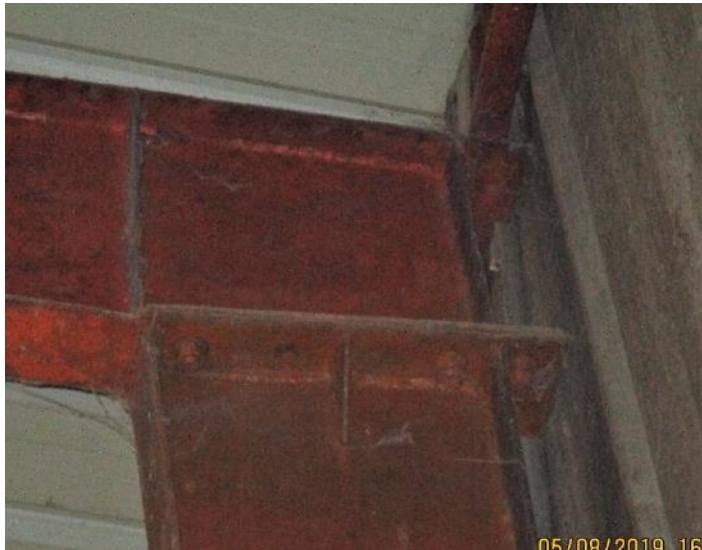
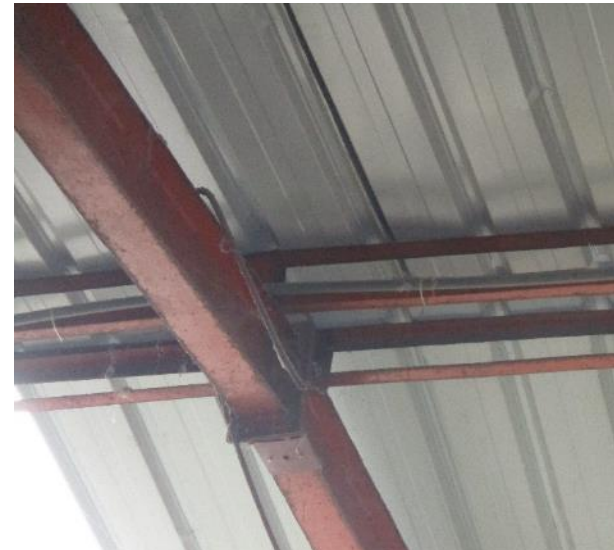
No connection detail was provided for most of the connections (Column-rafter, rafter-rafter connections).

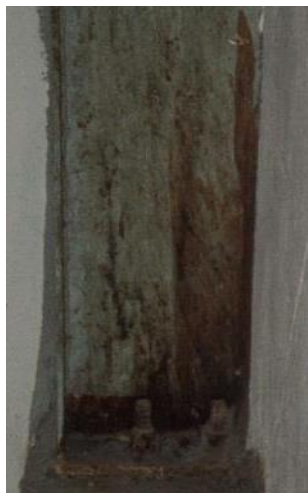
Dyeing shed

Corrosion on steel members

Corrosion was found on columns and rafters of all steel structures.
