# Unity Fabric Industries Ltd (Unit-2)

BAHADURPUR, BHAWAL MIRZAPUR, GAZIPUR 1703, BANGLADESH

15<sup>th</sup> & 22<sup>nd</sup> July 2019

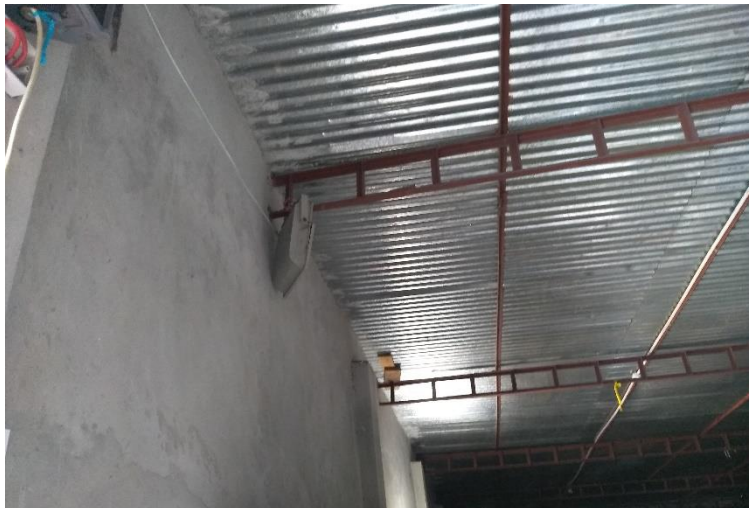
Truss inserted into brick wall

No documents were available for Garbage Shed. Building engineer is required to prepare “as constructed” drawings with complete structural information.

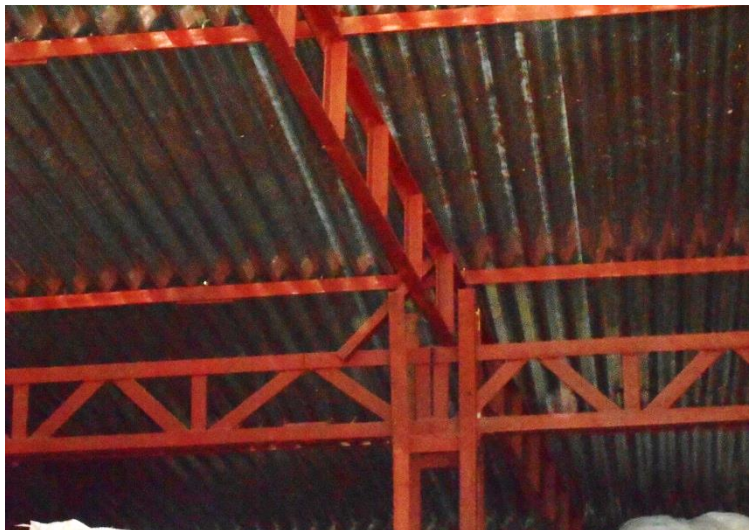
Roof truss system

There is no roof bracing and definite system to transfer the lateral loading through roof. Also, the connections between truss & brick columns are appeared to be inadequate. Factory engineer is required to assess the adequacy of the connections and propose proper suggestions.
