Sams Attire Ltd. (Extension)

Bhuiyan Tower, Plot #10, Jamgora, Ashulia Road, Saver, Dhaka, Bangladesh

20th August 2019

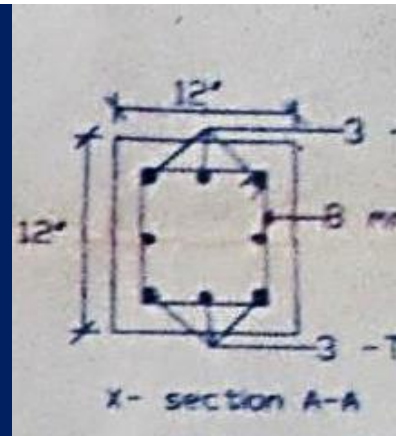
8 rebar was shown in RC column where 4 rebar was found by ferro scanning. Also, column size was found 250 mm instead 300 mm.

A set of permit layout drawings was provided where detail drawings not available. Also, the reinforced concrete column size and rebar detail does not match with on site. The factory engineer is required to survey the structure and prepare a full set of as-built drawings.
