# Aptech Caswier Ltd

Aptech Industrial Park Holding 30, Sarabo Kashimpur, Gazipur.

30<sup>th</sup> September and 13<sup>th</sup> October 2019

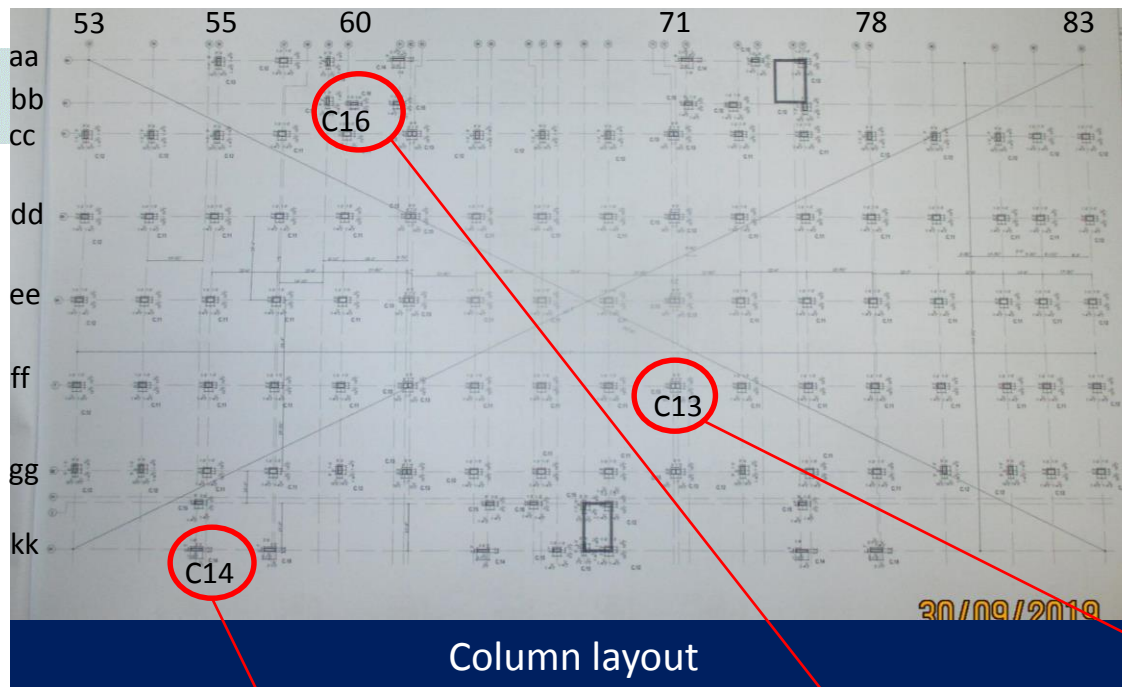
COLUMN SCHEDULE

**Observation: Suit Building**

5 rebar were found in long face of C14 column where 6 rebar shows in the column schedule. (14 rebar found instead of 16)

8 rebar were found in long face of C16 column where 10 rebar shows in the column schedule. (18 rebar found instead of 22)

4 rebar were found in both face of C13 column where 5 rebar shows in the column schedule. (12 rebar found instead of 16)
