BANDO DESIGN LTD. [NEW BUILDING]

PURBA NARSINGHAPUR, EARPUR UNION PARISHAD ROAD, ASHULIA, SAVAR, DHAKA-1349
(23.560502N, 90.181293E)

20th November 2017

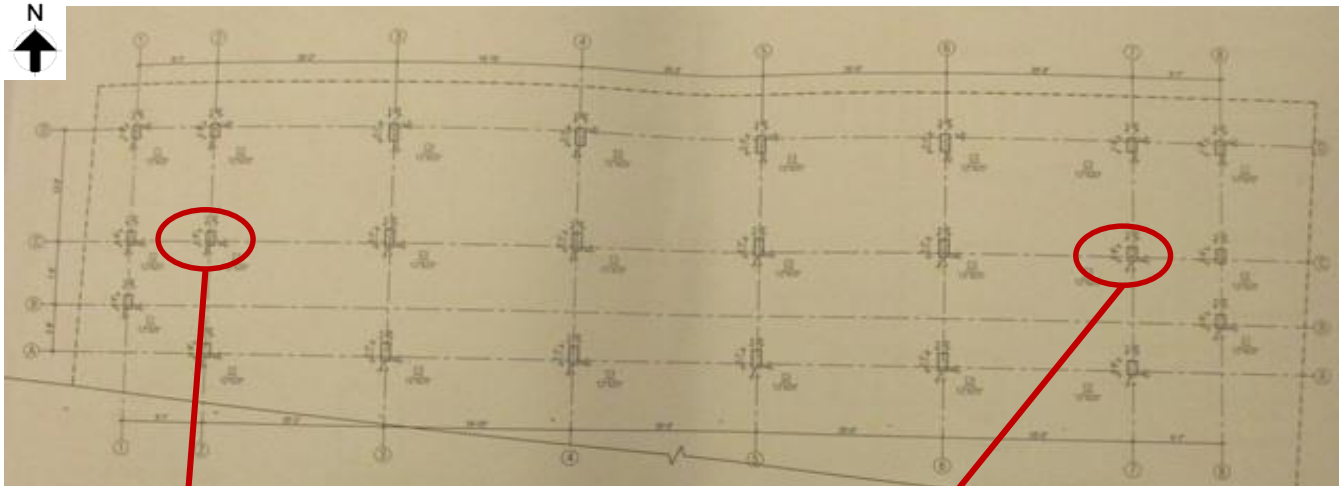
Provided Column Layout

C-2 column size shown 300mm x 500mm in provided drawing

Marked Columns size found 300mm x 680mm which are denoted as C2 (300mm x 500mm) type column in column layout

Marked column size in long direction was measured 680mm

Item No.	Observation	Recommended Action Plan	Recommended Timeline
1	(New building) Discrepancies between provided drawing and on site condition	Building Engineer required to prepare As –Built drawings reflecting the actual condition.	6-weeks
2	(New building) Prepared load plan required to be verified	Maintain 3 Kpa load on all floors.	6-weeks
3	(New building) Prepared load plan required to be verified	Produce and actively manage a loading plan for all floor plates within the factory giving consideration to floor capacity and column capacity if loading above 3kpa is considered.	6-weeks
4	(Bonded warehouse building) Discrepancies between provided drawing and on site condition	Building Engineer required to prepare As –Built drawings reflecting the actual condition.	6-weeks
5	(Bonded warehouse building) Prepared load plan required to be verified	Maintain 3 Kpa load on all floors.	6-weeks
6	(Bonded warehouse building) Prepared load plan required to be verified	Produce and actively manage a loading plan for all floor plates within the factory giving consideration to floor capacity and column capacity if loading above 3kpa is considered.	6-weeks

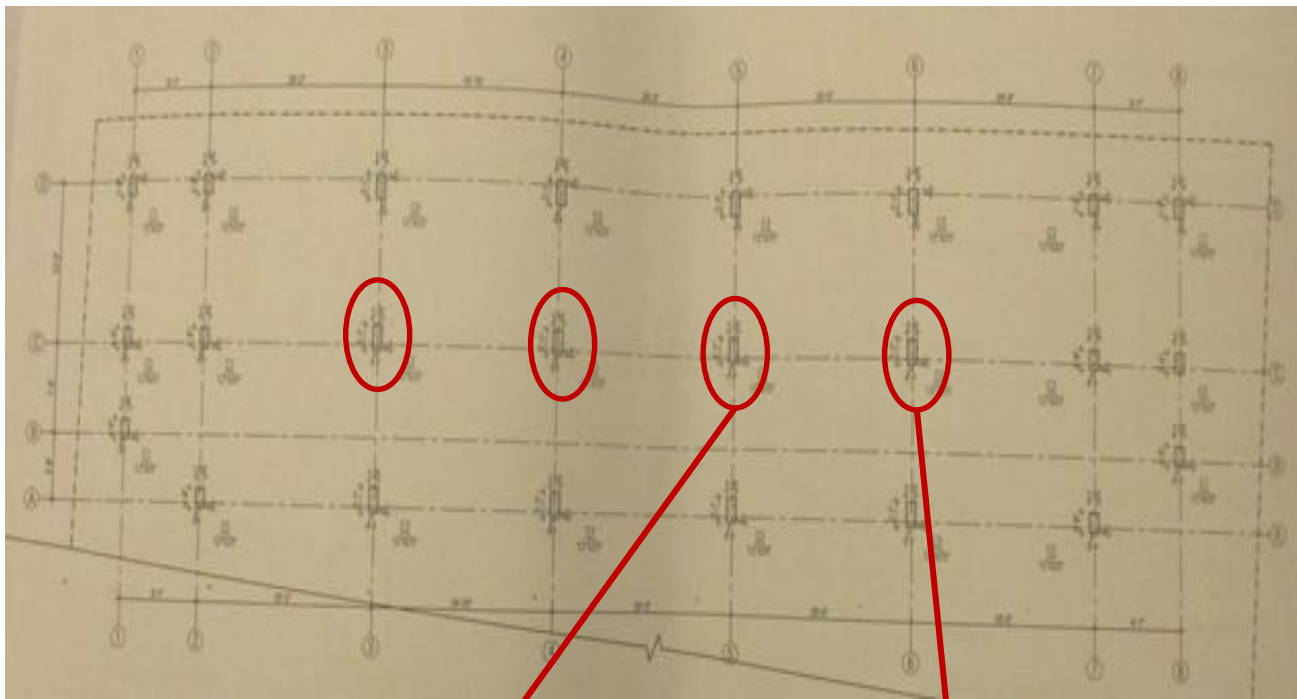
Provided Column Layout

9 nos. rebar were shown on long direction of C3 column in ground floor

5 Nos of reinforcement found in long direction of C3 type columns at ground floor and 1st floor. But in column schedule, 9 nos of rebar shown for same direction of C3 type column.

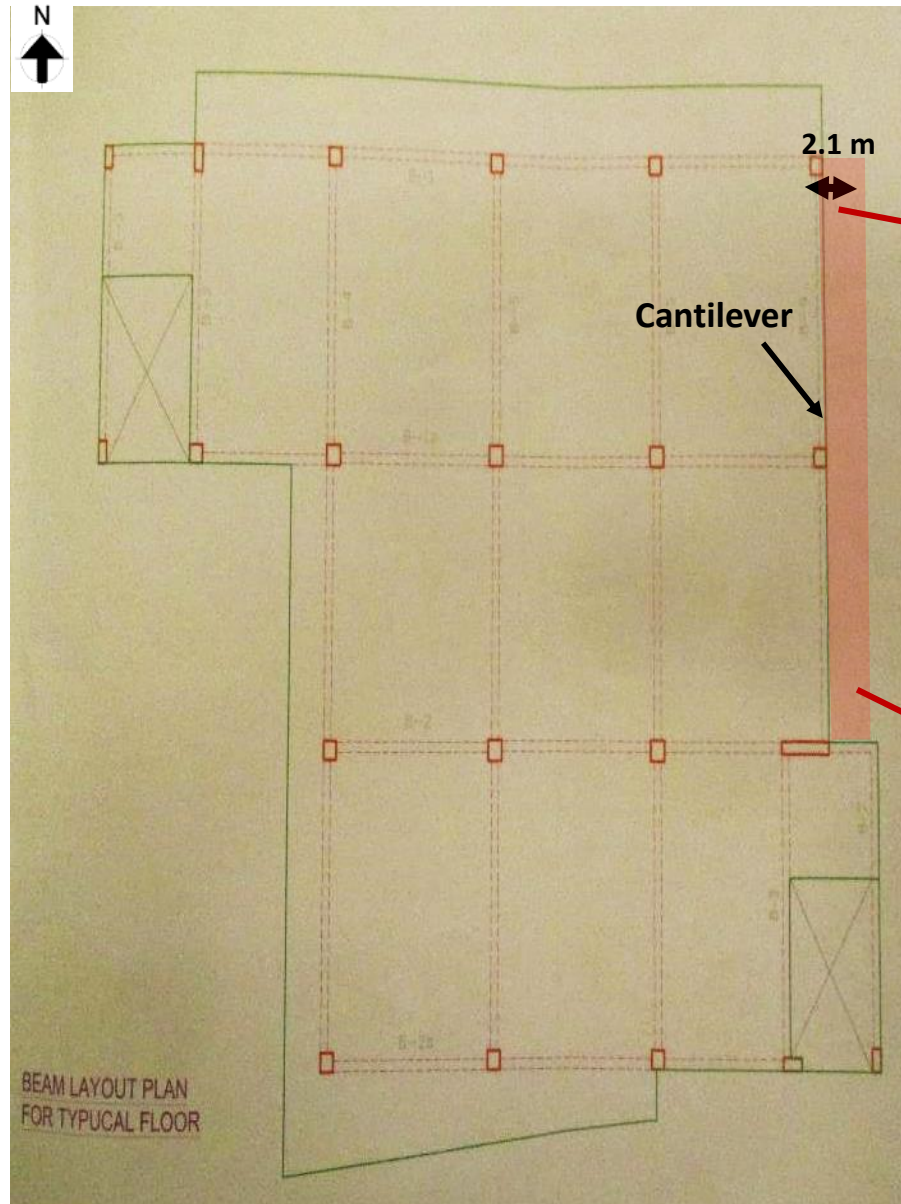
Typical slab layout

Discrepancies between provided drawing and on site condition
