# Torque Fashions Limited sheds 7, 9 & 13

Paragram, Ashulia, Ashulia Bazar, Dhaka, Bangladesh  
(23.877551, 90.332523)

1<sup>st</sup> & 17<sup>th</sup> September 2019

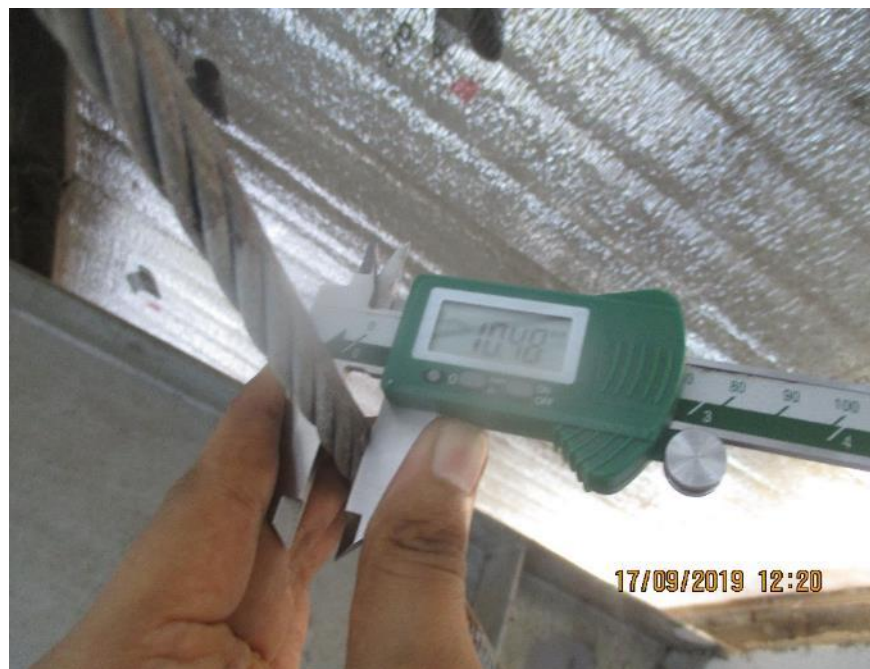
10 mm roof cable bracings were found where the drawings indicate 14 mm bracings. Also connection details were not provided in structural drawing. Moreover 2x1000 ltrs water tanks were found above the toilet block slab.

10 mm roof cable bracing
