# Chorka Textile Ltd (Extension -2)

Kazirchor, Danga, Palash, Narshingdi

15<sup>th</sup> October 2019

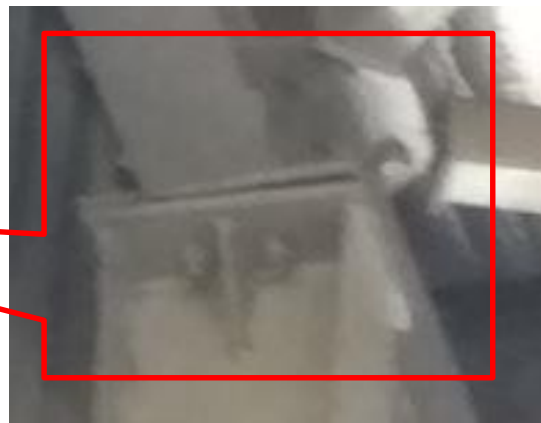
Gap in column-rafter joint

Significant gaps were found in column-rafter-rafter joint. Factory engineer is required to carry out suitable remedial works.

| Item No. | Observation | Recommended Action Plan | Recommended Timeline |
|---|---|---|---|
| 3 | Significant gaps in connection | Factory engineer is required to carryout suitable repair works. | 6-weeks |

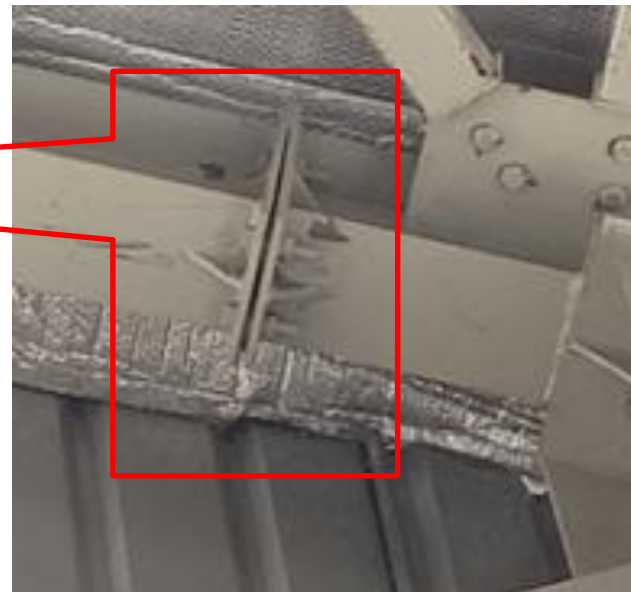
Gap in rafter-rafter joint

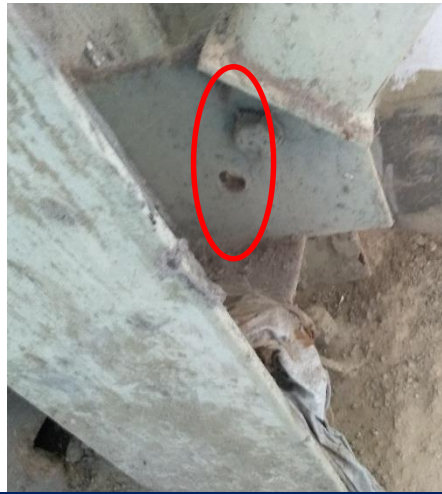
Bolt missing at column-rafter joint

Bolts were found missing in several connections. Factory Engineer is required to identify the locations of missing bolts and install bolts as per specifications.

| Item No. | Observation | Recommended Action Plan | Recommended Timeline |
|---|---|---|---|
| 4 | Bolt missing and light connection | Factory Engineer is required to identify the locations of missing bolts and install bolts as per specifications. | 6-weeks |
