P.M. Knittex (Pvt.) Ltd. -New Building -3

Plot No.- Chowdhuri bari, Godhnail, Narayangonj.

05th November 2019

Discrepancies between as-built drawings and on-site condition

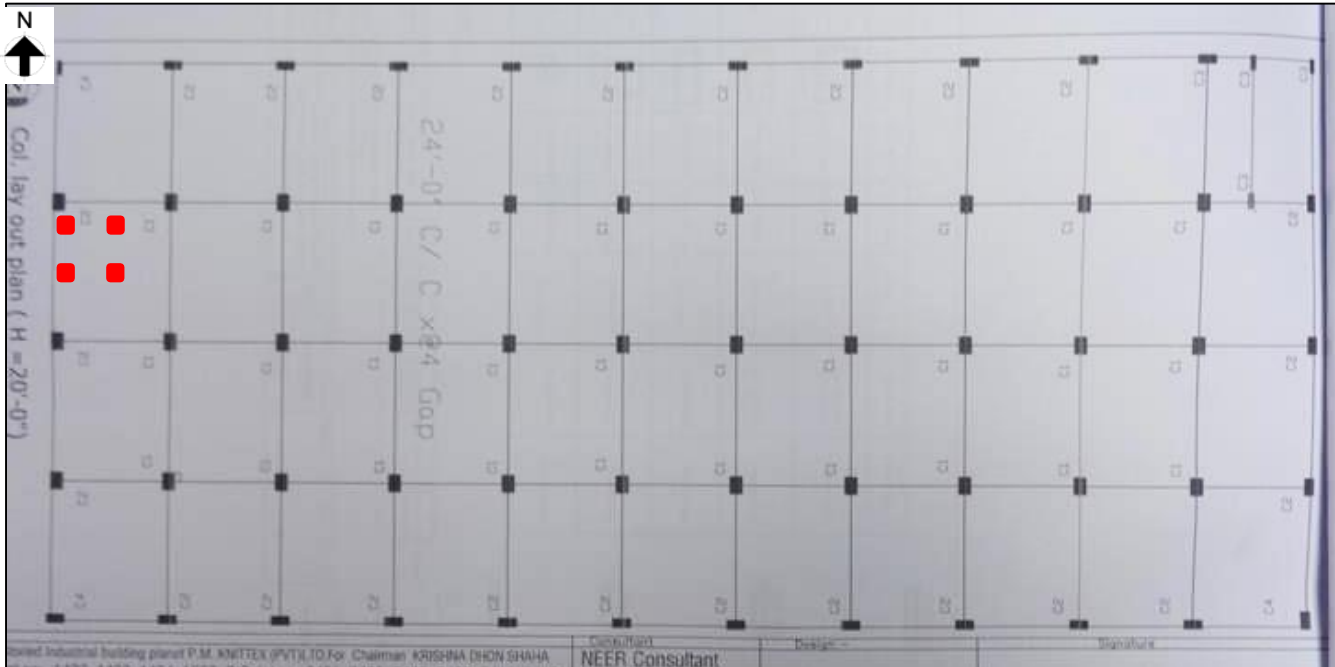
Column Layout Plan

Lift Core

Column size was found 300mmX250mm

Column was found at marked location for lift core. Column size was found 300mmX250mm. But in as-built drawing, no columns has been shown. Grid dimensions was found missing in the column Layout plan.

Item No.	Observation	Recommended Action Plan	Recommended Timeline
1	Discrepancies between as-built drawings and on-site condition	The factory engineer is required to survey the structure and produce as-built drawings with complete structural information.	6-weeks
2	Uncontrolled loading at 1st Floor	Factory is required to prepare the floor loading plan and maintain accordingly.	6-weeks
3	Uncontrolled loading at 1st Floor	Continue to implement load plan.	6-months
4	Column to be stressed above normal design limit for possible vertical extension	The factory engineer is required to carry out a Detail Engineering Assessment considering BNBC provision prior to any extension work.	6-weeks
5	Column to be stressed above normal design limit for possible vertical extension	Carryout remedial works if required.	6-months
6	Corrosion in Exposed Re-bar at roof	All exposed reinforcement to be protected from corrosion.	6-weeks

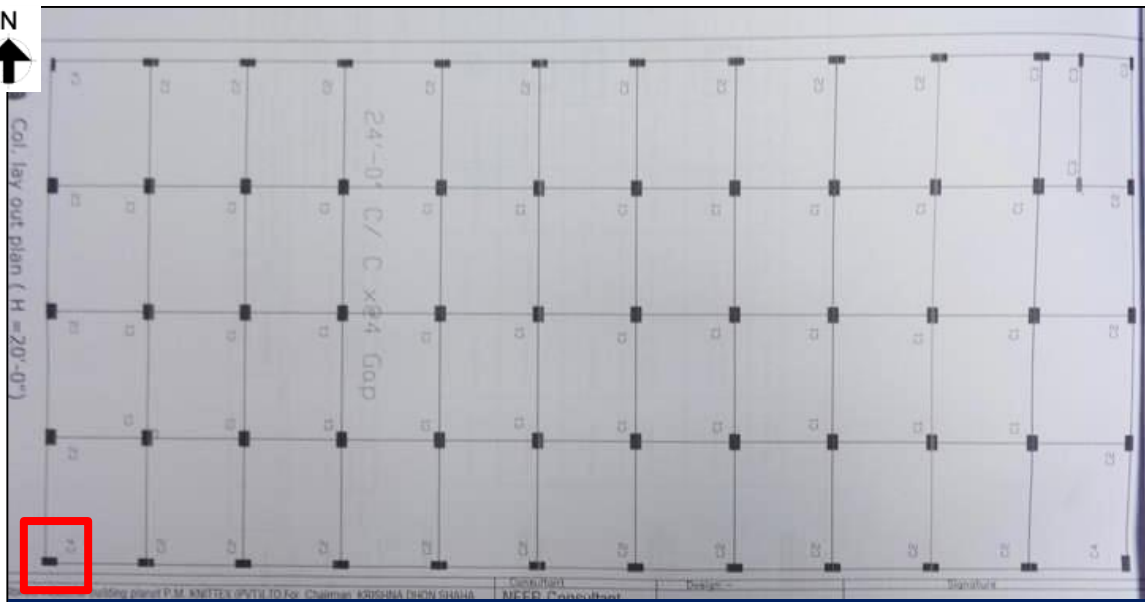
Column Layout Plan

Column Orientation Mismatch

Actual Size of column was found 750mmX450mm

Size of column shown
450mmX450mm

Column orientation was found mismatch with site condition (as shown in drawing). Long face of column was found along north direction. Size of column was found 750mmX450mm instead of 450mmX450mm.
