# Dhaka Garments & Washing Ltd

Dakkhin Vangnahati, Sreepur, Gazipur-1740  
(24.192597, 90.457385)

30<sup>th</sup> December 2019 & 3<sup>rd</sup> February 2020

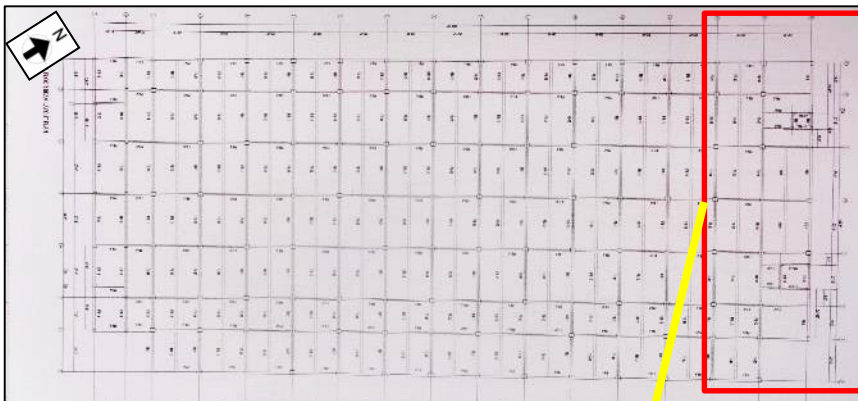
Beam layout plan

In as built, drawing the D/S depth of FB-5 & FB-6 has been shown 375mm. But at factory site, the D/S depth of the Beam was found 250mm.

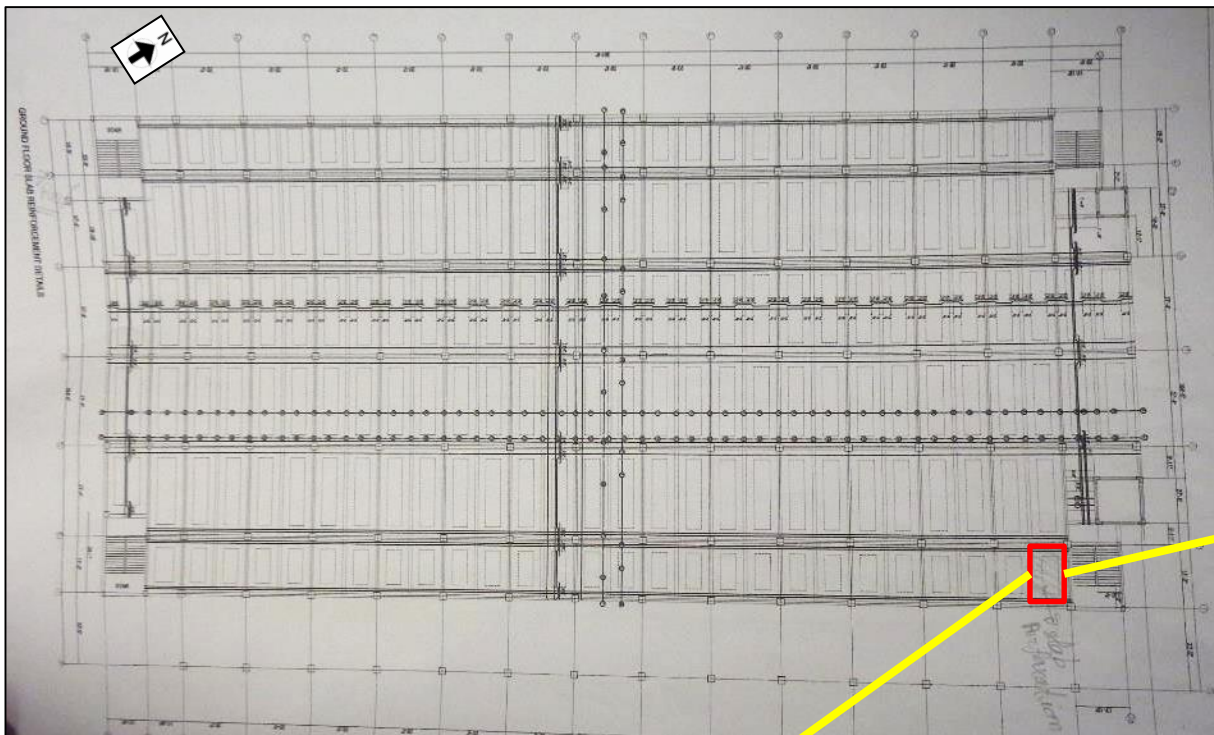
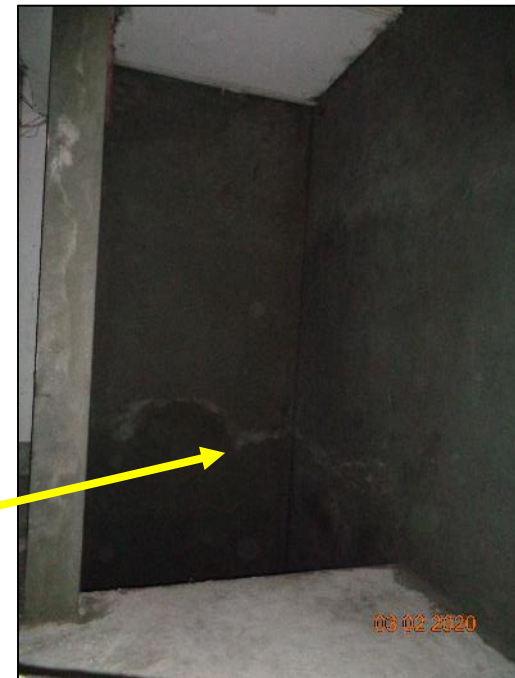
Slab reinforcement details

Slab perforation was found at 1<sup>st</sup> floor for the installation of cargo lift. But no information has been provided in the as built drawing.

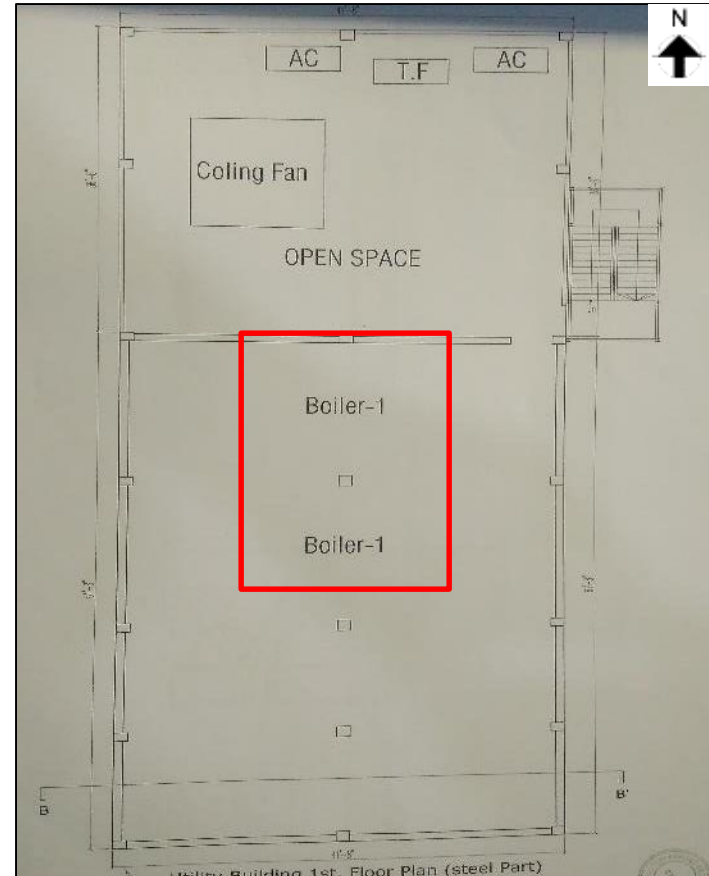
Roof plan

Heavy Boiler machine placed on roof slab

Factory engineer is required to carry out the flexural adequacy check of the roof slab. Suggest any implementation of remediation where required.

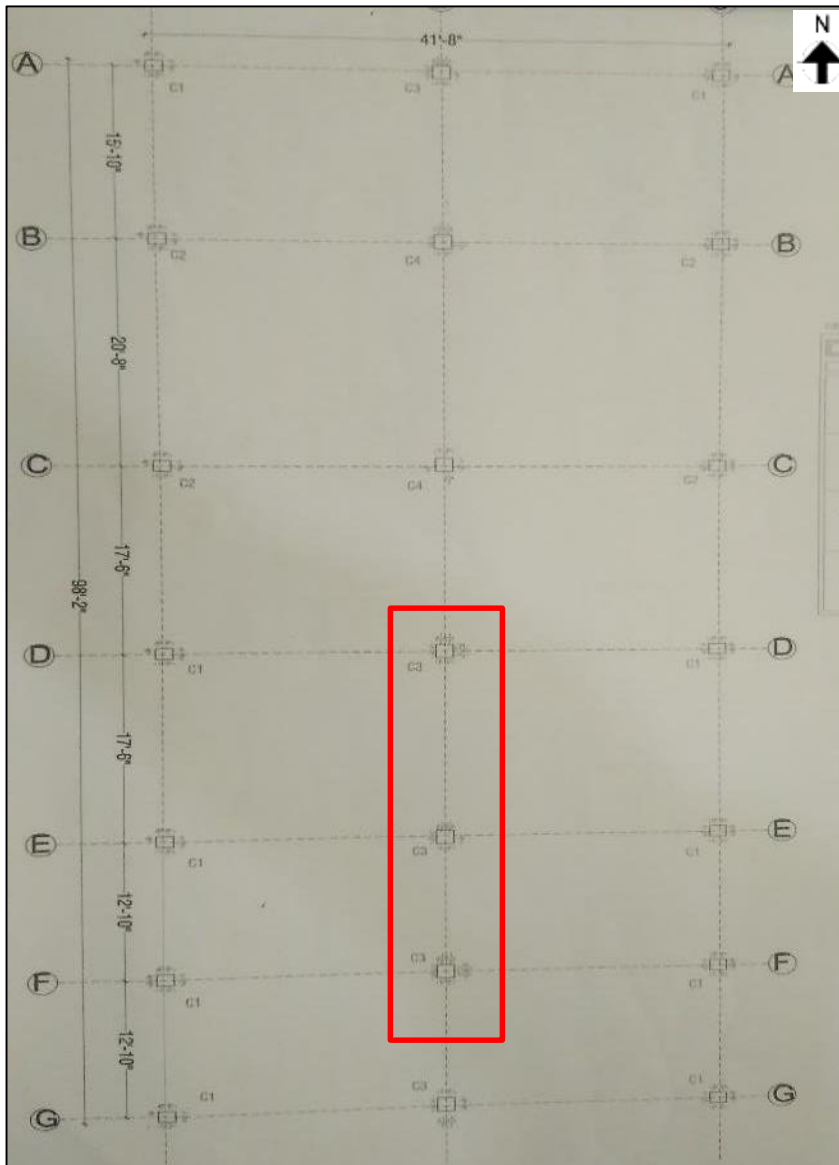
Highlighted columns in layout

Column appeared to be slender with long  
unsupported length

Factory engineer is required to carry out  
the adequacy check of the columns and  
implement remediation if required.

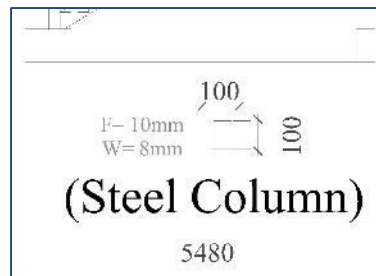
Thickness in  
drawing F10 mm  
W8mm

Discrepancy was found between as-built drawing. The dimension of web of I column was found to be 100 mm instead of 130 mm. the thickness was also found lesser than mentioned.

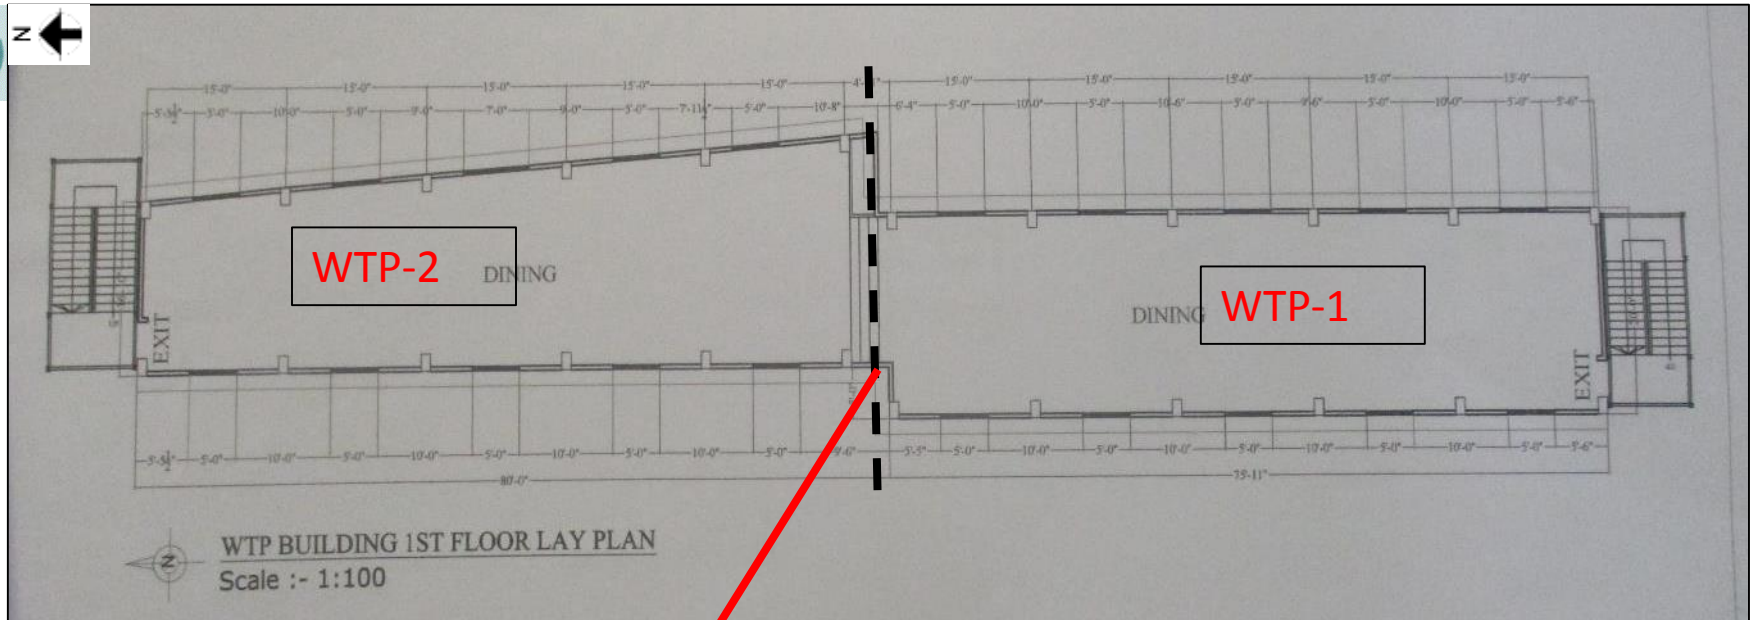
Expansion joint between WTP-1 & WTP-2

**Expansion joint filled with rigid material**

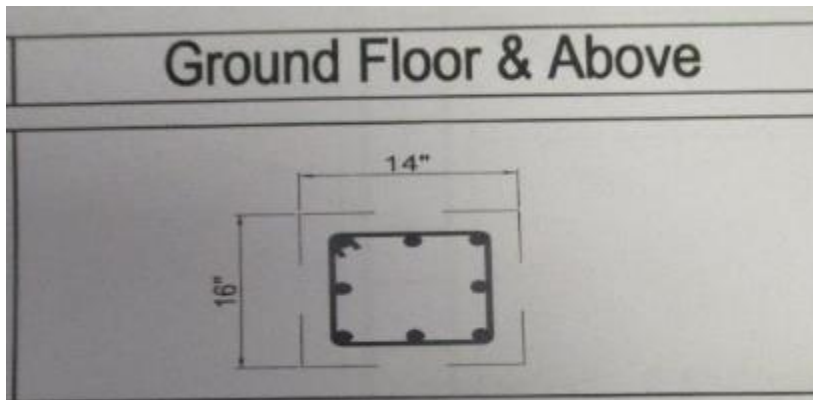
Dimension of pedestal column was measured as 350mmX 300mm without render instead of 400mmX350mm. Also orientation of all internal columns were found 90 degree rotated from original position

Dimension of all column shown as 400mmX350mm

Factory engineer is required to update as-built drawing and carry out the adequacy of the shed considering the changes.

| Item No. | Observation | Recommended Action Plan | Recommended Timeline |
|---|---|---|---|
| 24 | Discrepancy between as-built drawing & as-built condition (Store: Chemical Warehouse) | Factory engineer is required to carry out the adequacy check of the shed considering the changes in as-built drawing. | 6-weeks |
| 25 | Discrepancy between as-built drawing & as-built condition (Store: Chemical Warehouse) | Update as-built drawing. | 6-weeks |

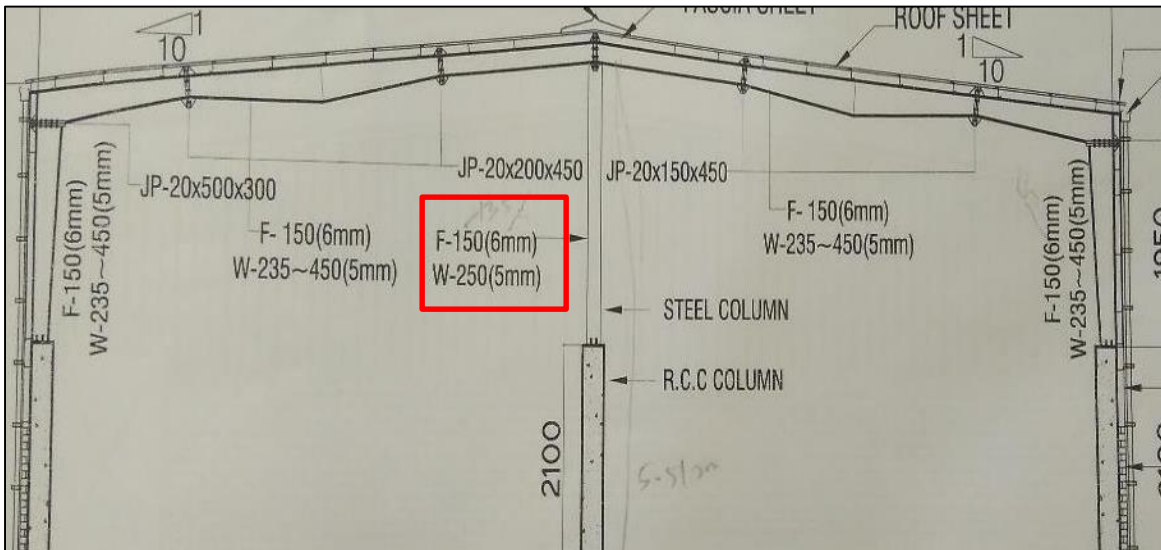
Flange dimension and thickness of all internal steel columns were measured as 135mmX5mm instead of 150mmX6mm

Dimension of flange shown in drawing as 150mmX6mm

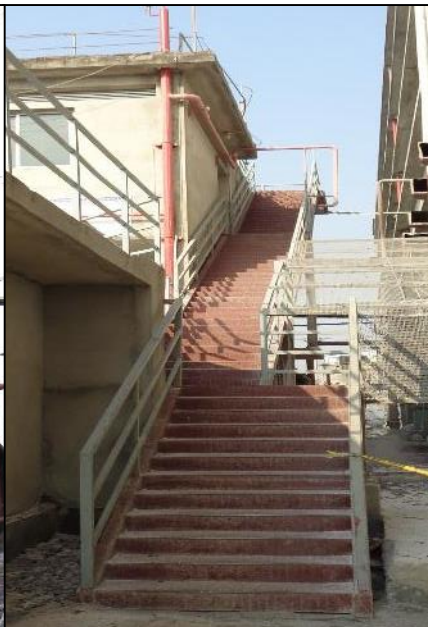
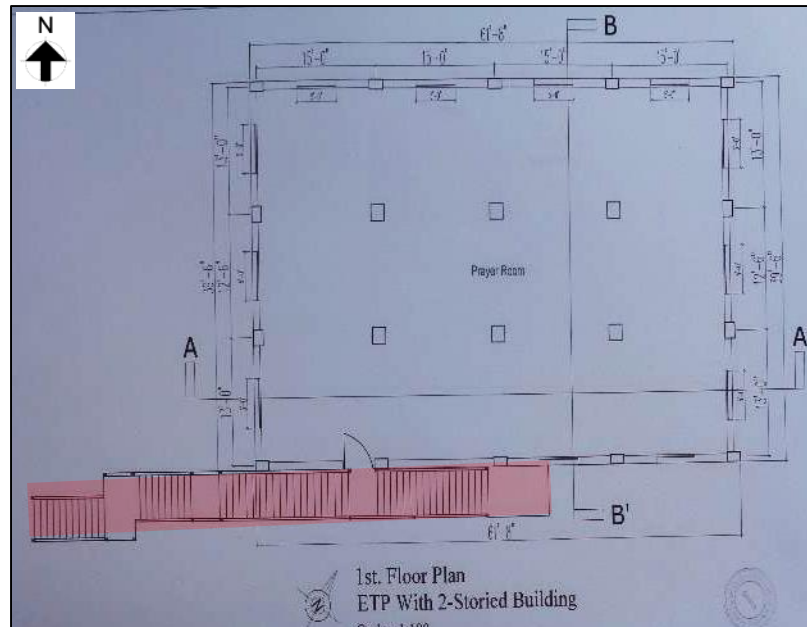
Floor Layout Plan. Steel stair ( marked location)

Steel stair found at south side of the ETP building from ground floor to roof level. No as built-structural drawing was available at site. The stability of the stair is ambiguous. Factory engineer is required to prepare “as constructed” drawings with complete structural information. The factory engineer is also required to carry out Engineering Assessment for the steel stair including connection adequacy check.

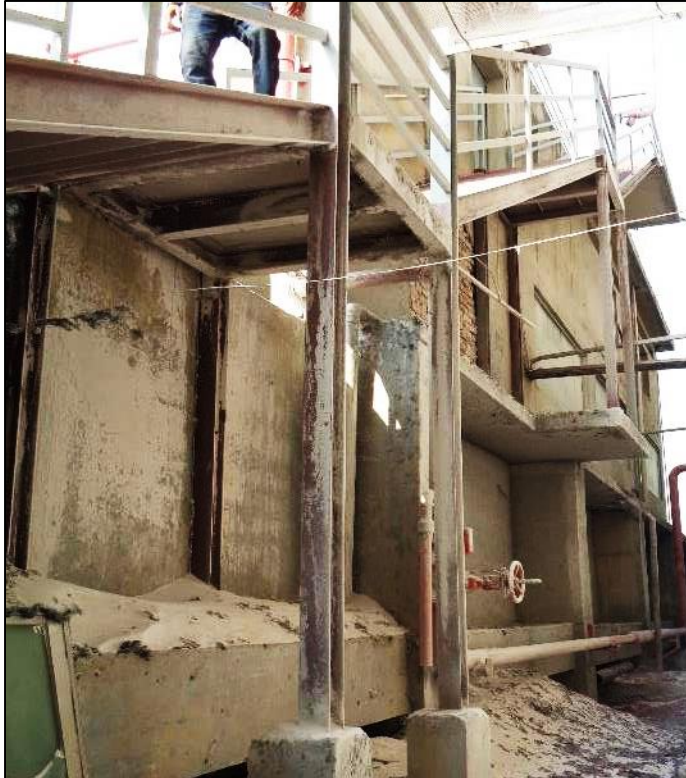
Steel stair

Pier of steel stair resting on RCC cantilever slab of the ETP building. No design documents found to confirm the capacity of the cantilever slab to bear the load from the steel pier. Factory engineer is required to check the capacity of the RCC cantilever slab.
