# GMS Textiles Ltd.

Tansutrapur, Kaliakoir, Gazipur

13<sup>th</sup> January, 16<sup>th</sup> February and 3<sup>rd</sup> March 2020

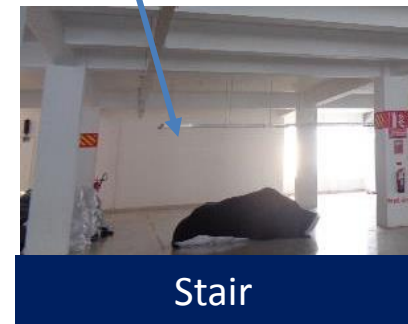
Stair

Mezzanine floor is being supported by some additional columns. No drawings details were found for the mezzanine floor.

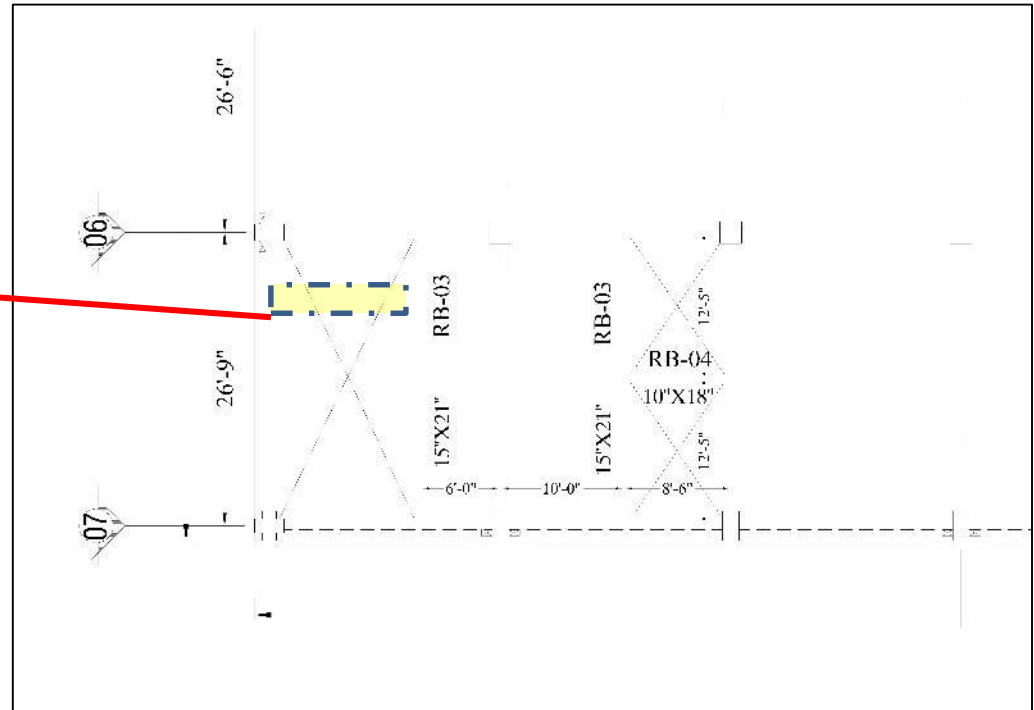
Captured from beam layout

Extra beam was found on the south west portion between grid 07-08 and A-B. the measurement of the beam found to be 305 X 355 mm (d/s). This beam was found only on 1<sup>st</sup> floor.

| Item No. | Observation | Recommended Action Plan | Recommended Timeline |
|---|---|---|---|
| 4 | Discrepancies between as-built structural drawings and onsite condition. (B-5) | The building engineer to check the structure, collect information of missing beam and revised as-built drawings. | 6-weeks |

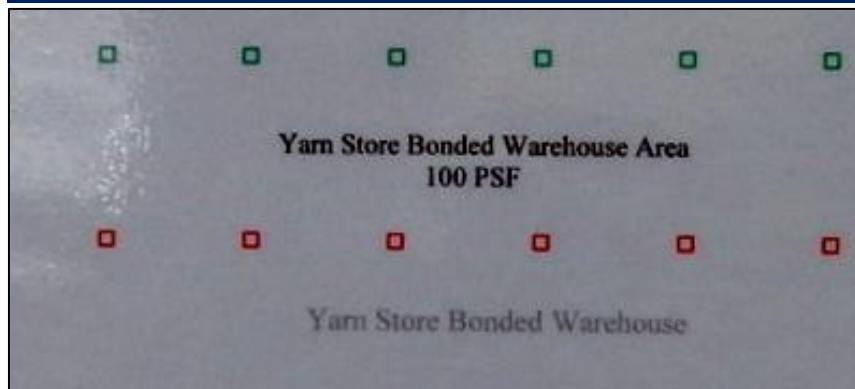
The load plan indicates the maximum allowable live load is 100 Psf (5 kPa). Though no calculation was provided to claim the rationality of using this load plan. No load height marking was observed.

100 Psf (5 kPa) load mentioned in all floors

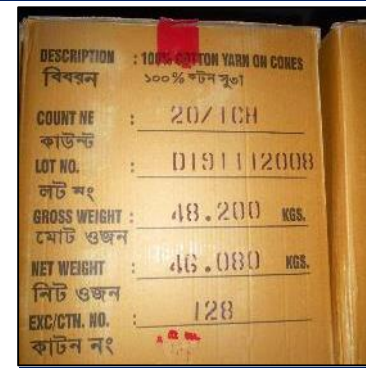
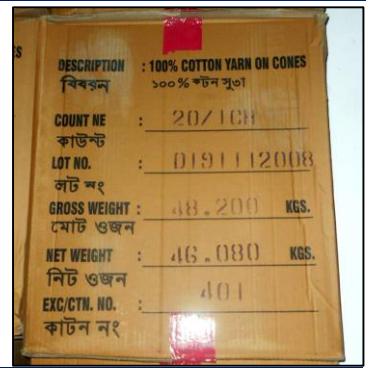
Weight written in the box

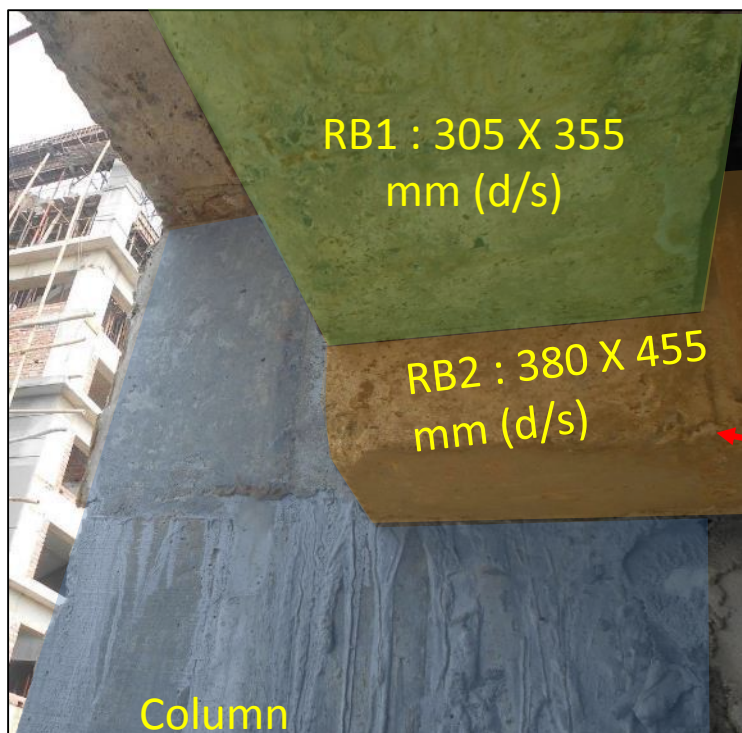
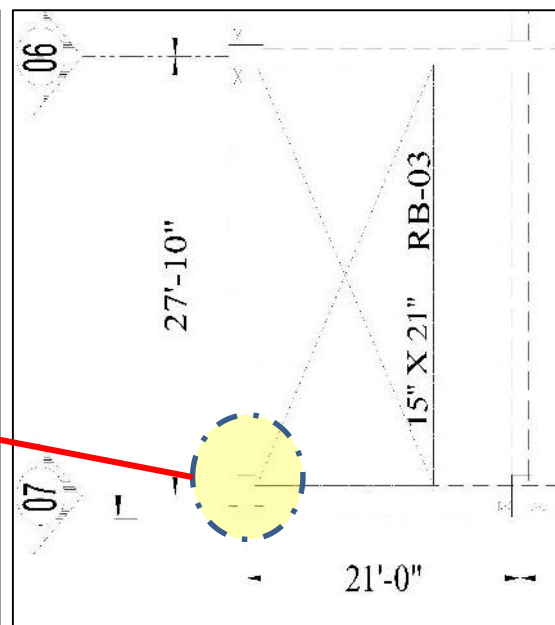
Captured from beam layout

As per the drawing, RB02 was supposed to be connected to column with the edge. There was 125 mm offset found in RB02, which rise question of how the rebar of RB02 is joined with Column. The connection adequacy is required to be verified.

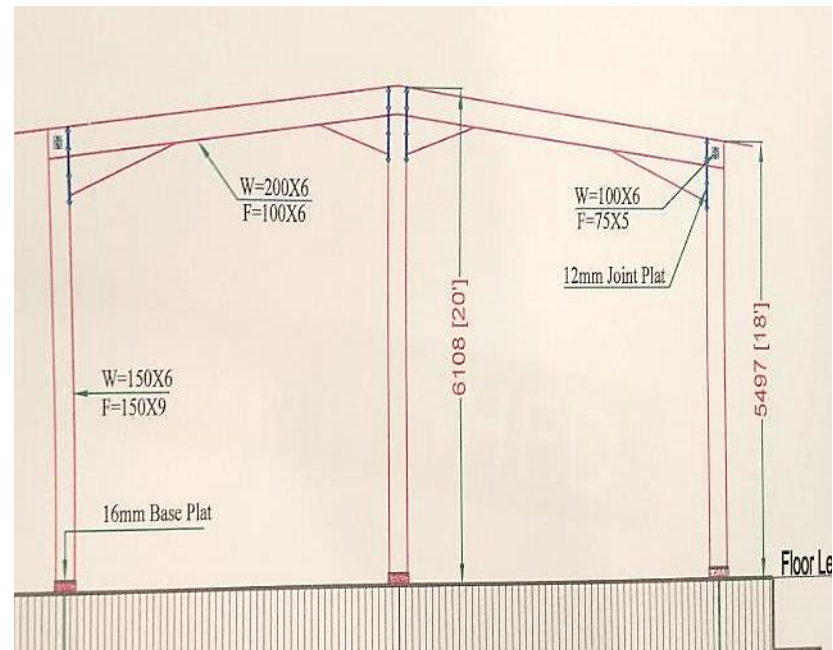
Flange thickness was shown as 9mm for all columns

The factory engineer is required to produce accurate as-built structural drawings.

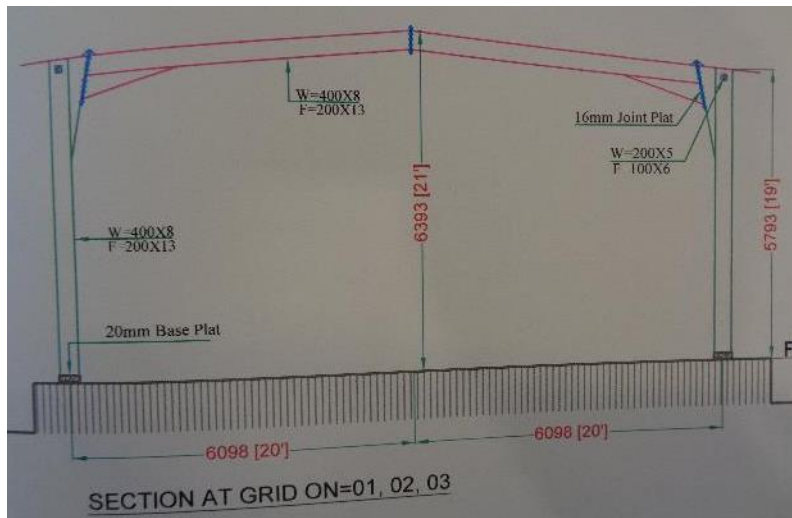
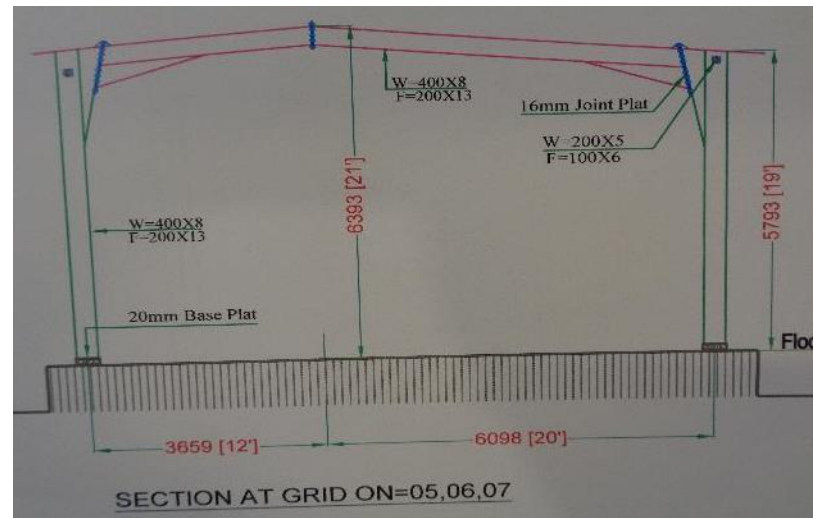
Section of two end grids

Connection details of all connection are not shown in provided drawing  
The factory is required to produce accurate as-built drawing with proper connection detail.

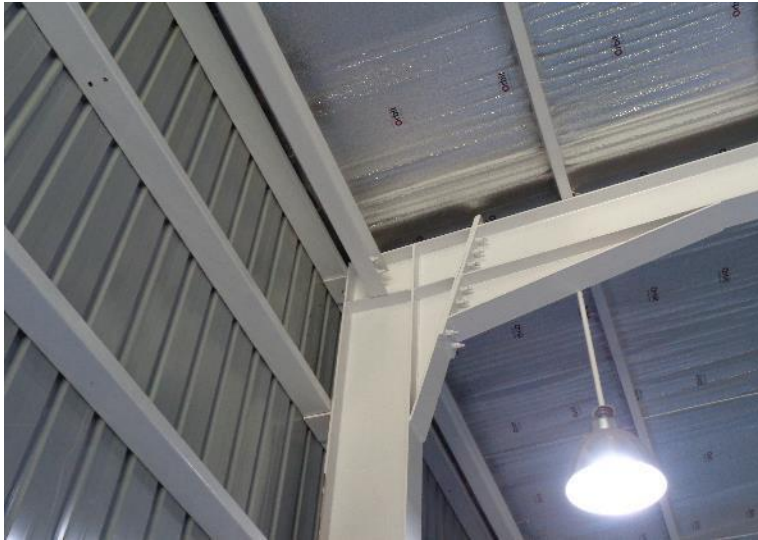
Rafter to column connection

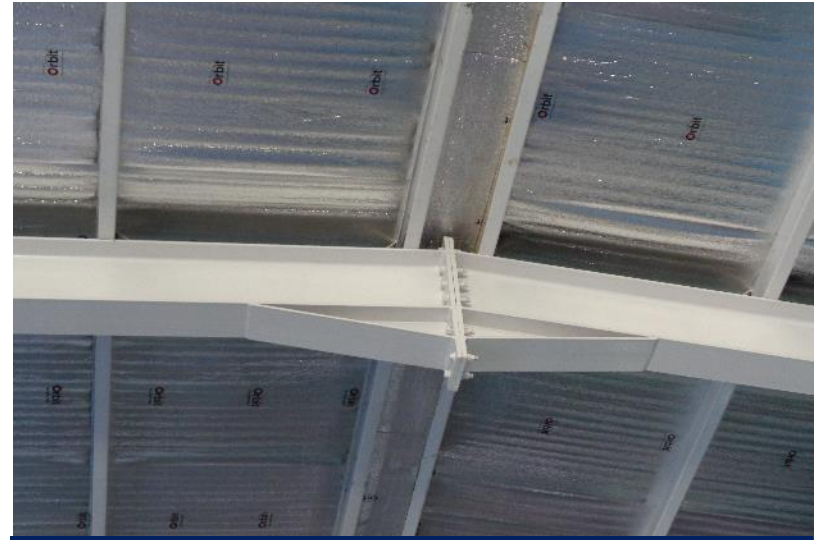
Rafter to rafter connection

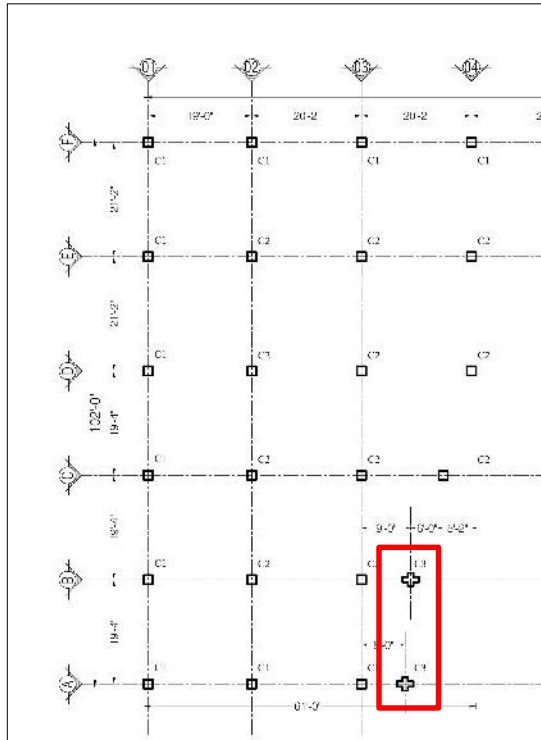
As per column schedule, the shape of C3 column on upper floors was to be rectangular shaped but on site it was found “+” shaped.

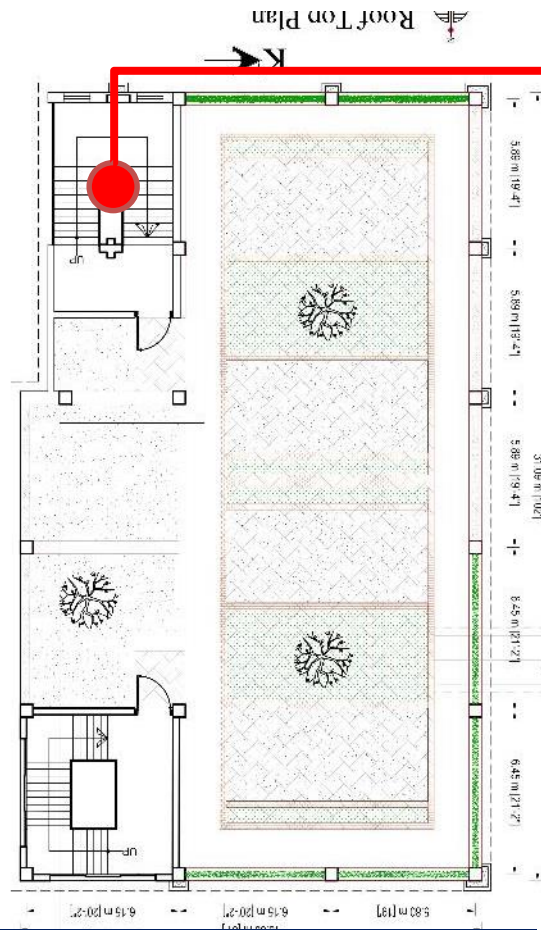
Roof top plan

During inspection, a 3000 liters plastic water tank was found on the roof of southern staircase which not shown in as built architectural drawings.
